James Still Office Preservation Plan

Submitted to:
New Jersey Historic Trust

Prepared by:
KSK Architects Planners Historians, Inc.

Final Copy: 30 October 2009

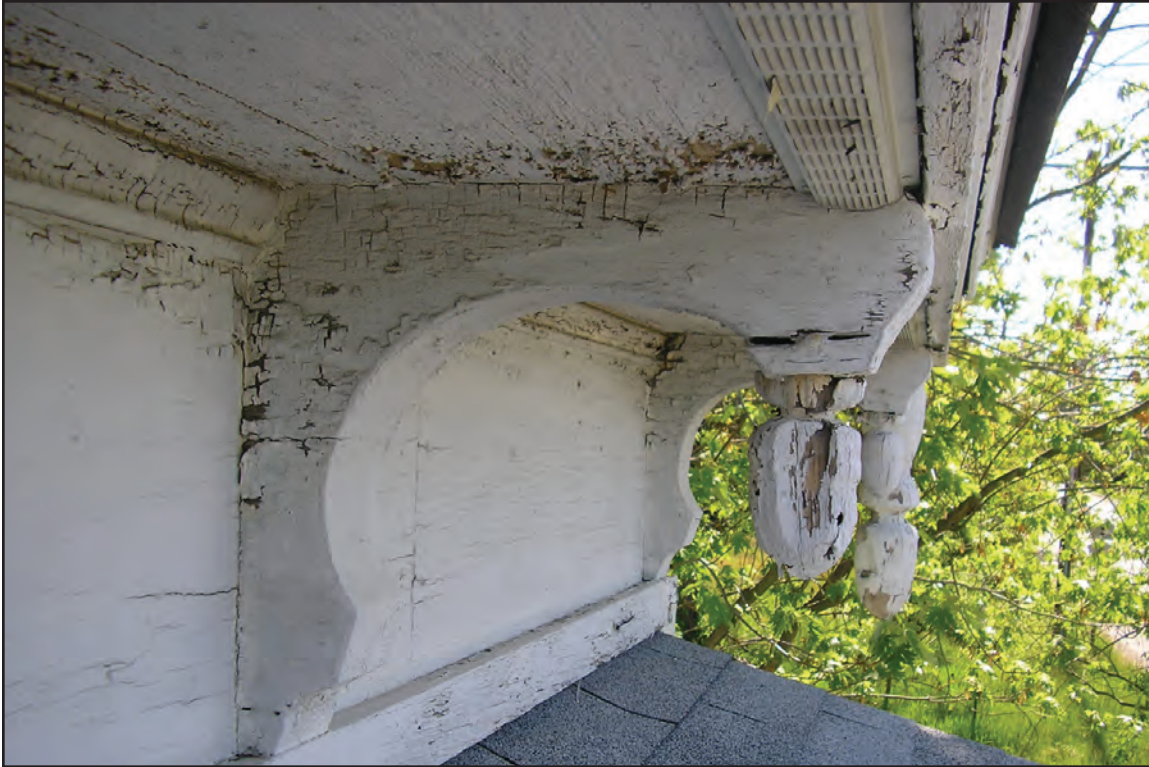
Figure 27 The Office cornice on the south façade. Note the paint deterioration and the loss of detail on the acorn pendant.

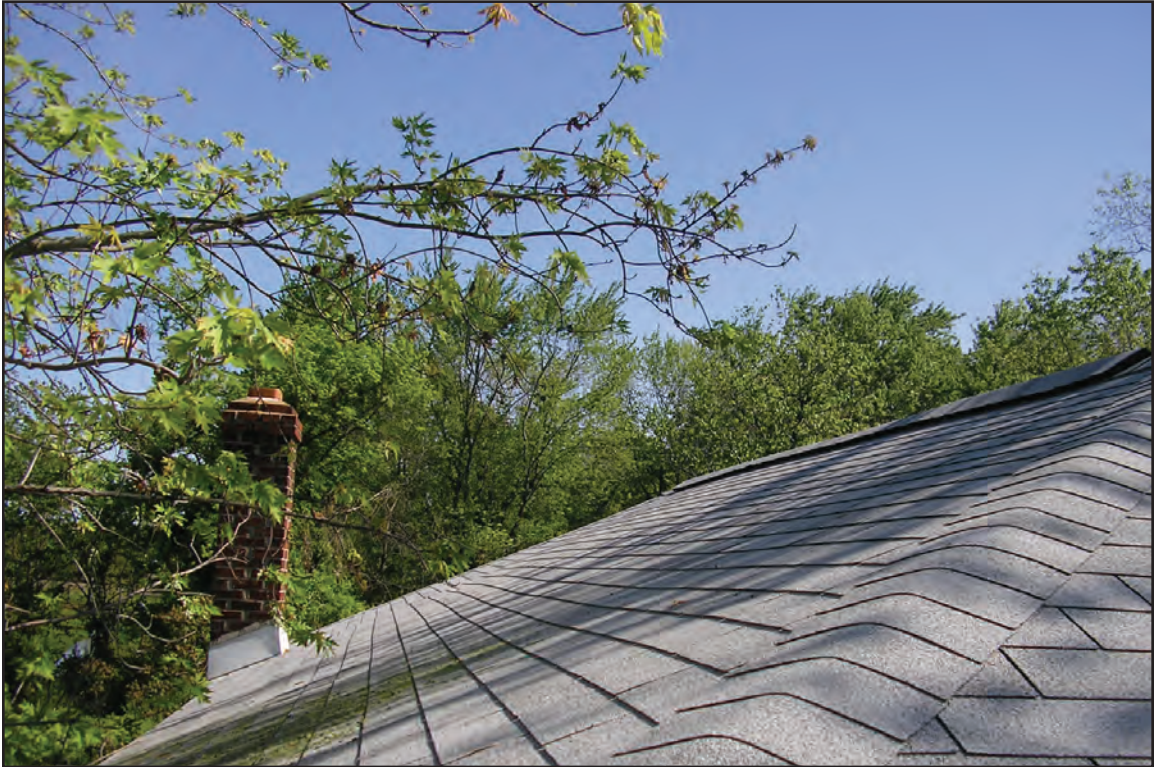
Figure 31 West roof slope, view to north. Note the overhanging tree limbs and staining on the shingles below them.

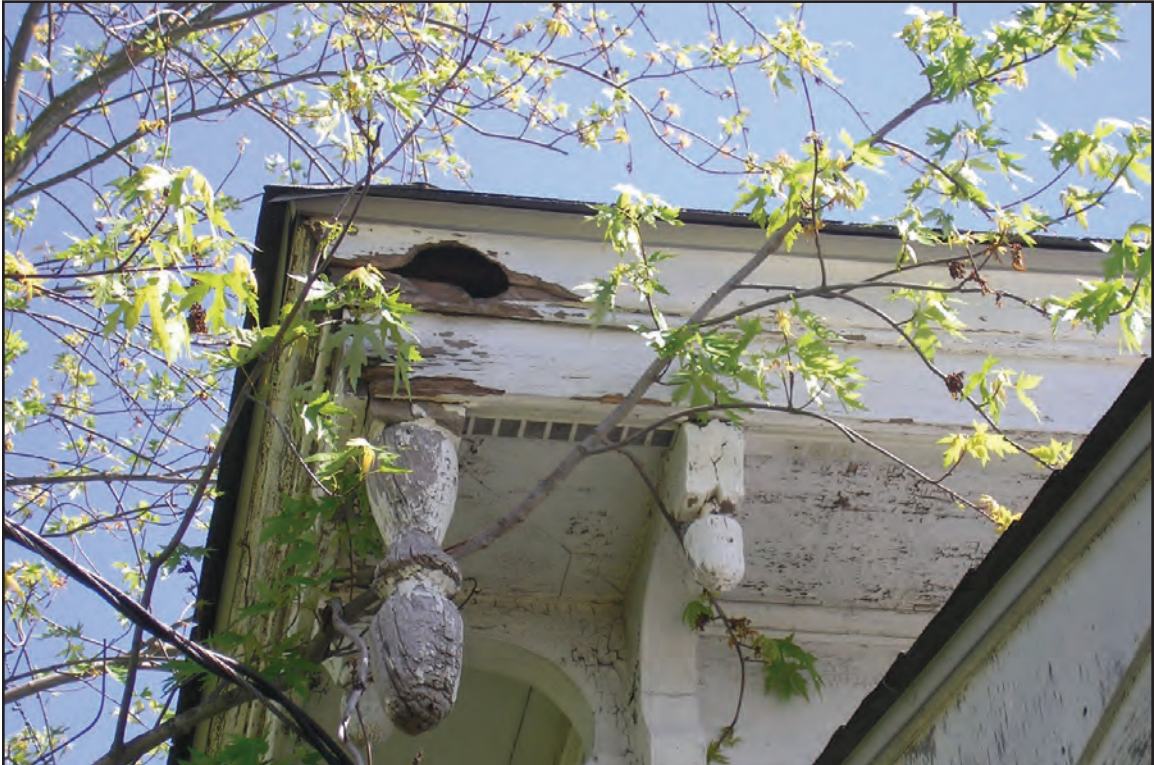
Figure 33 Squirrel hole and paint deterioration on the cornice at the northwest building corner.

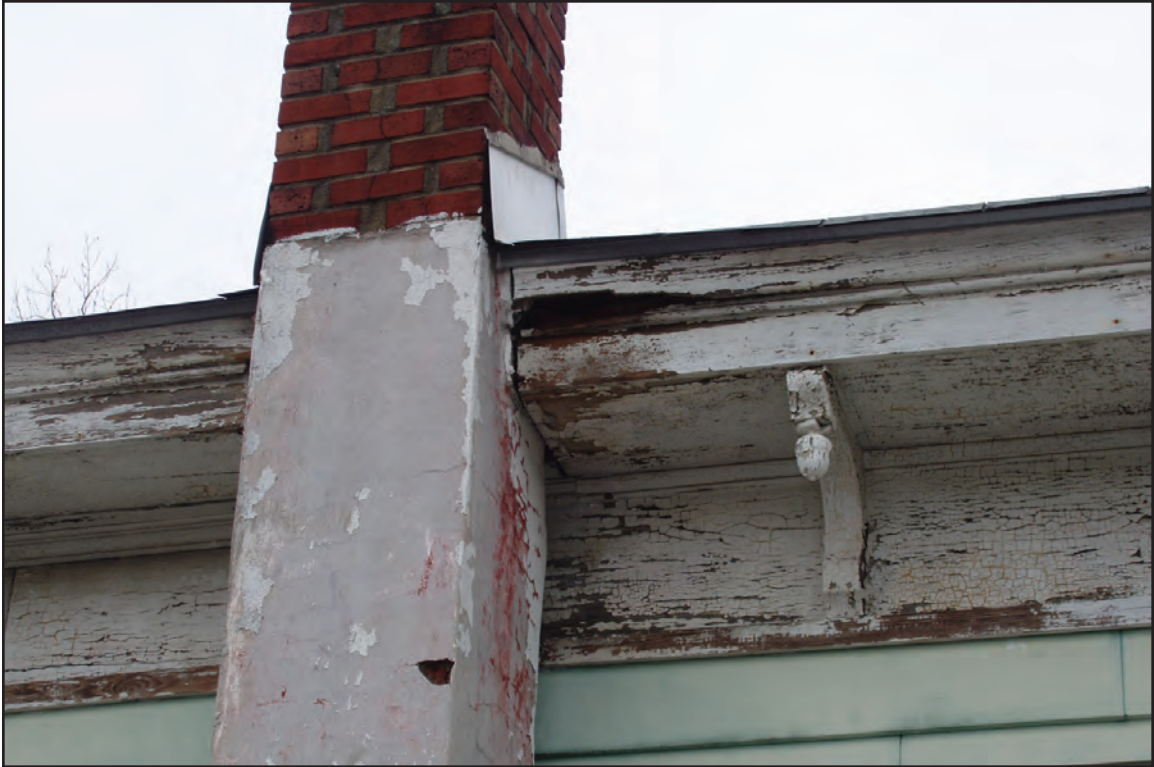
Figure 34 Paint failure and deterioration on the west elevation cornice, adjacent to the chimney stack.

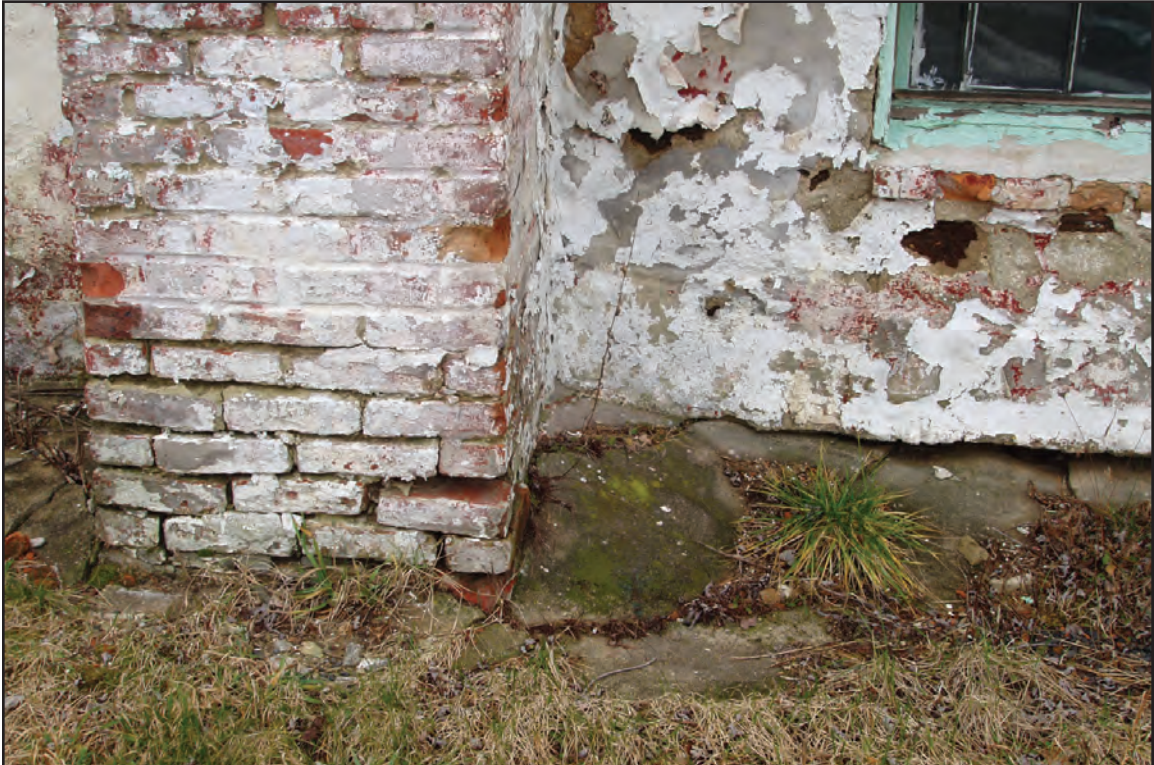
Figure 35 Open and deteriorated mortar joints at the bottom of the chimney stack. Also note deteriorated stucco and the gap between grade and the stucco foundation wall at right photo.

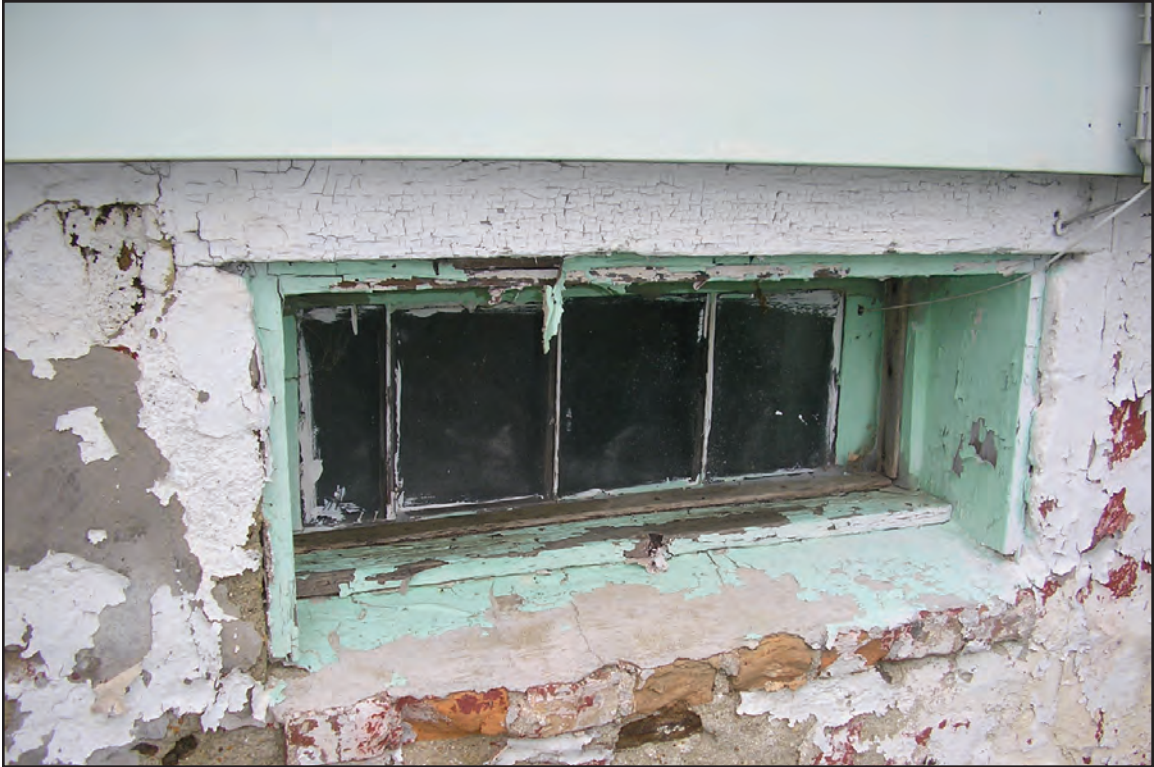
Figure 39 Typical basement window on the west (side) elevation. Note the brick header sill replacement sash with uneven pane sizes, and overall finish and material deterioration.

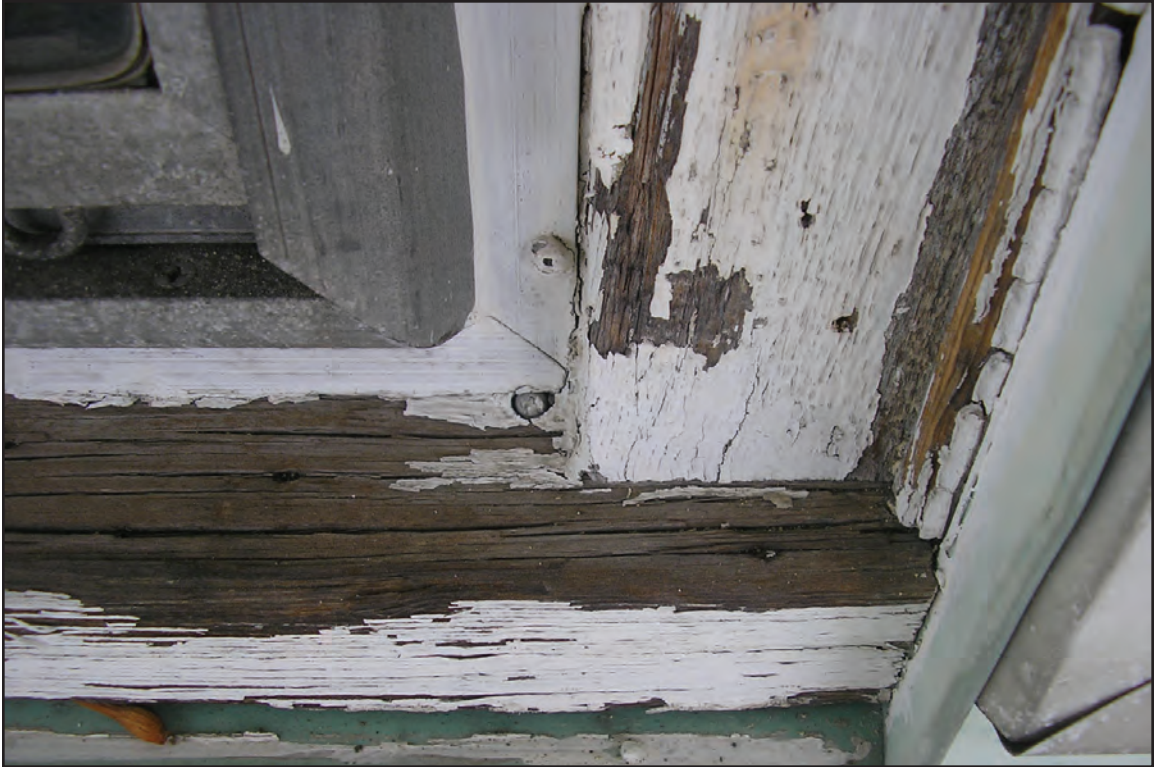
Figure 41 Typical paint deterioration and loss at window sills.

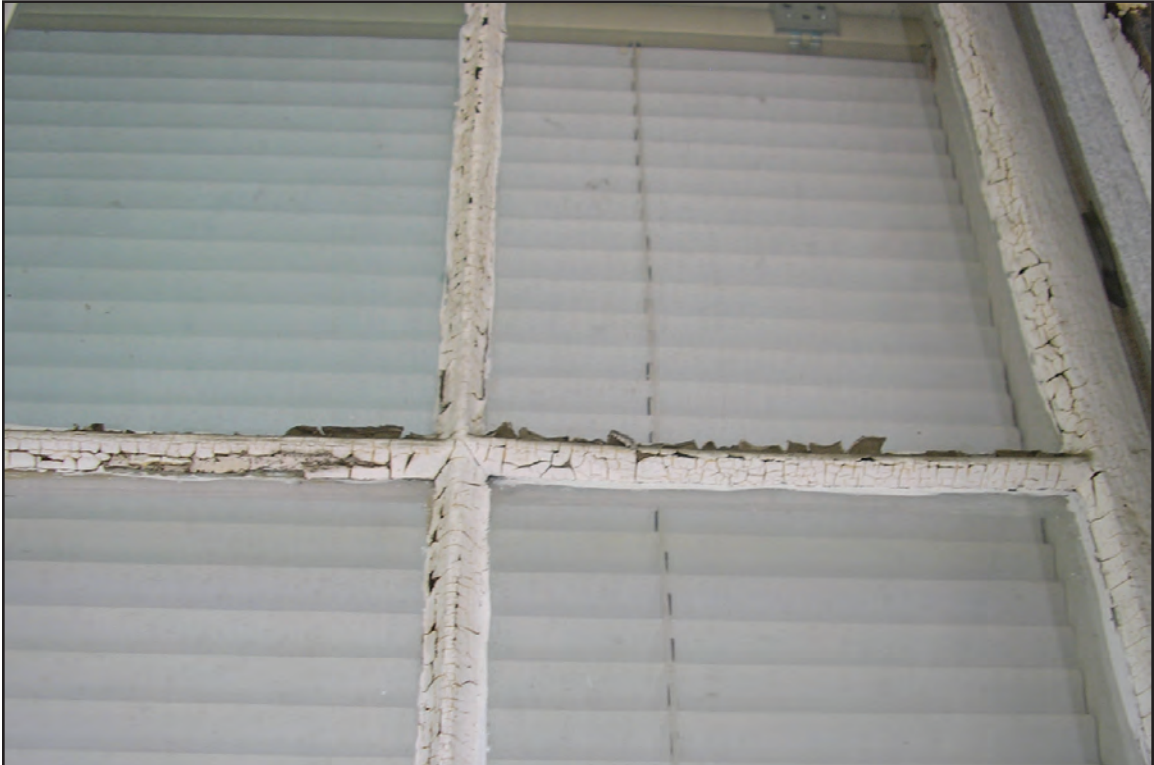
Figure 42 Typical paint and glazing putty deterioration at windows.

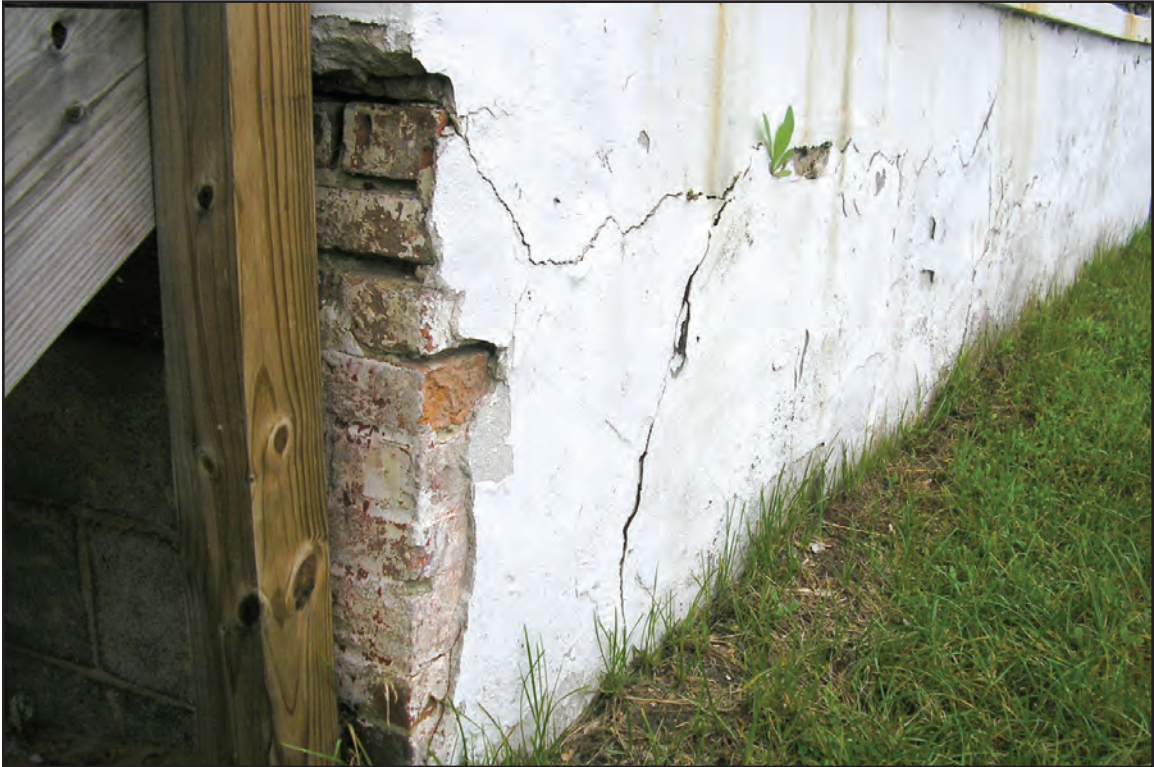
Figure 48 South porch foundation: stucco cracking and deterioration exposing the southwest brick pier.

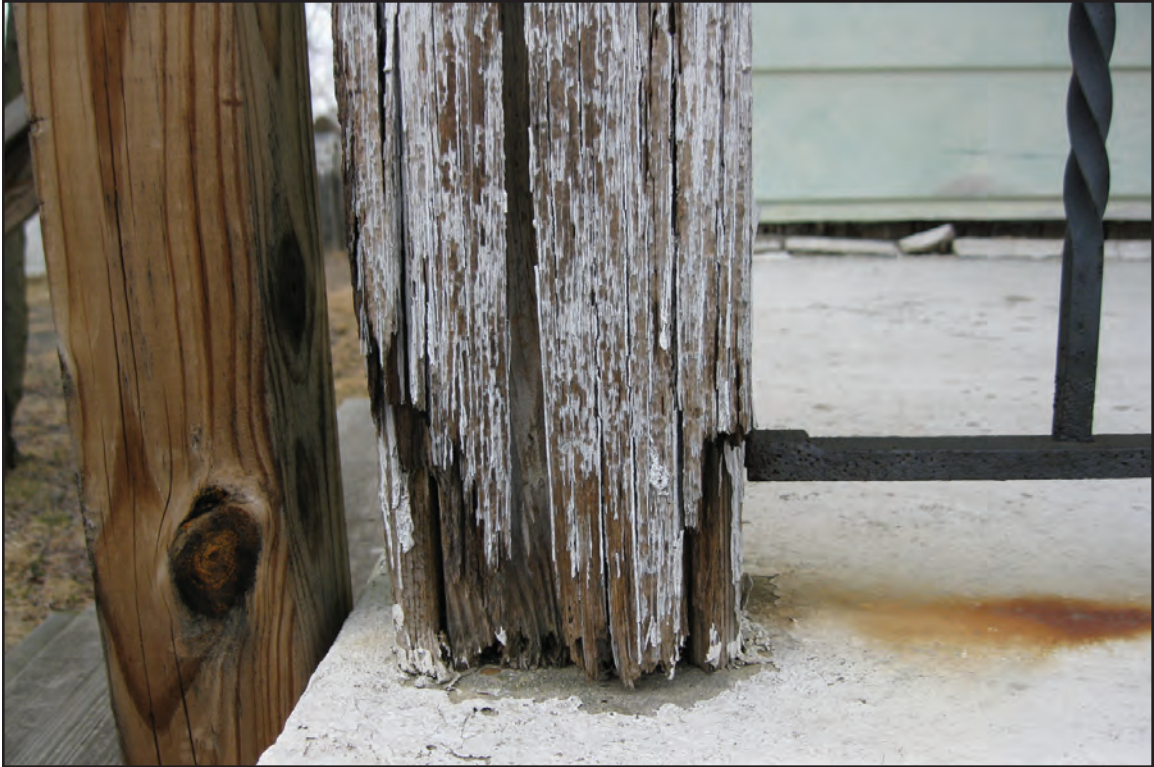
Figure 49 Typical south porch post deterioration.

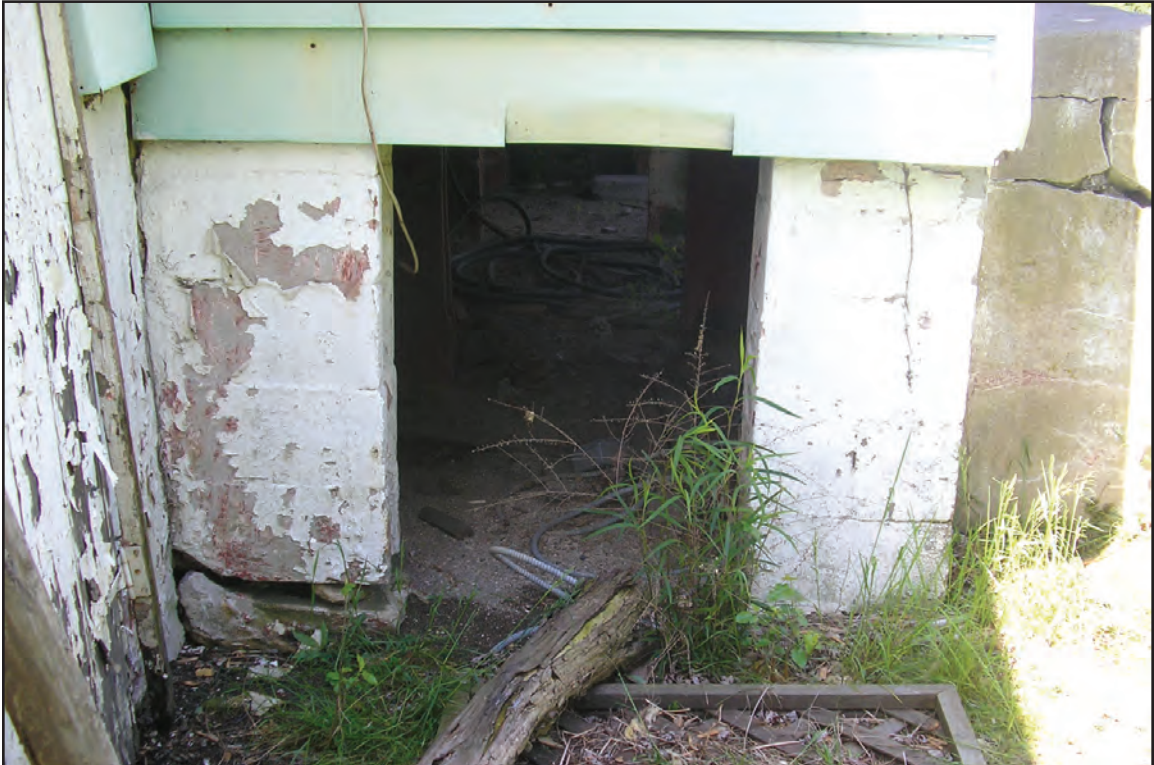
Figure 52 North porch, east foundation piers. Note horizontal crack at the bottom of the south pier (left photo).

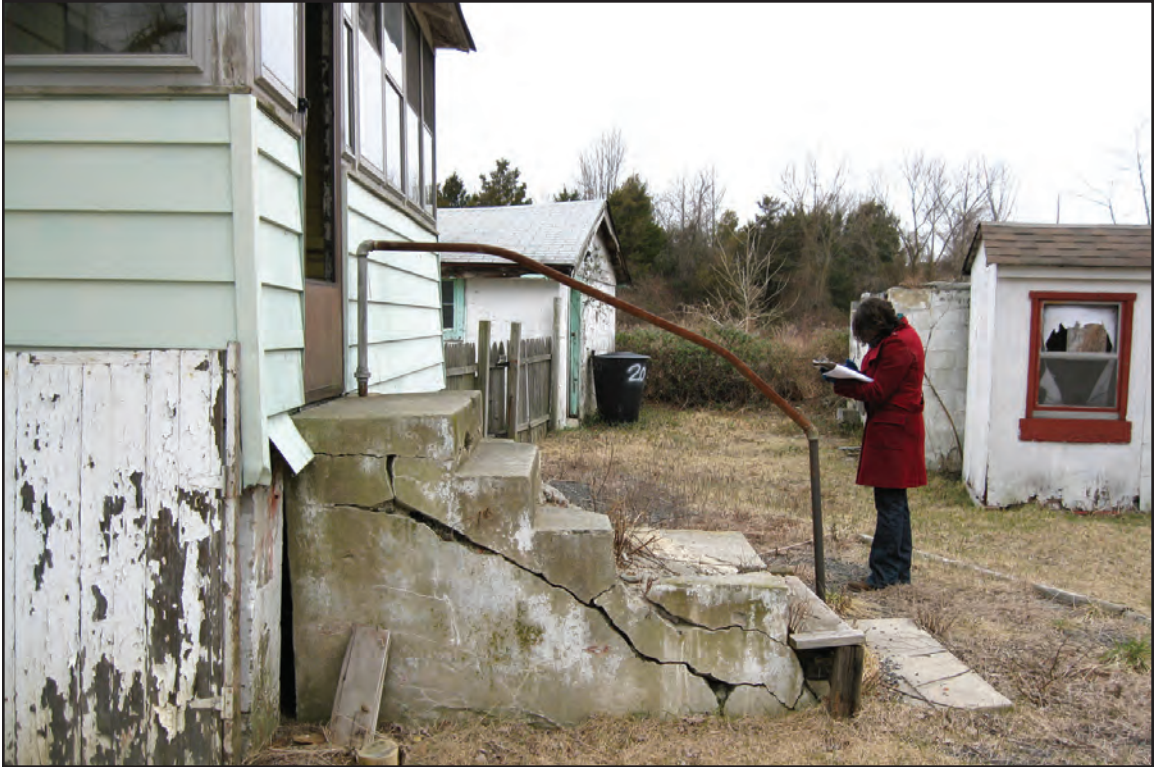
Figure 53 North porch concrete stairway, view from the east. The stairway is dilapidated; removal is recommended.

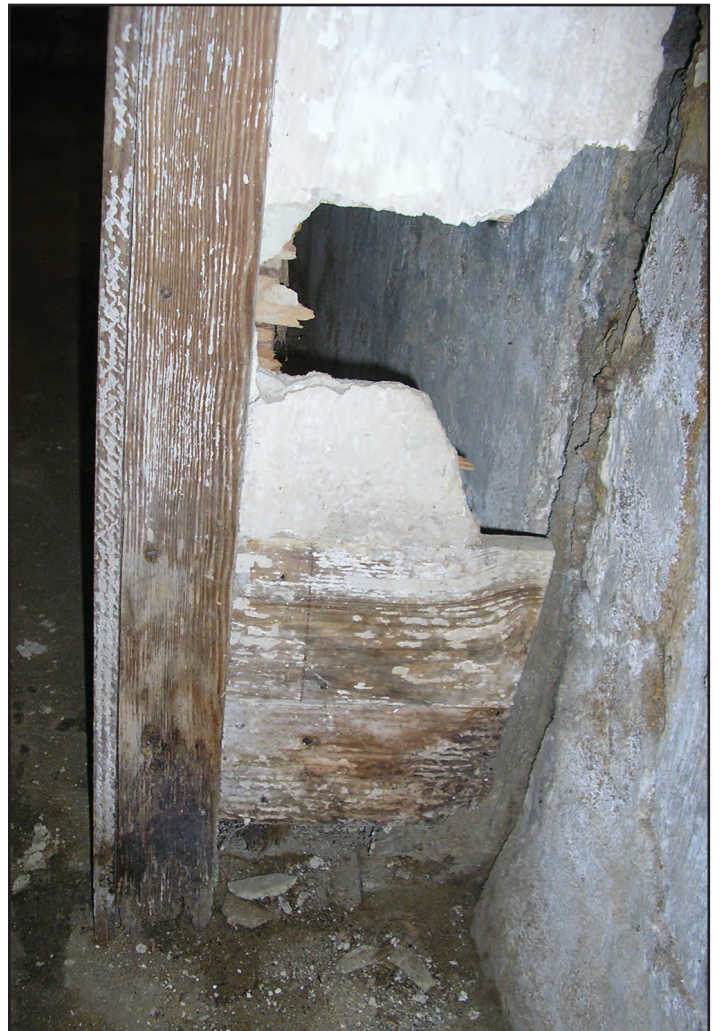
Figure 71 Rising damp and possibly periodic flooding of the basement has caused decay in of the post of the doorway between the front and rear rooms, and the bottom of the plaster wall, which has been replaced with flush boards.

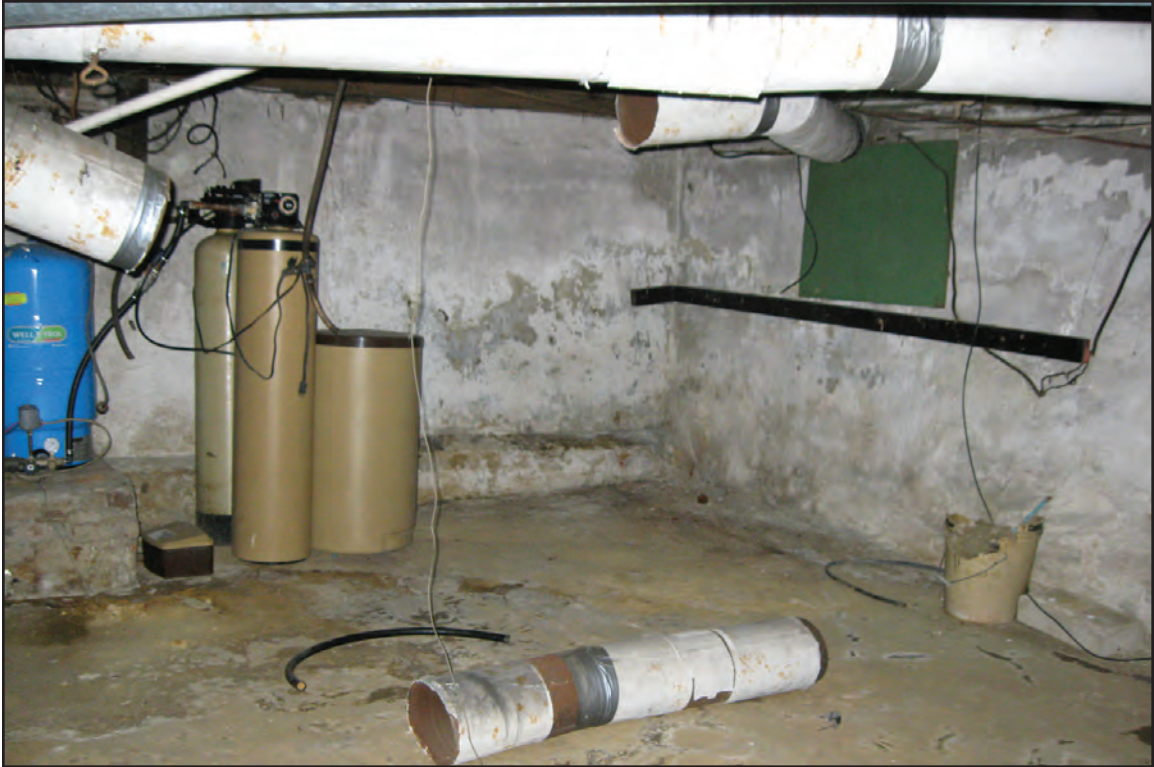
Figure 72 Rear (north) basement room, view to northeast. Note the masonry curb at the base of the north wall (left photo), which may have been installed to prevent water infiltration.

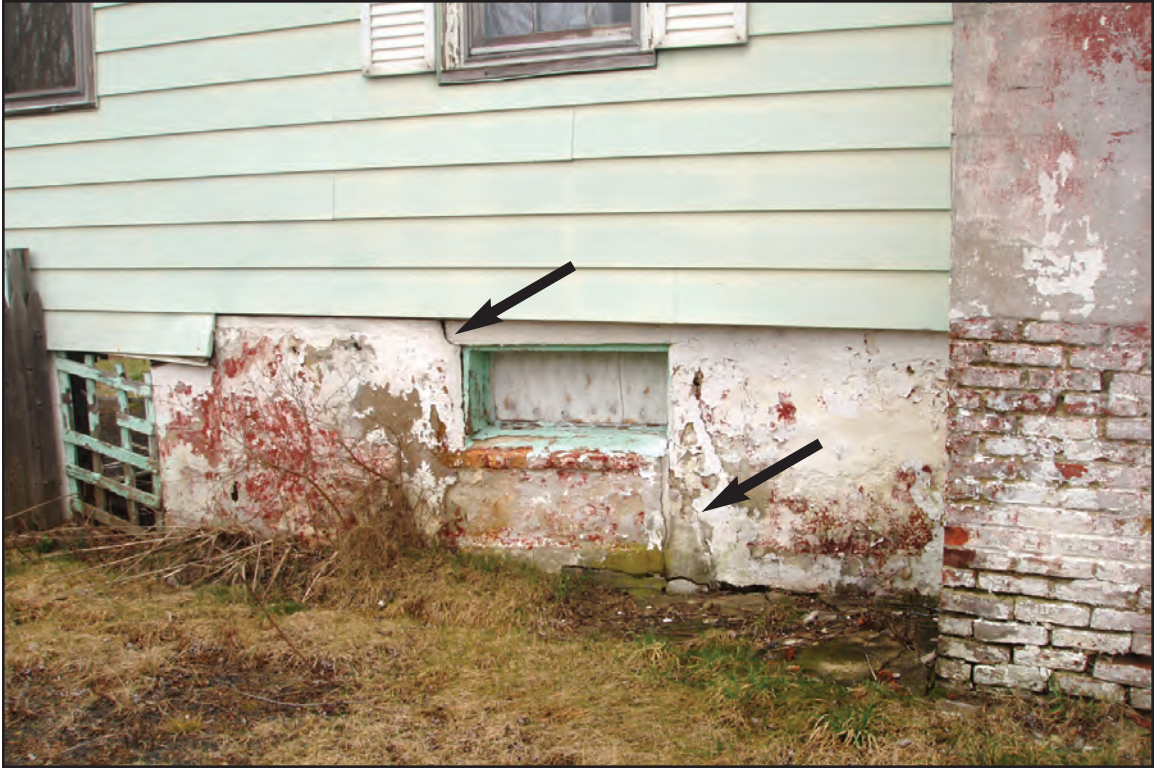
Figure 74 Settlement of the foundation can be seen in cracking patterns around the basement window at the north end of the west elevation foundation wall.

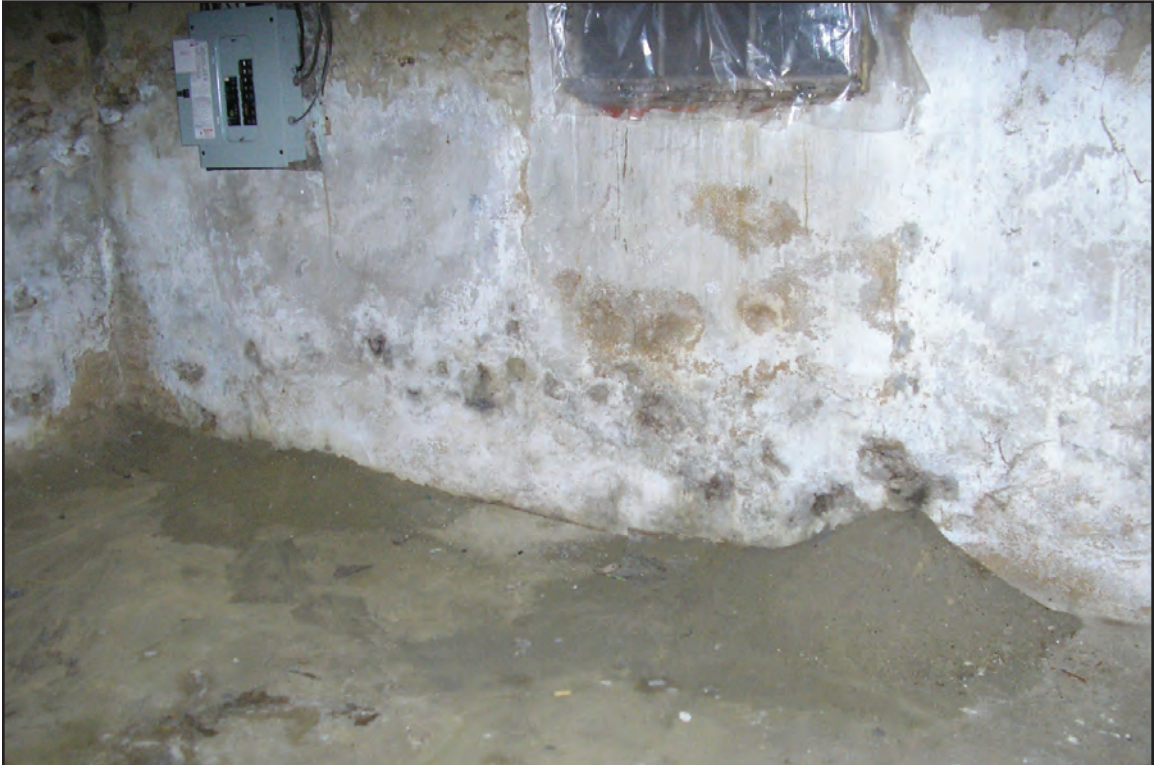
Figure 75 Front (south) basement room, west wall, view to southwest showing alluvial mud fans deposited by water infiltration through the basement walls.

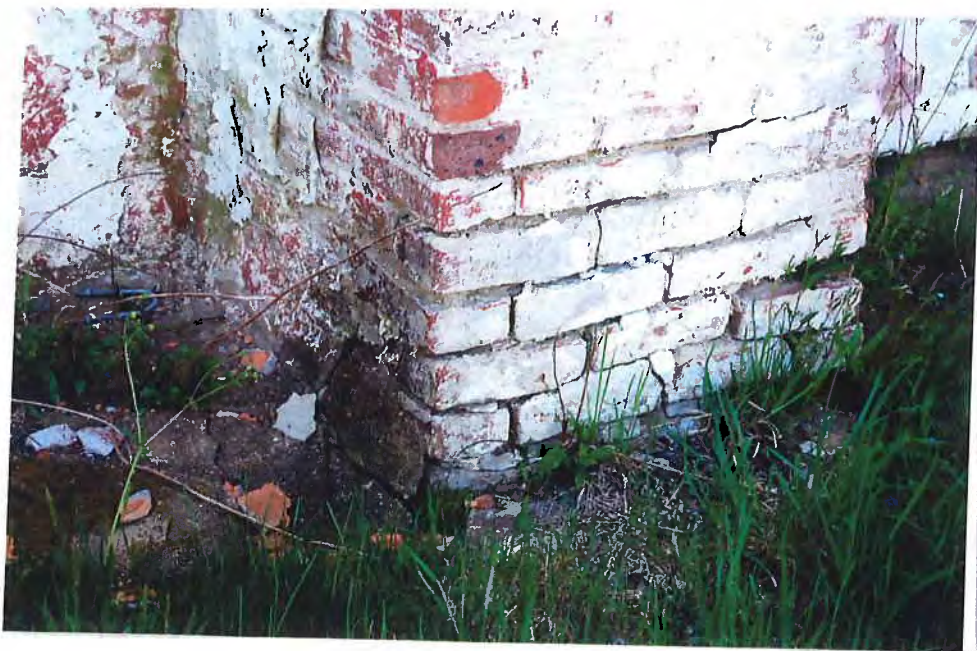
Photo 11

Loose and eroded brick at the base of the chimney.

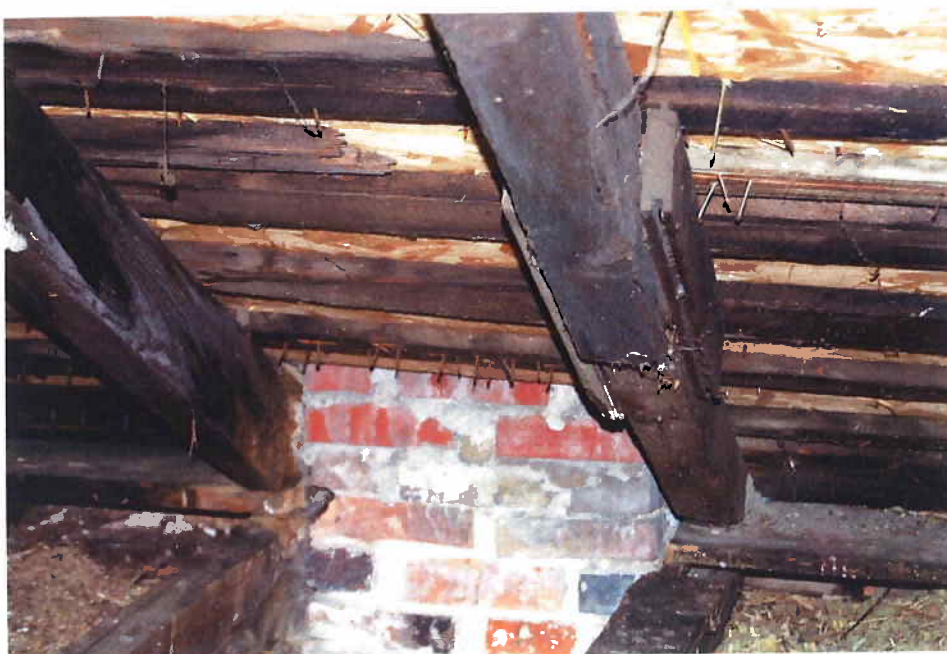
Photo 19

Some decayed wood around the chimney.

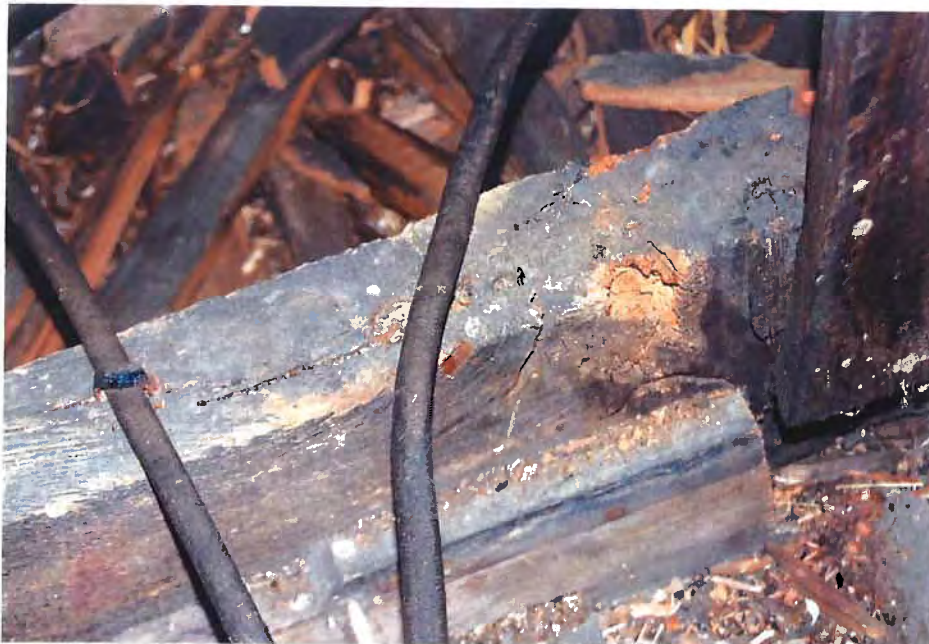
Photo 20

Minor decay and crack at one ceiling joist.

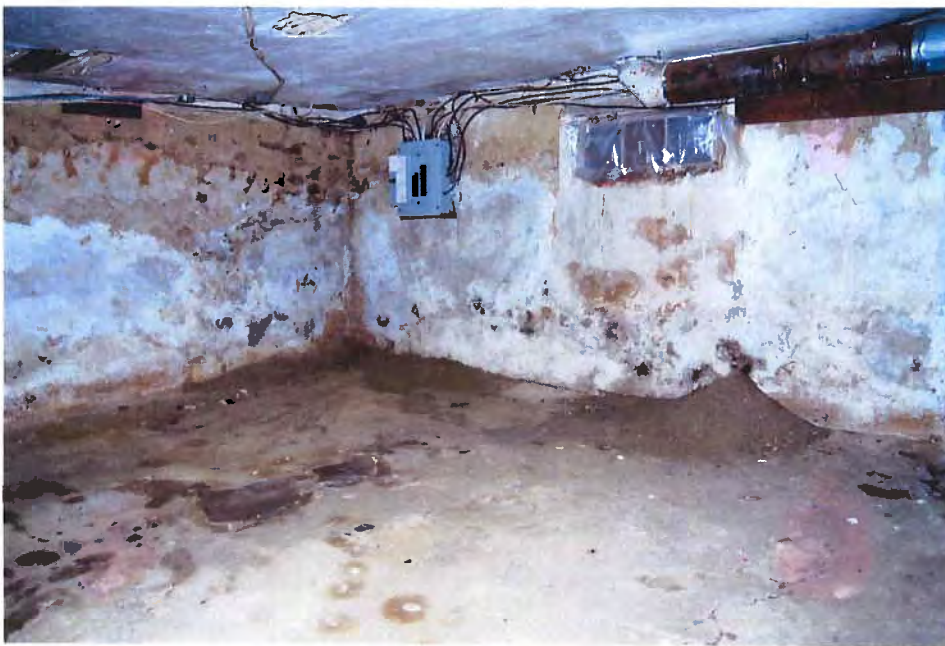
Photo 21

Basement wall, loose parge and sand with mud deposits.

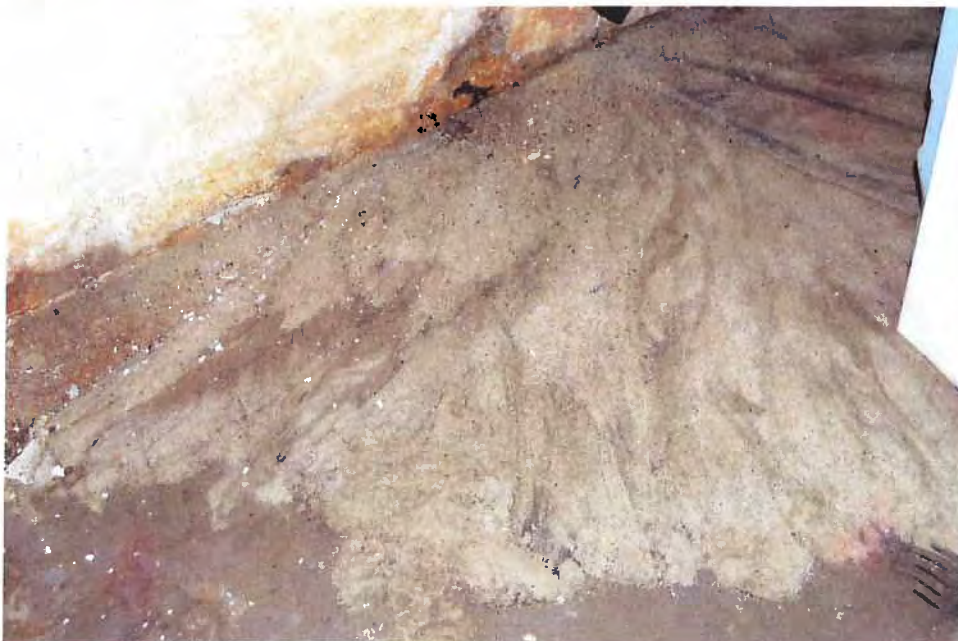
Photo 22

Sand and mud deposit in the basement.
