James Still Office Preservation Plan

Submitted to:
New Jersey Historic Trust

Prepared by:
KSK Architects Planners Historians, Inc.

Final Copy: 30 October 2009

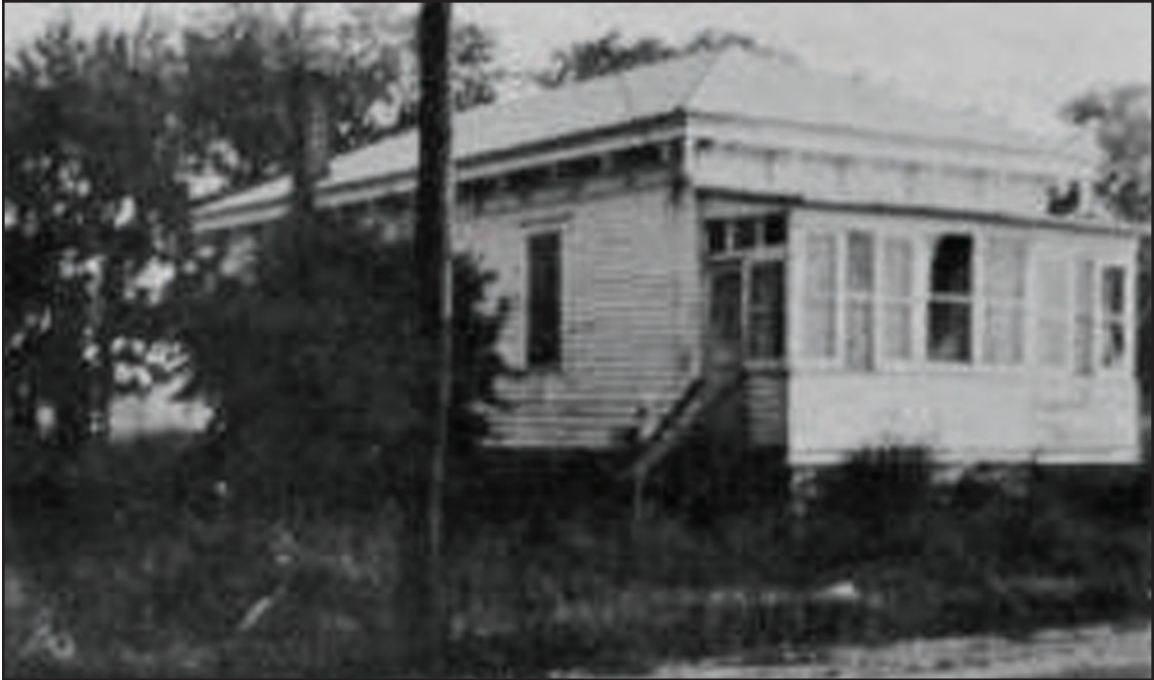
be distinguished, it is most likely the painted clapboard siding seen in a circa 1962 image published in the Burlington County Times. (Figure 8)

Figure 8 The Still Office, view from the southwest, c. 1962. (Lloyd E. Griscom, "Dr. Still saved by ingenuity," Burlington County Times, n.d., n.p., available in the vertical files at Burlington County Historical Society Library, Burlington, NJ.)

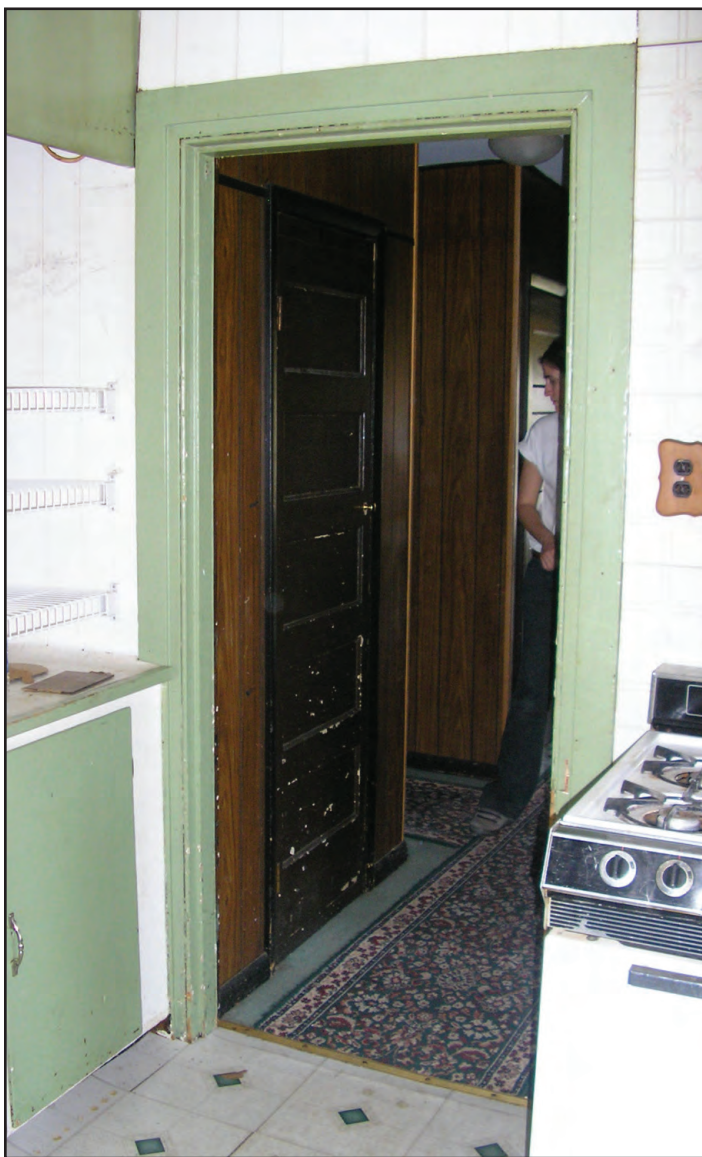
Figure 14 North Room interior door, view toward Hallway (southeast). The hallway door and windows in this room have surviving original trim.

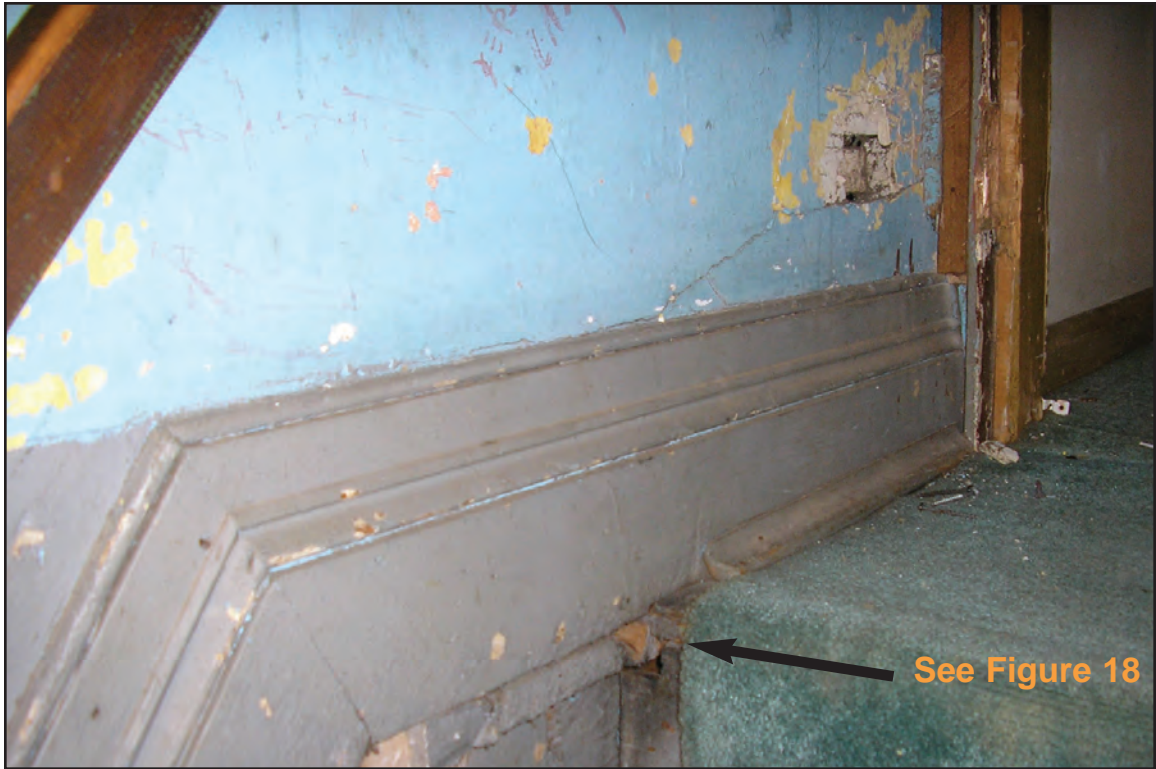
Figure 17 Basement stairway at first floor landing, view to northeast showing notch at original extent of landing.

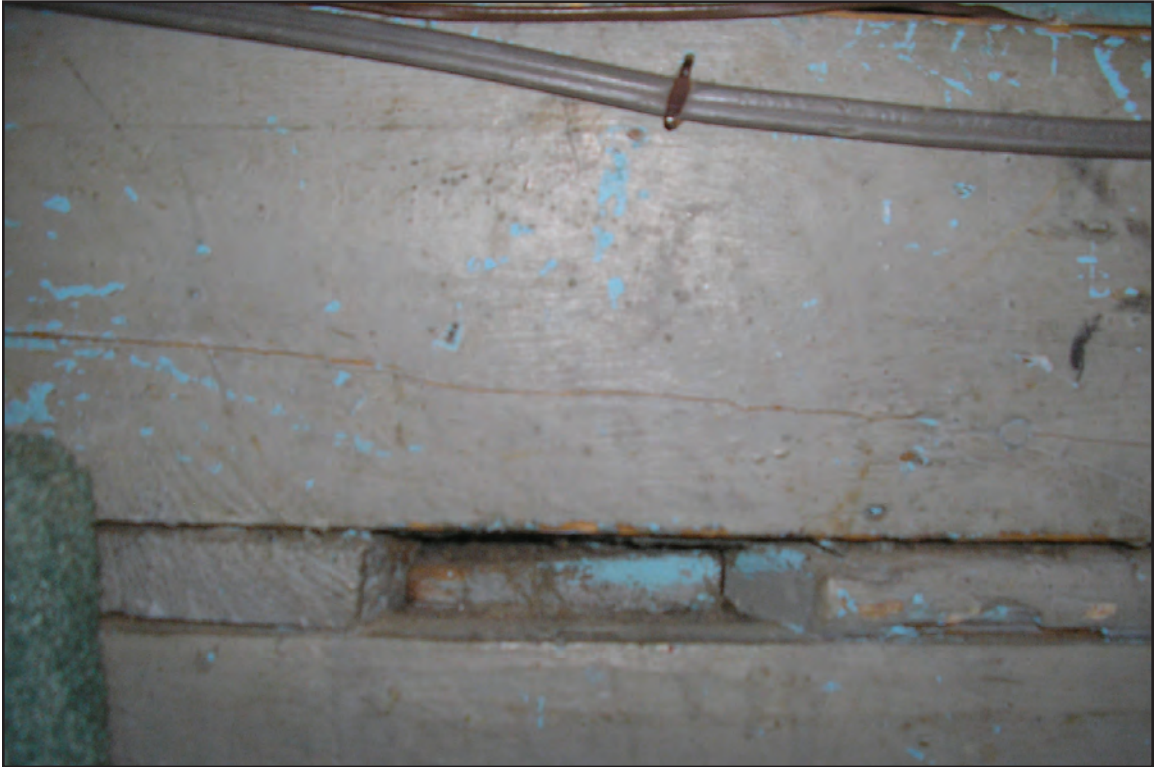
Figure 18 Basement stairway at first floor landing, view to south showing notch at original extent of landing.

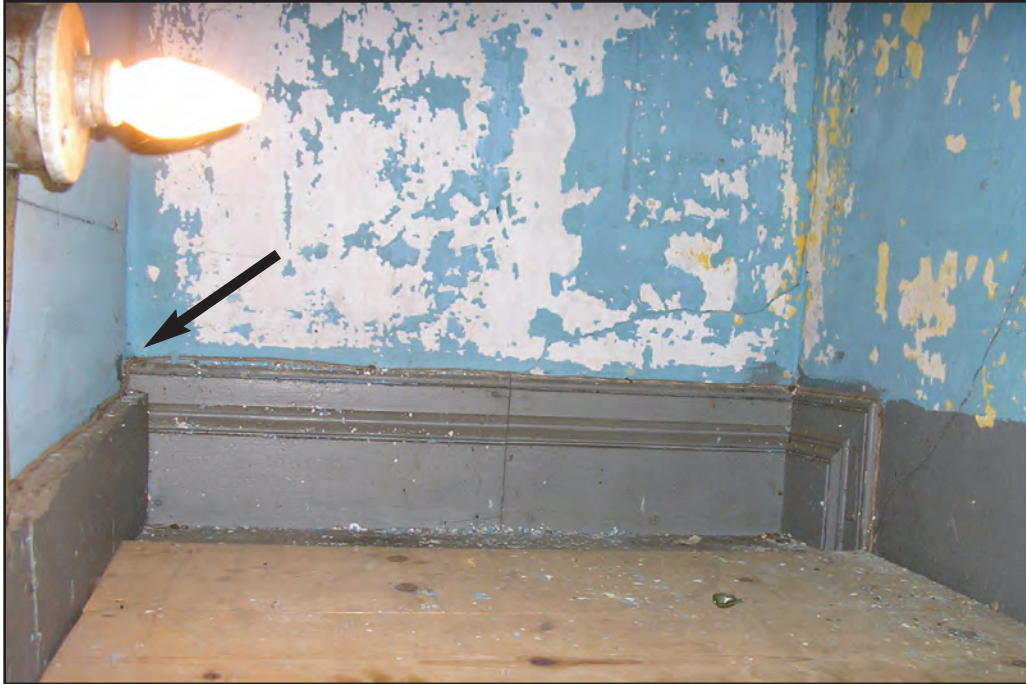
Figure 19 Basement stairway, view to west (wall opposite first floor landing). Note that the baseboard moulding at left (south) is behind the south partition wall. Also note moulding return at right.

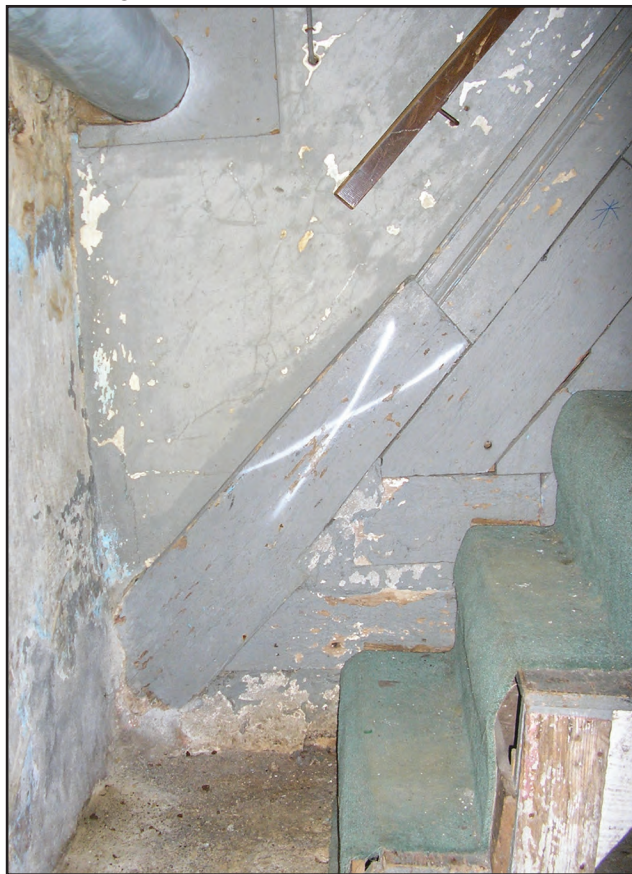
Figure 20 Basement stairway at basement landing. View to north showing where the baseboard was removed when the original winder stair configuration was changed to a dog-leg.

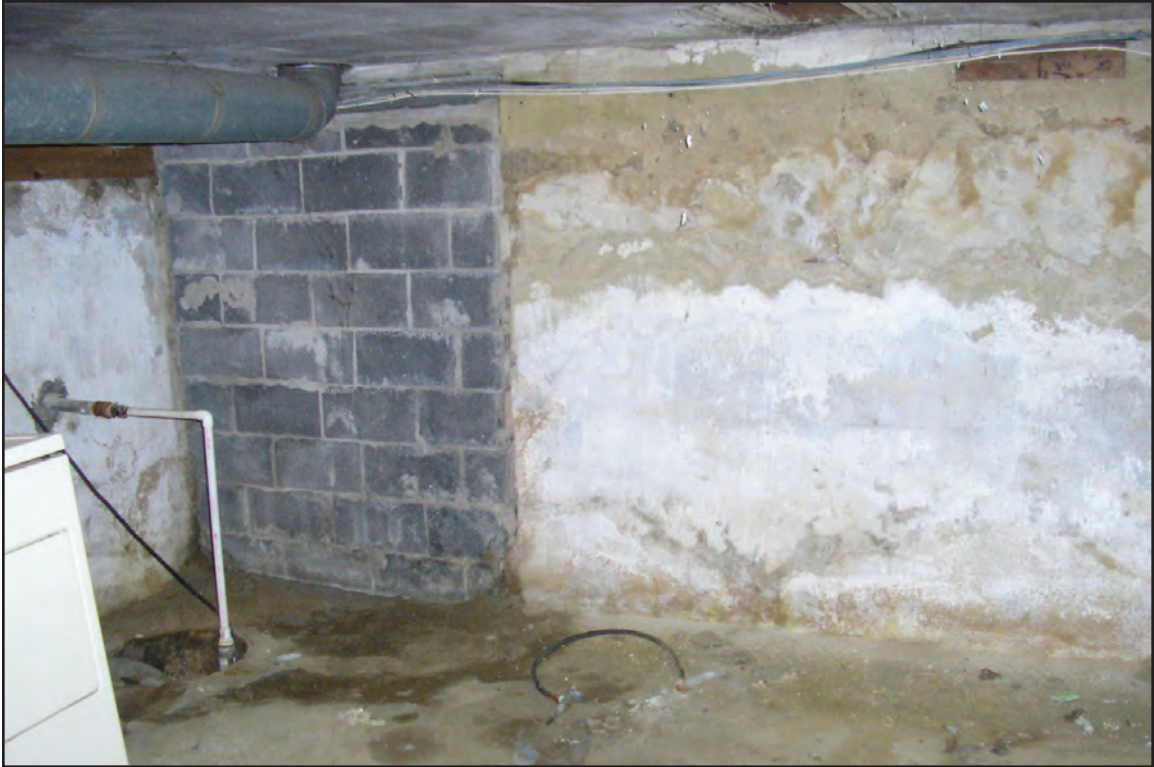
Figure 21 North (front) basement room, south wall, showing original doorway infilled with CMU.

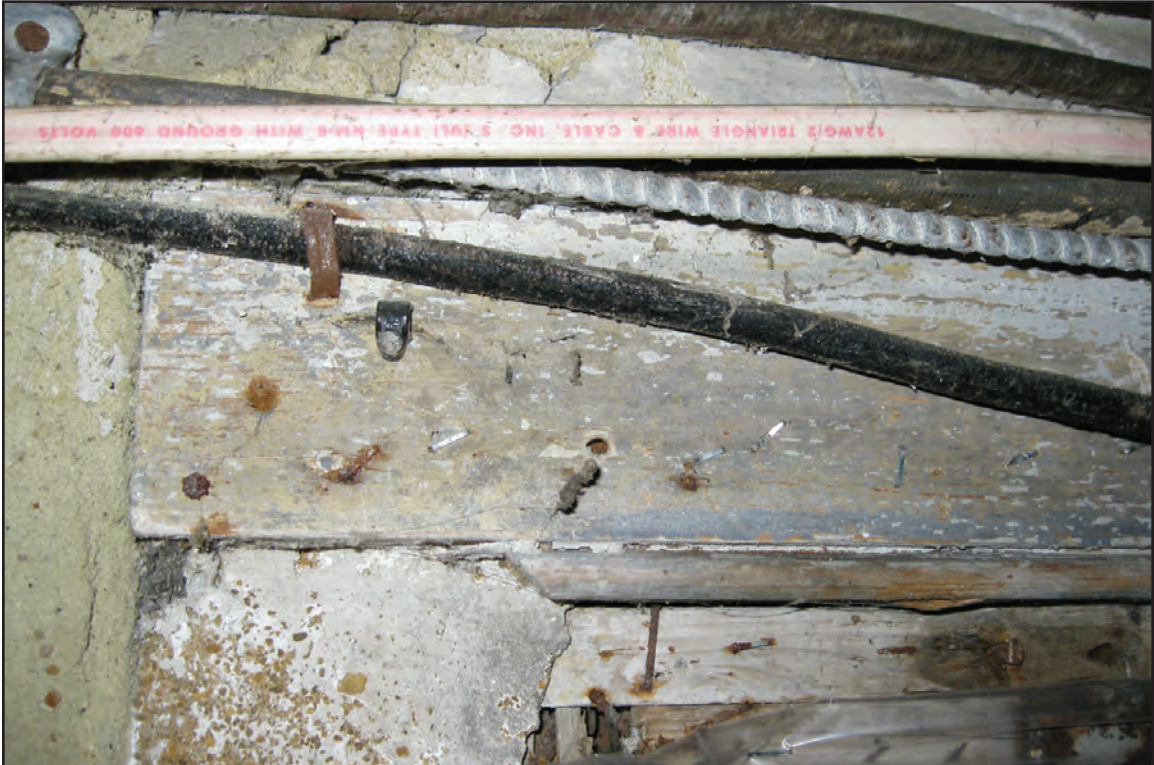
Figure 22 Detail of trim at original north basement room doorway.

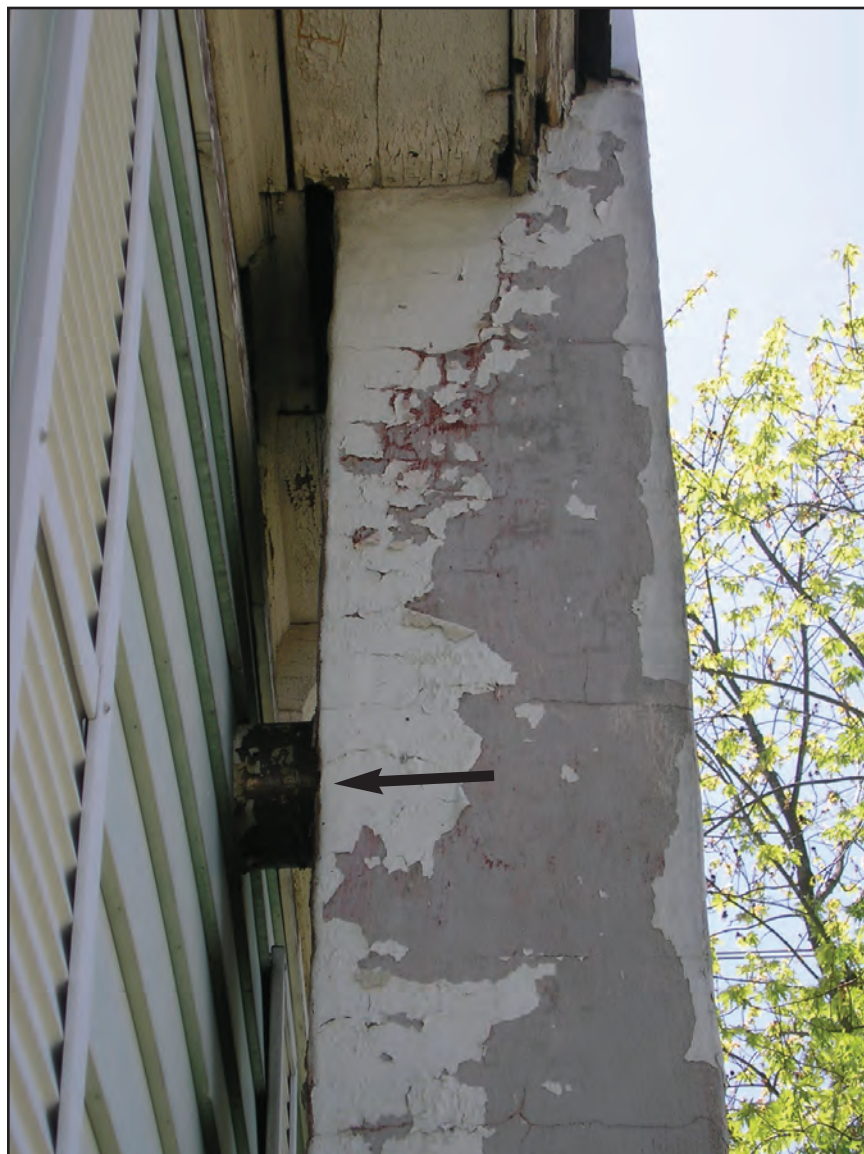
Figure 23 A stove vent remains in the chimney on west wall. The stove would have been located in the middle room.

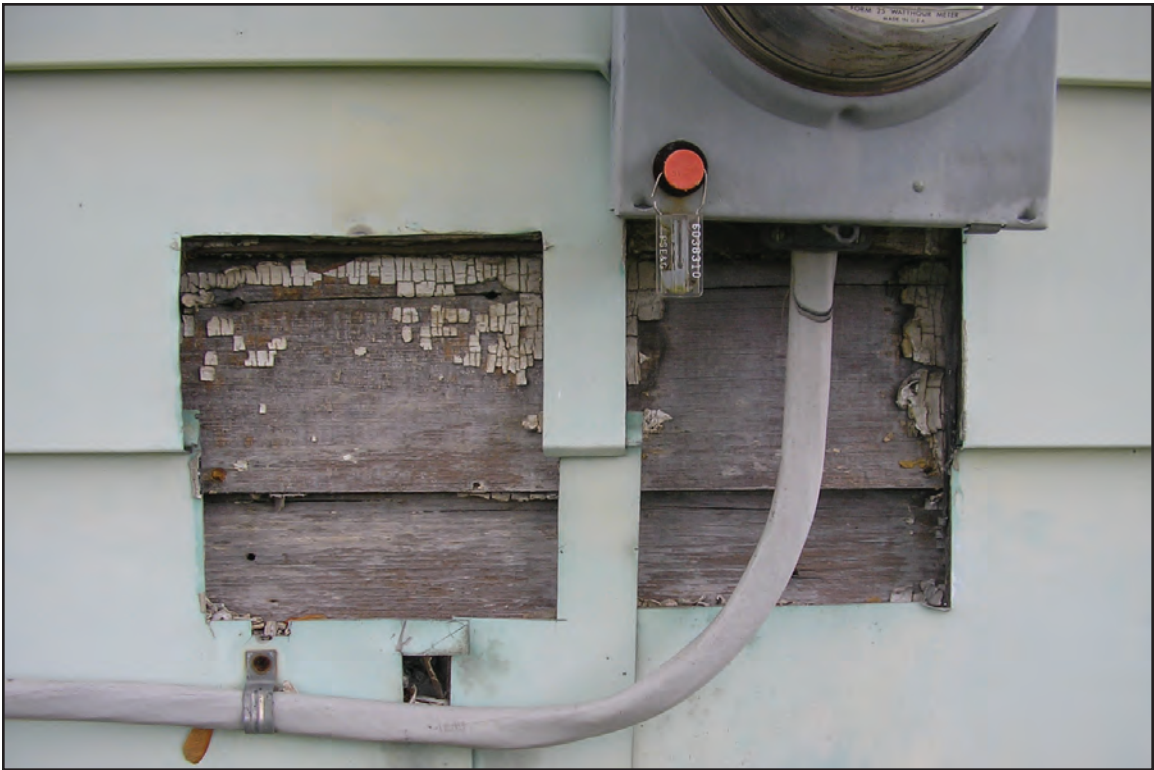
Figure 24 West (side) wall, detail showing clapboard behind aluminum siding.

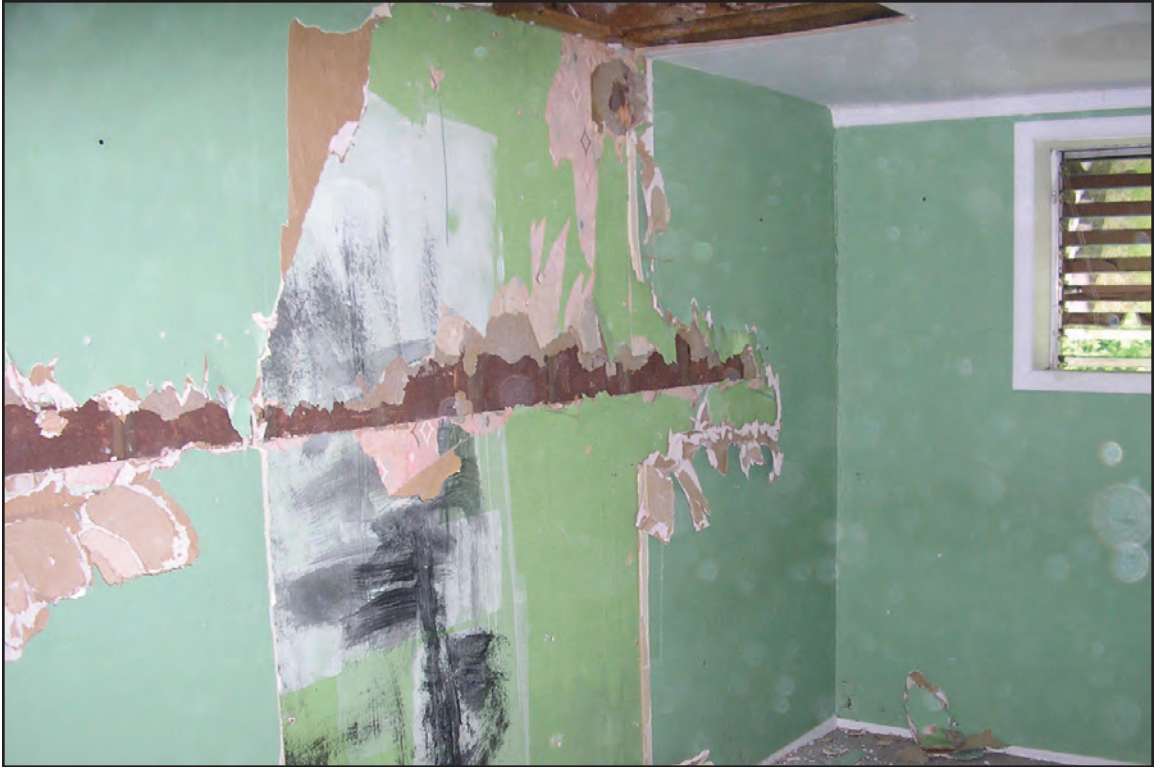
Figure 25 The original east exterior wall of the Office, now within the East Addition, view to northwest showing removal of particle board exposing a horizontal line of the original board-and-batten siding.

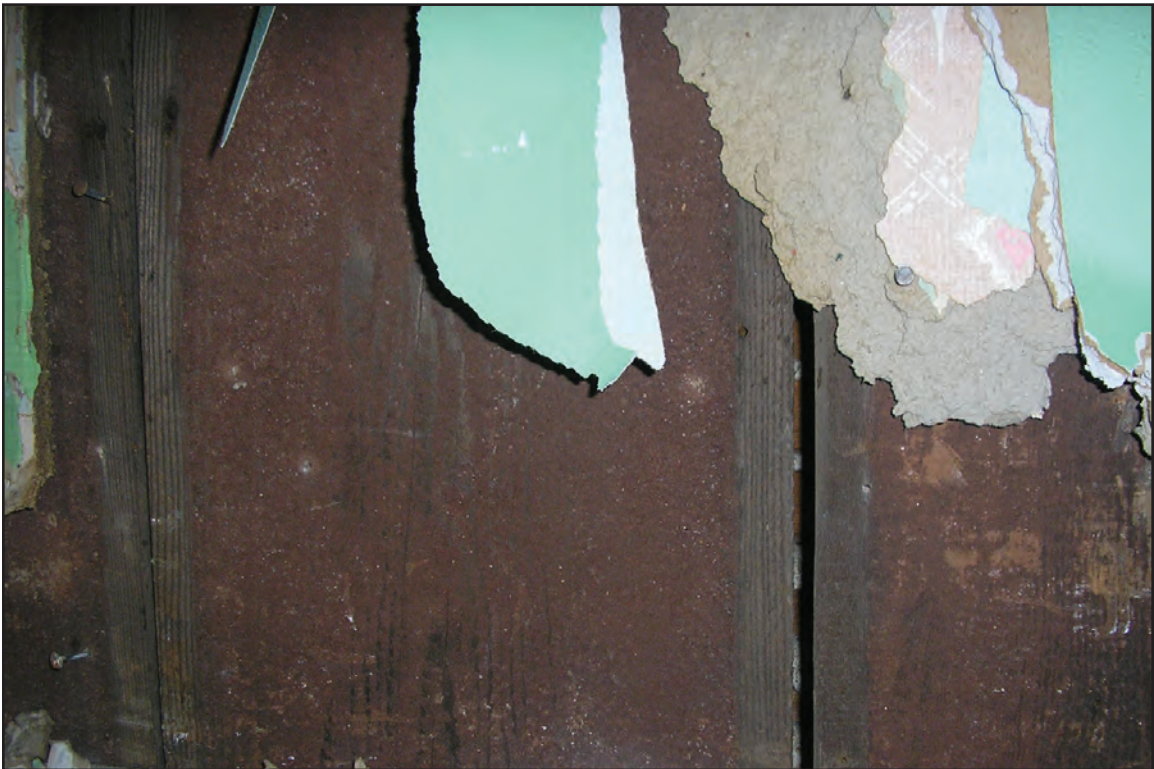
Figure 26 Detail of the original board-and-batten siding uncovered on the original east exterior wall of the Office.

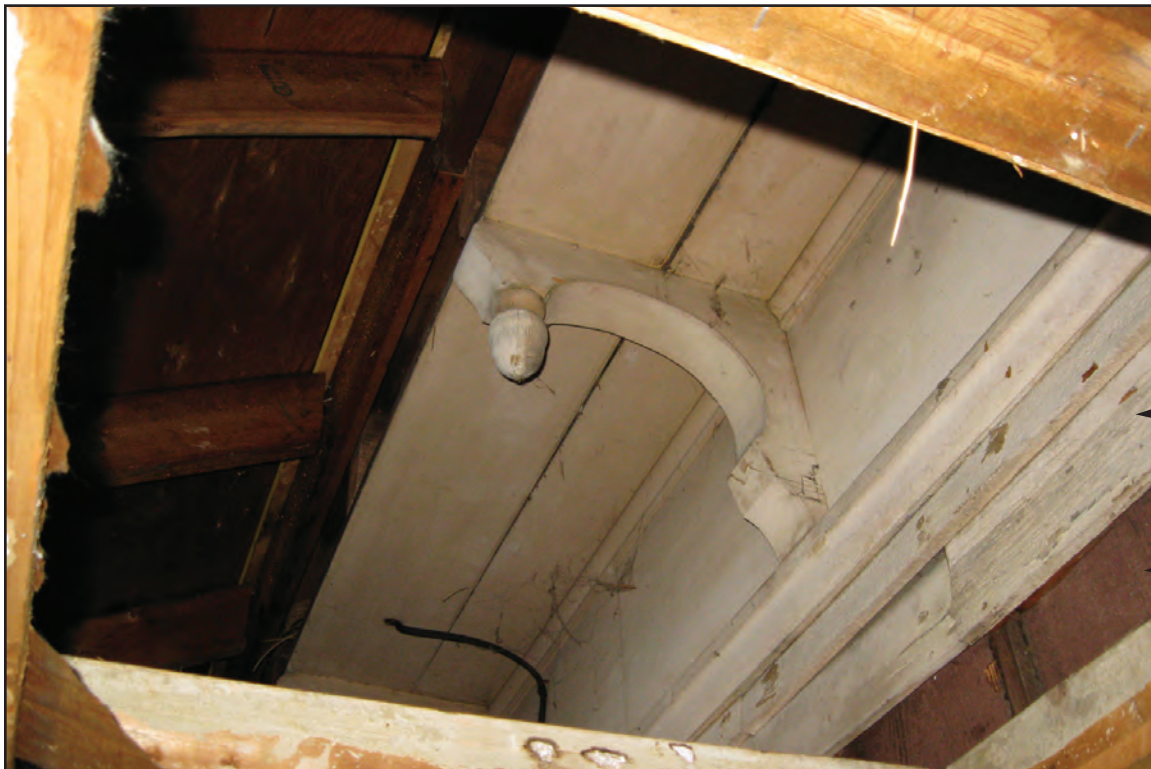
Figure 28 The cornice was retained on the east Office wall when the East Addition was built, preserving it above the ceiling in the addition.

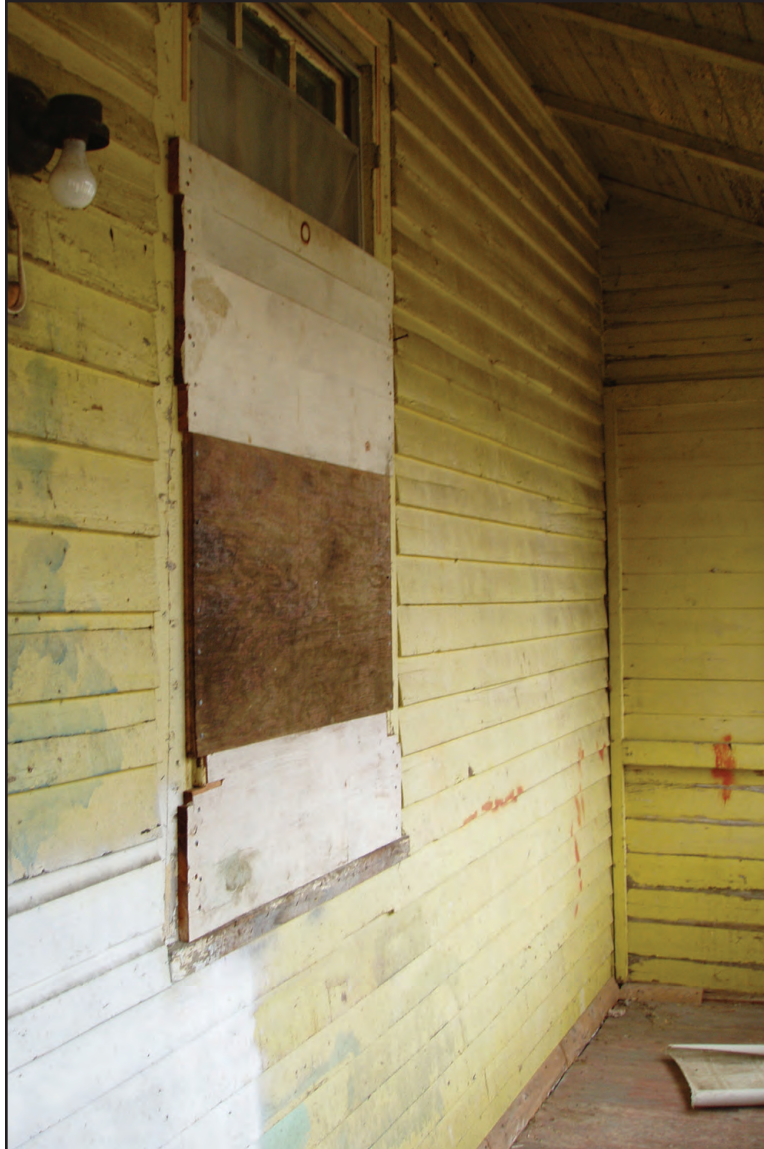
Figure 29 North (rear) wall of the Office, showing the mix of siding materials: shiplap siding (bottom left photo) and clap-board siding (center photo).

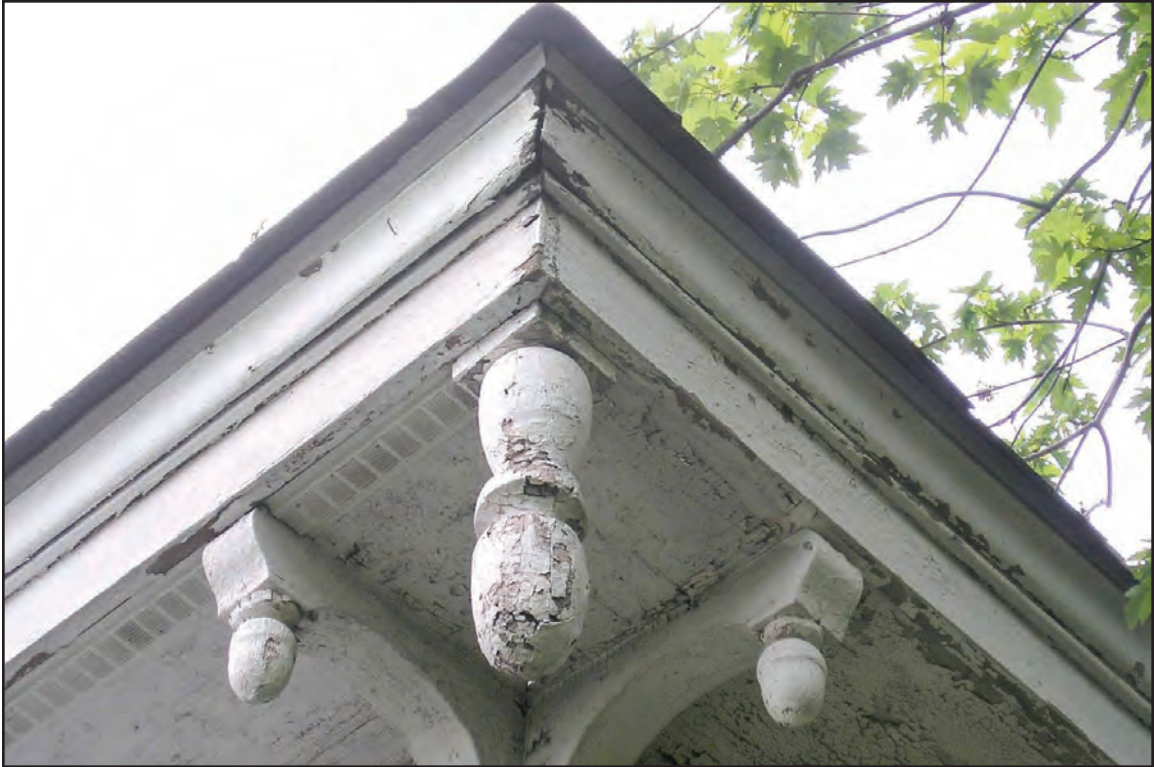
Figure 30 Cornice brackets and large drop pendant at the northeast building corner.

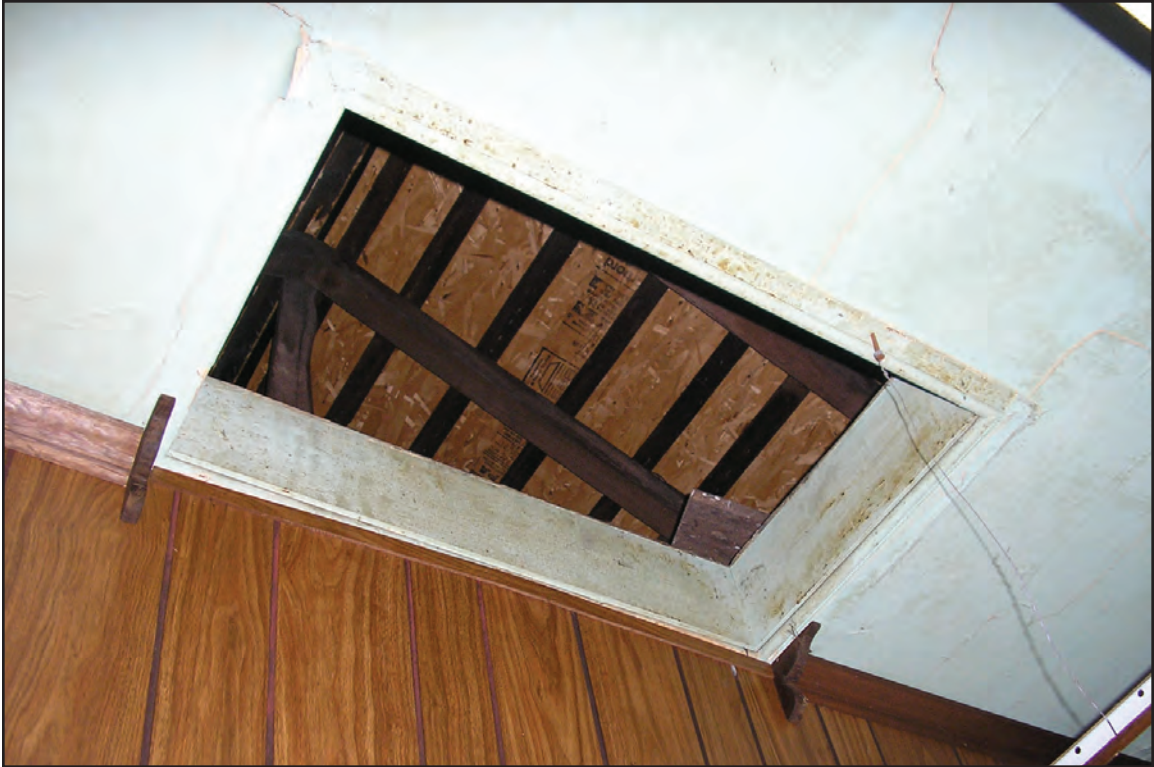
Figure 32 Roof framing and wood shingle lath is visible on the underside of the west roof slope, viewed through the roof hatch above the suspended ceiling in the north room.

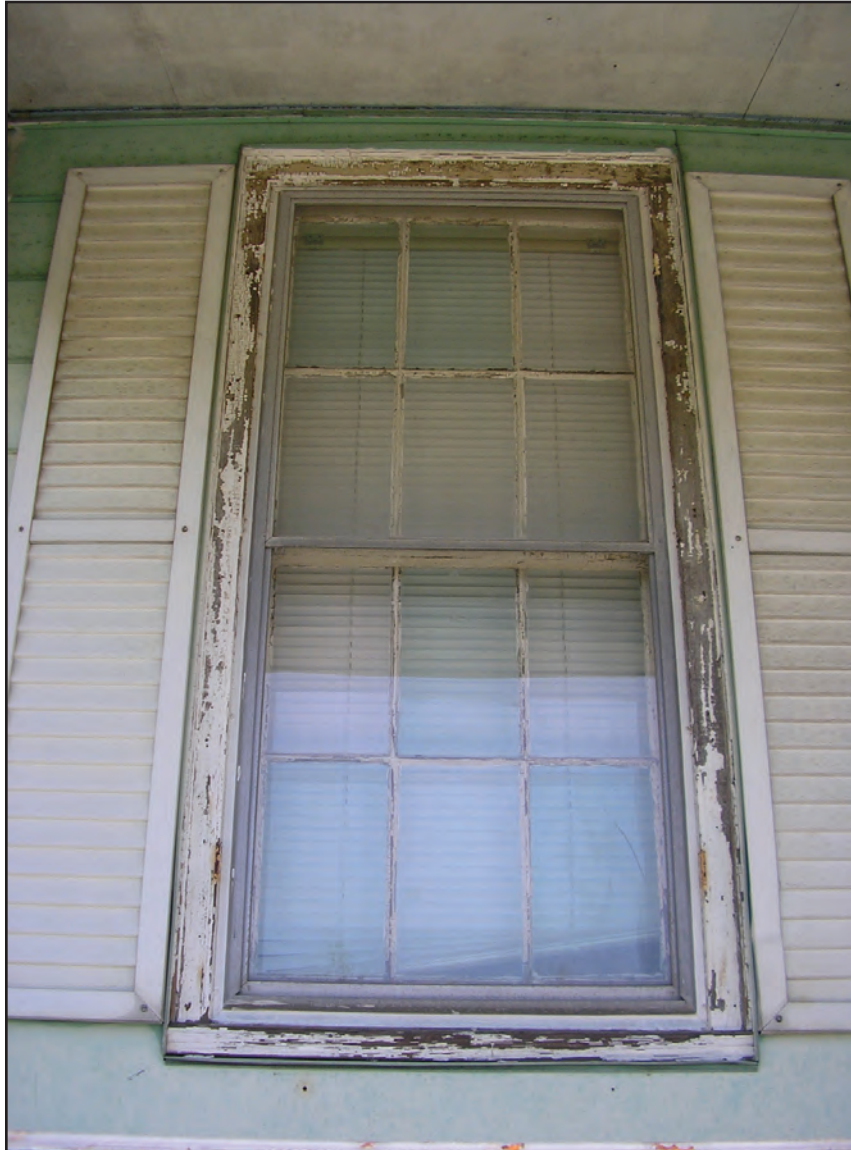
Figure 36 Typical six-over-six Office window.

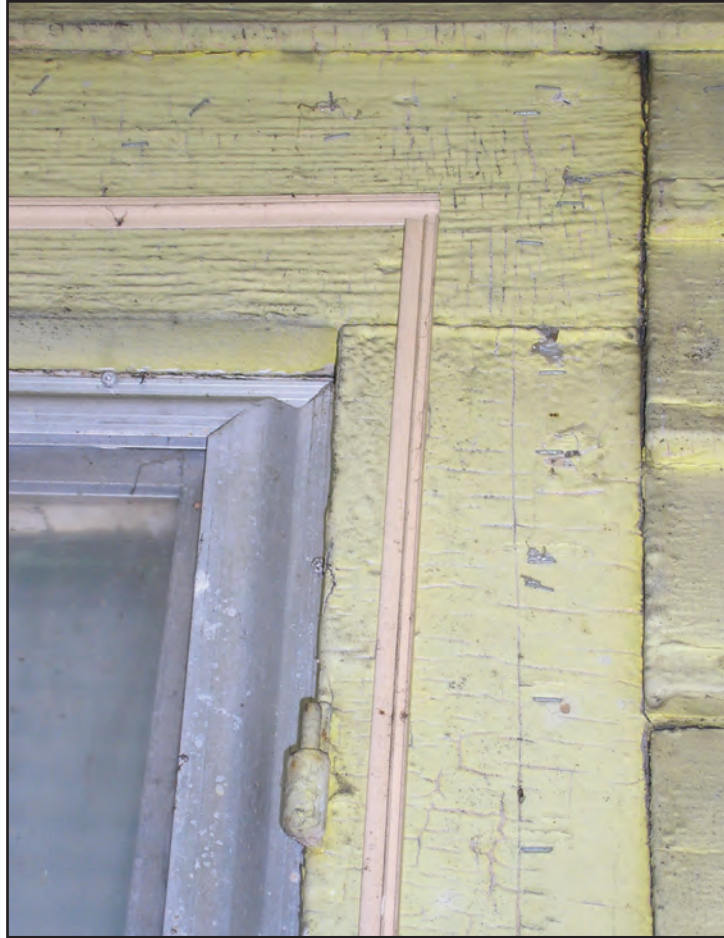
missing, but shutter plates (or evidence of) survive at all window openings. (Figures 37 and 38) Both the front and rear doors are later replacements in the original frames.

Figure 37 Original shutter pintle on the west side of the north (rear) window.

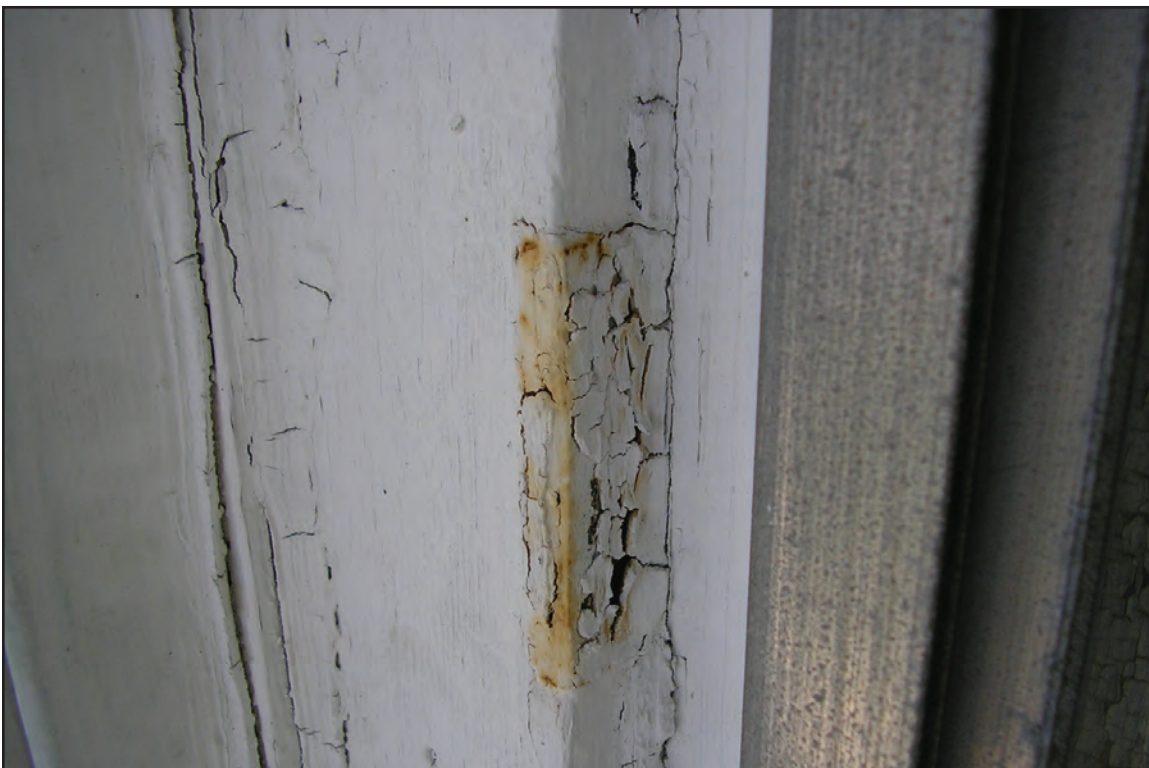
Figure 38 Most shutter hardware is missing although plates survive on most window frames.

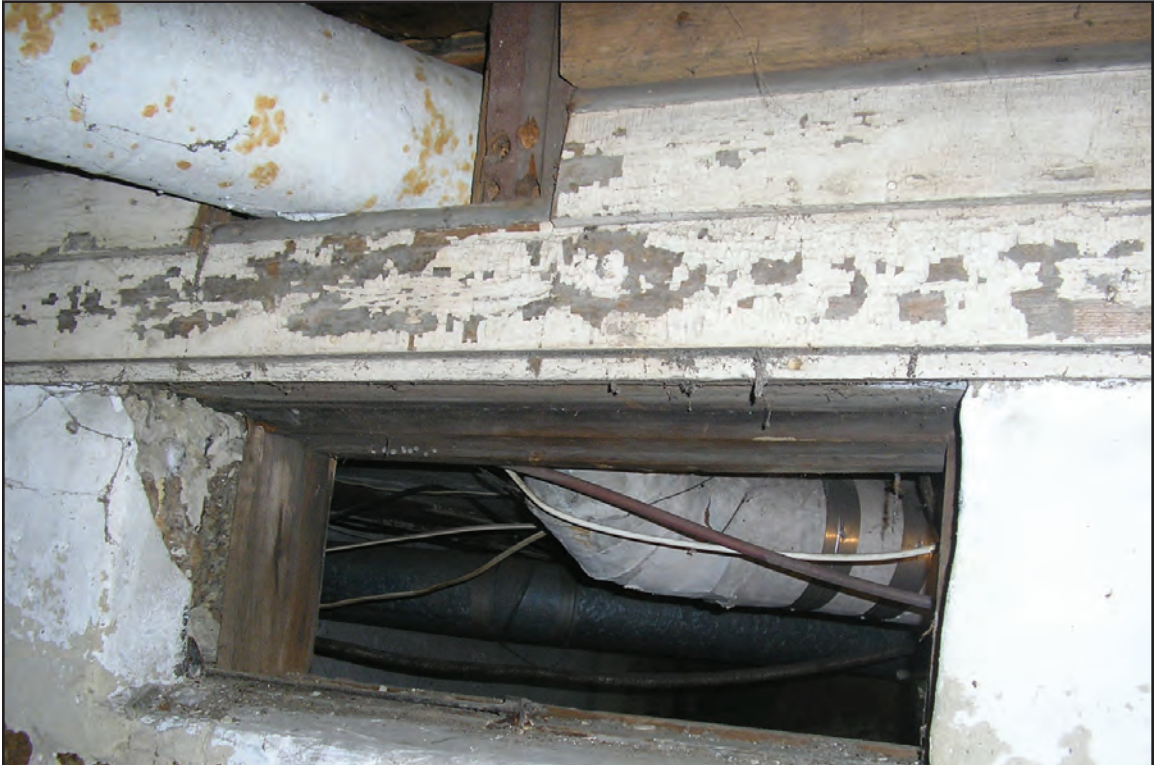
Figure 40 Typical basement window on the east (side) elevation, within the East Addition. Note the absence of any visible painted finish.

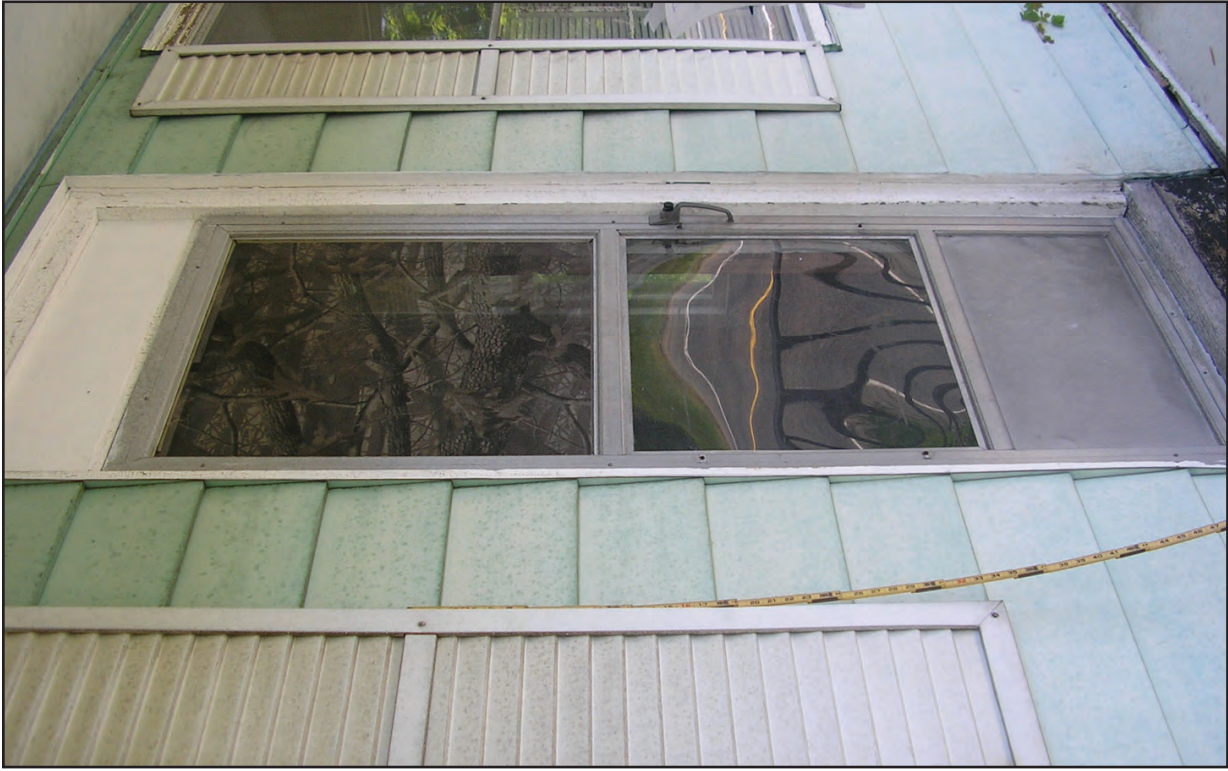
Figure 43 South façade door, view to northeast.

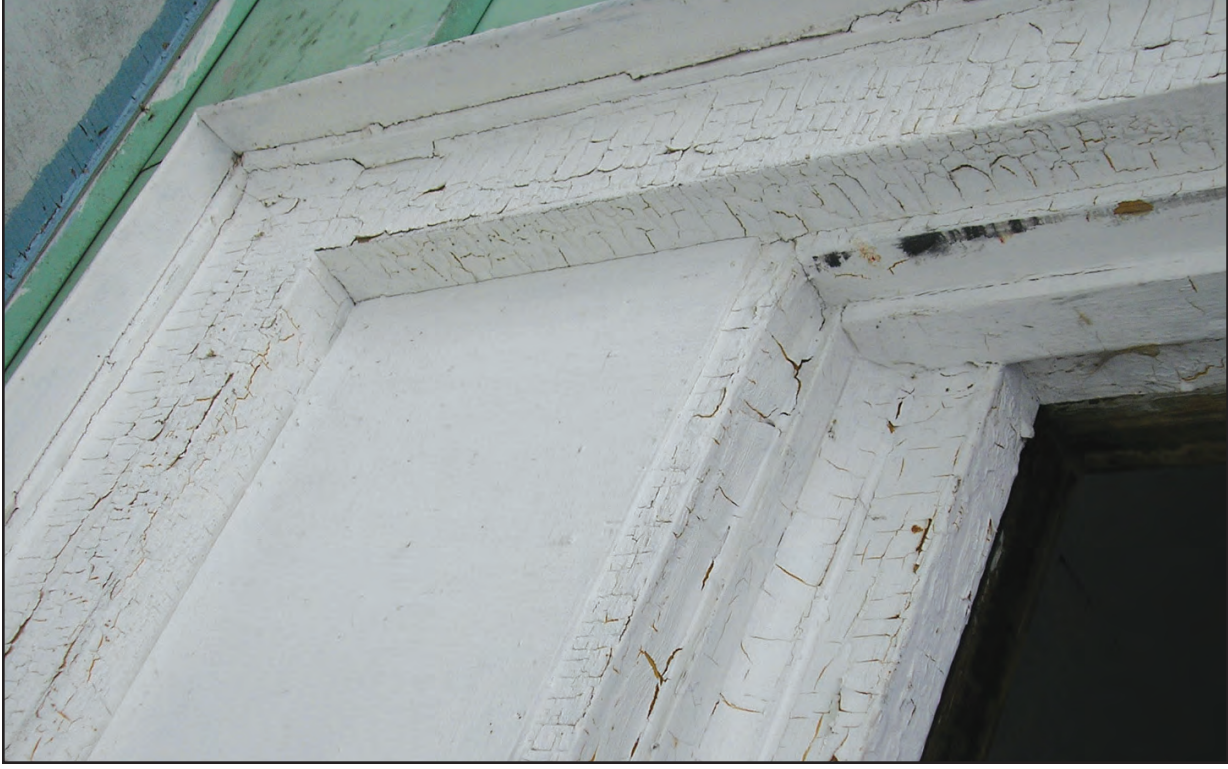
Figure 44 Detail, south façade door, showing transom covered over.

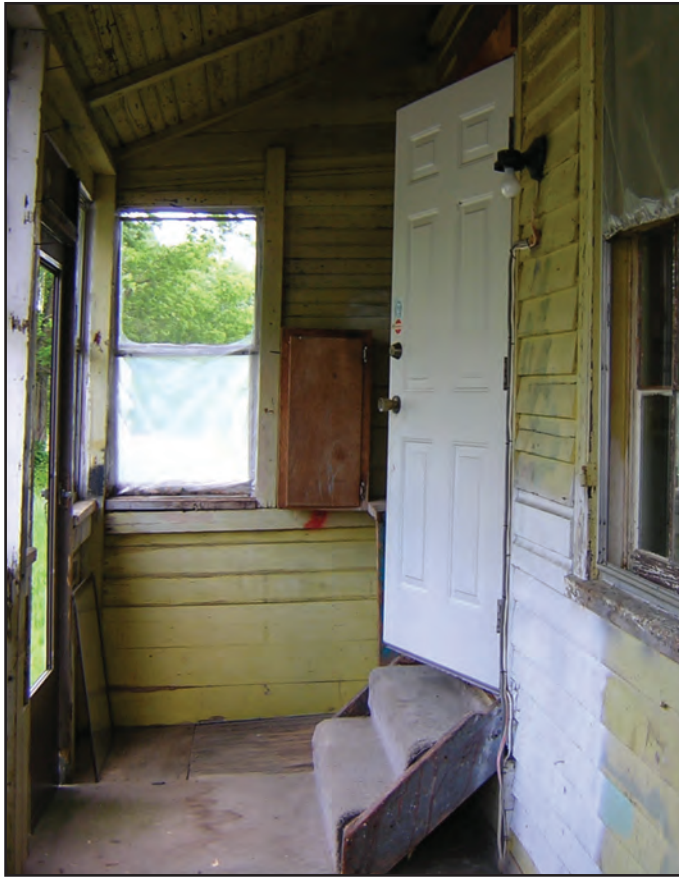
Figure 45 North (rear) door, view to southeast.

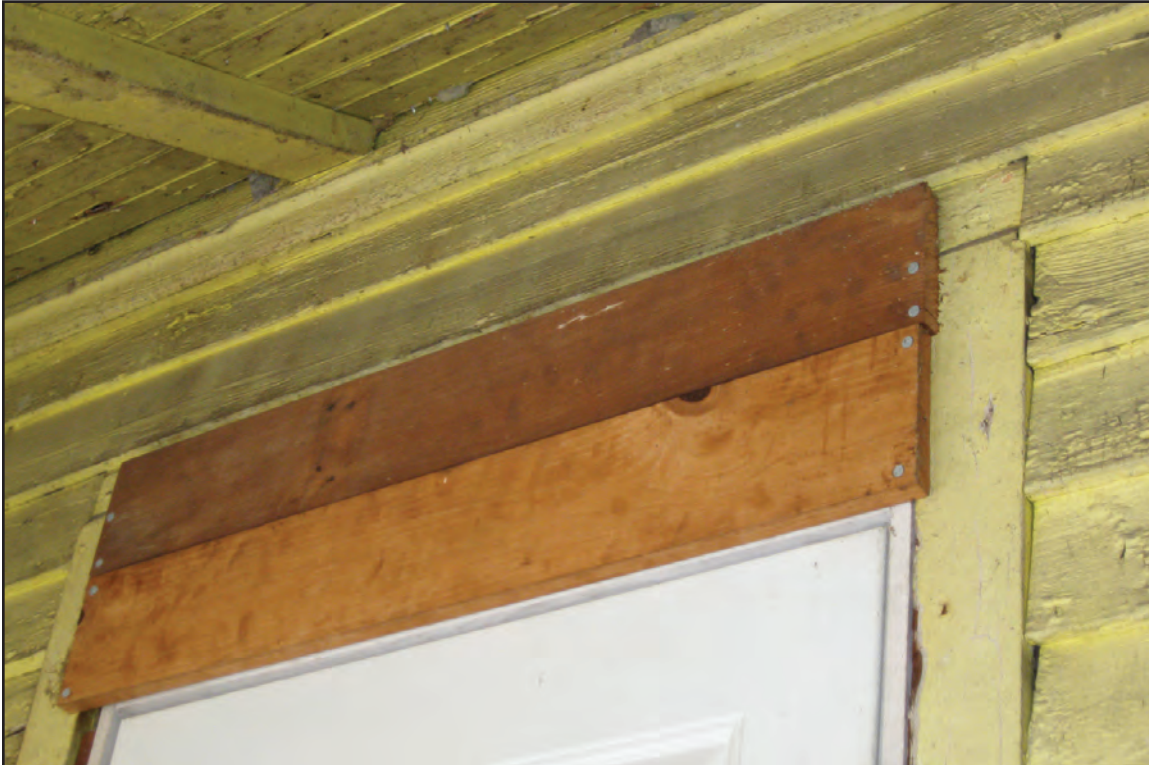
Figure 46 Detail, north (rear) door showing infill at the top of the doorway opening. The doorway was originally taller, or might have had a transom.

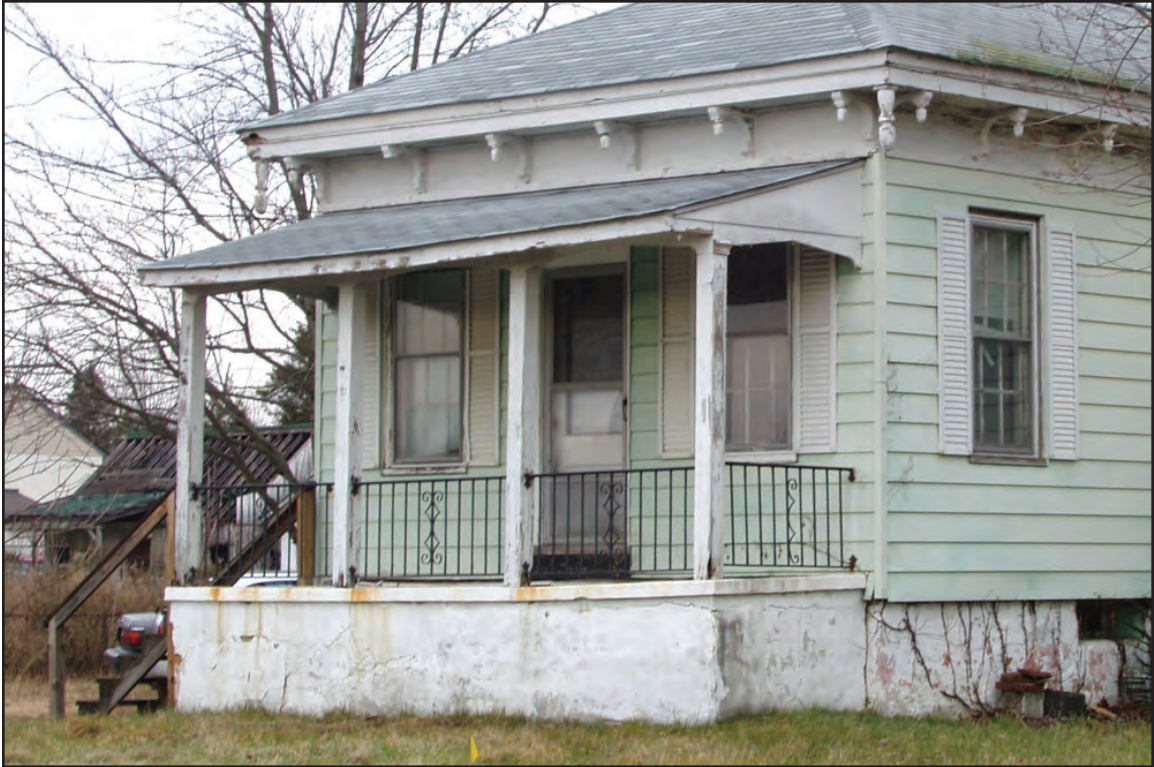
Figure 47 South porch, view from the southeast.

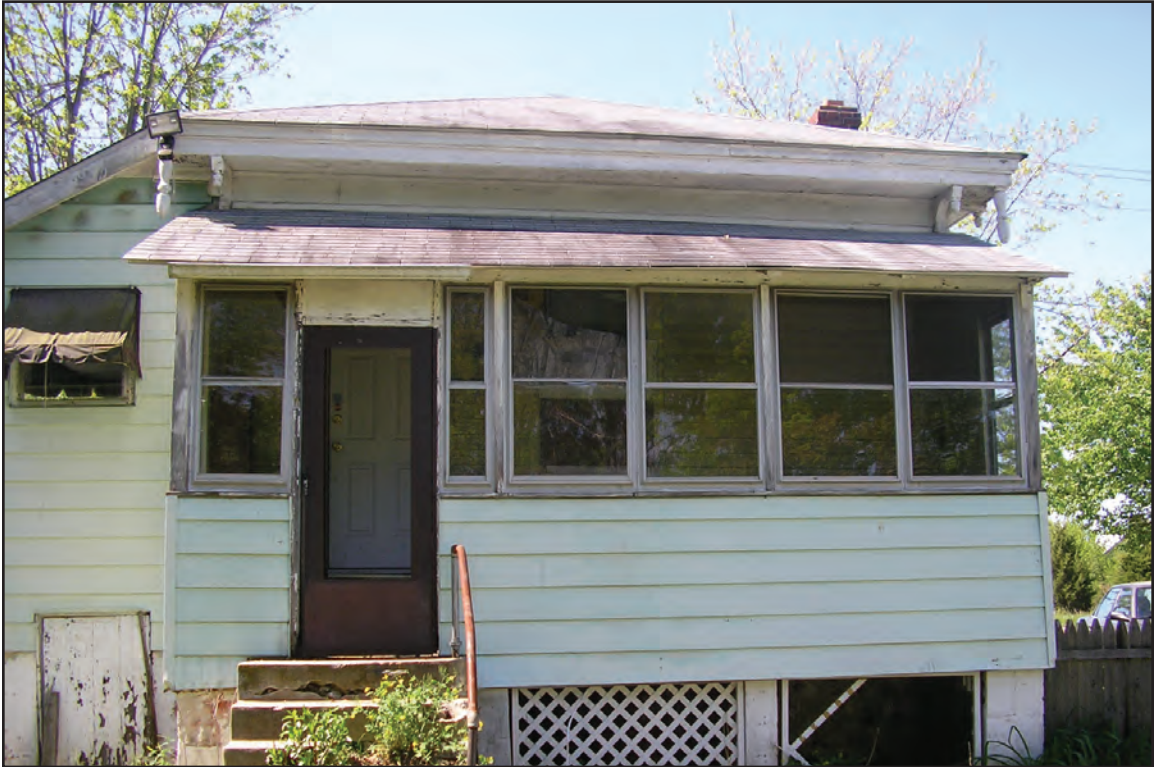
Figure 50 North elevation, north porch. East Addition is at left photo.
