James Still Office Preservation Plan

Submitted to:
New Jersey Historic Trust

Prepared by:
KSK Architects Planners Historians, Inc.

Final Copy: 30 October 2009

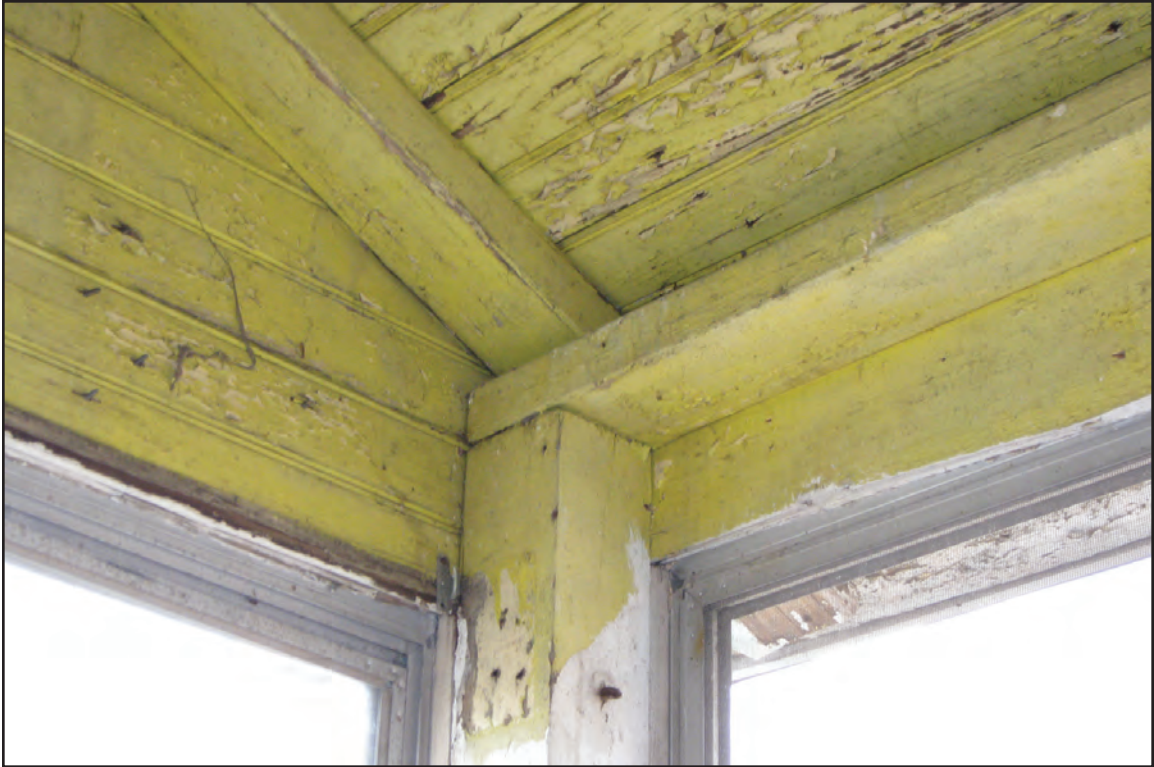
Figure 51 Detail showing north porch framing; roof rafters and wall header are 2x4s laid flat.

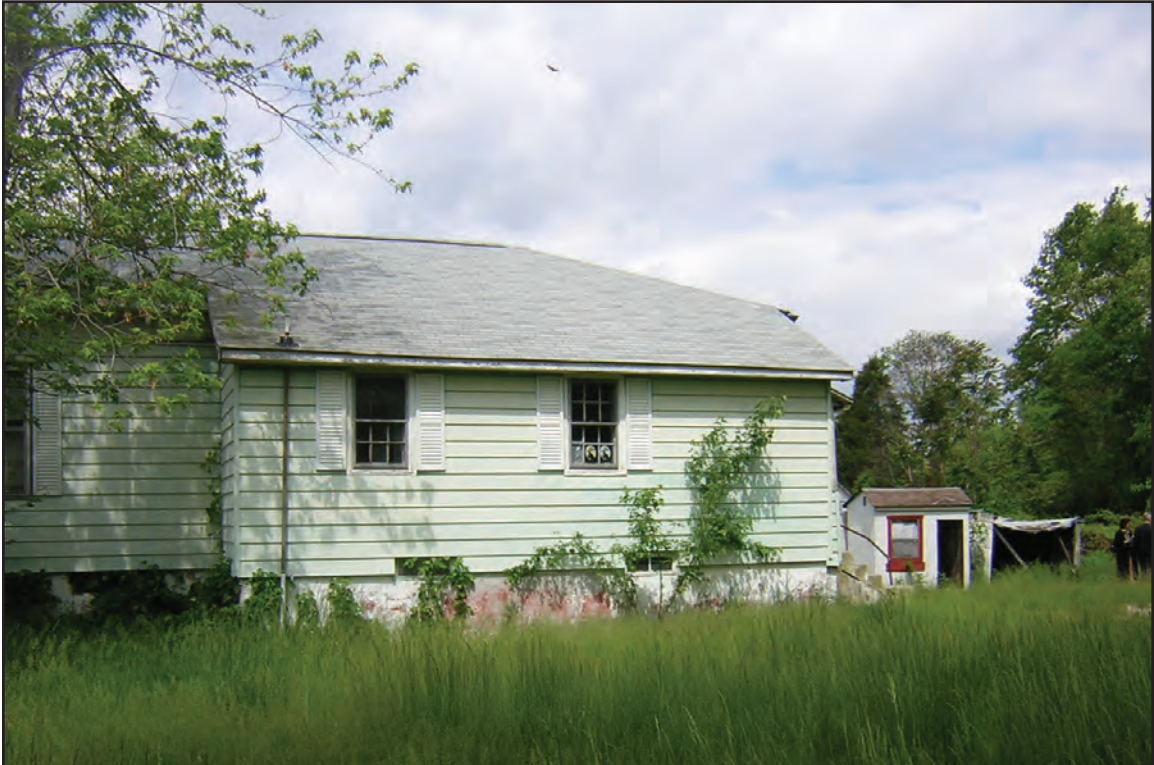
Figure 54 East Addition, east elevation.

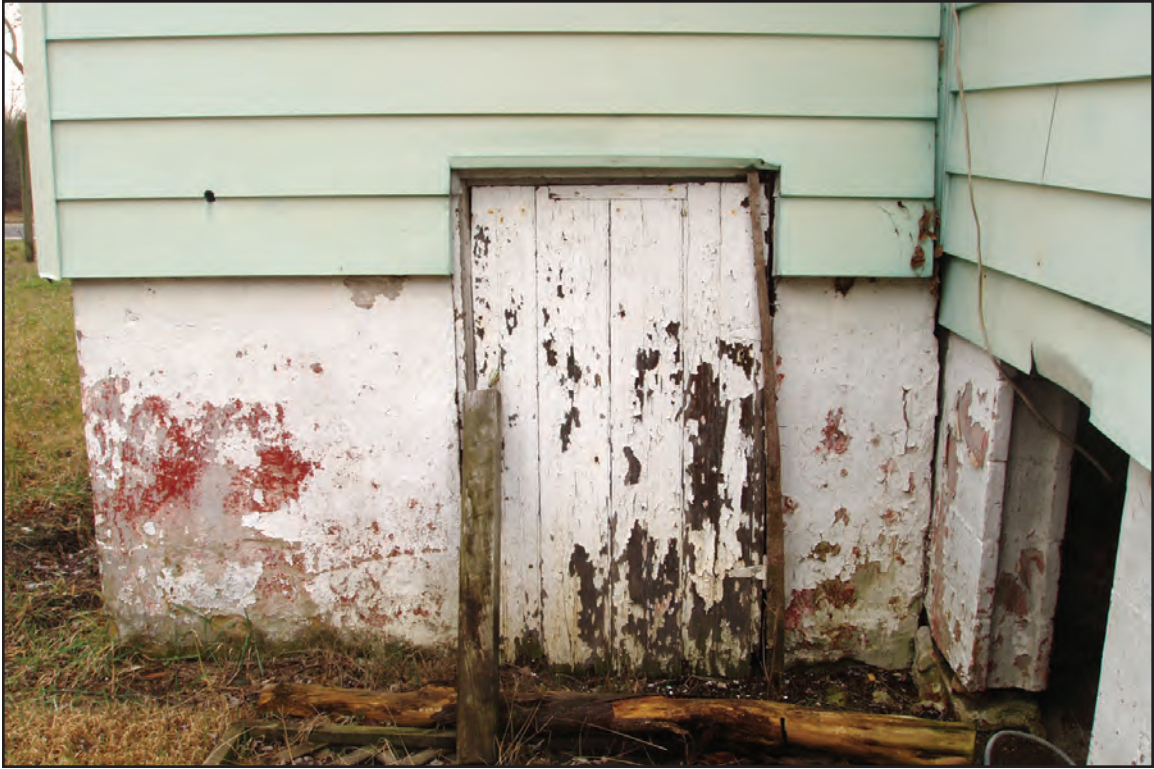
the ground, is a vertical board door constructed with galvanized nails. (Figure 55)

Figure 55 East Addition, north elevation, access door to crawl space under addition.

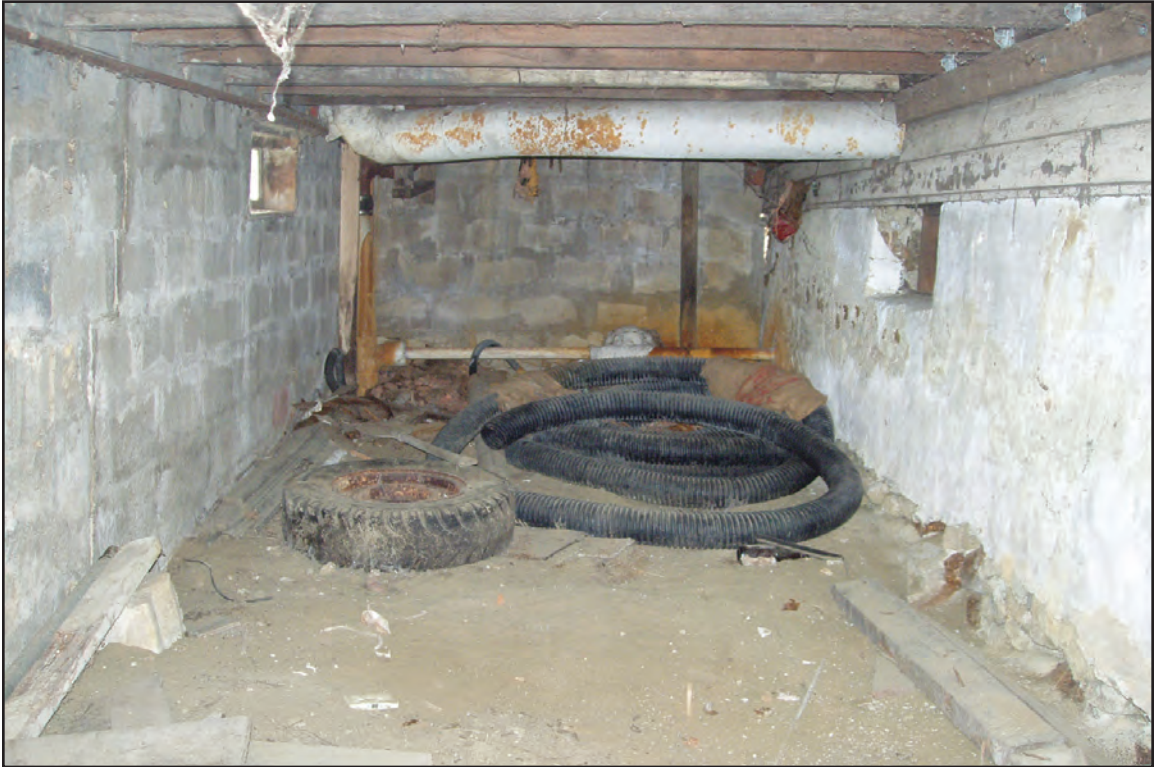
Figure 56 View to the south in the East Addition crawl space. The original east Office wall is at right photo; the CMU East Addition foundation wall is at left and center photo.

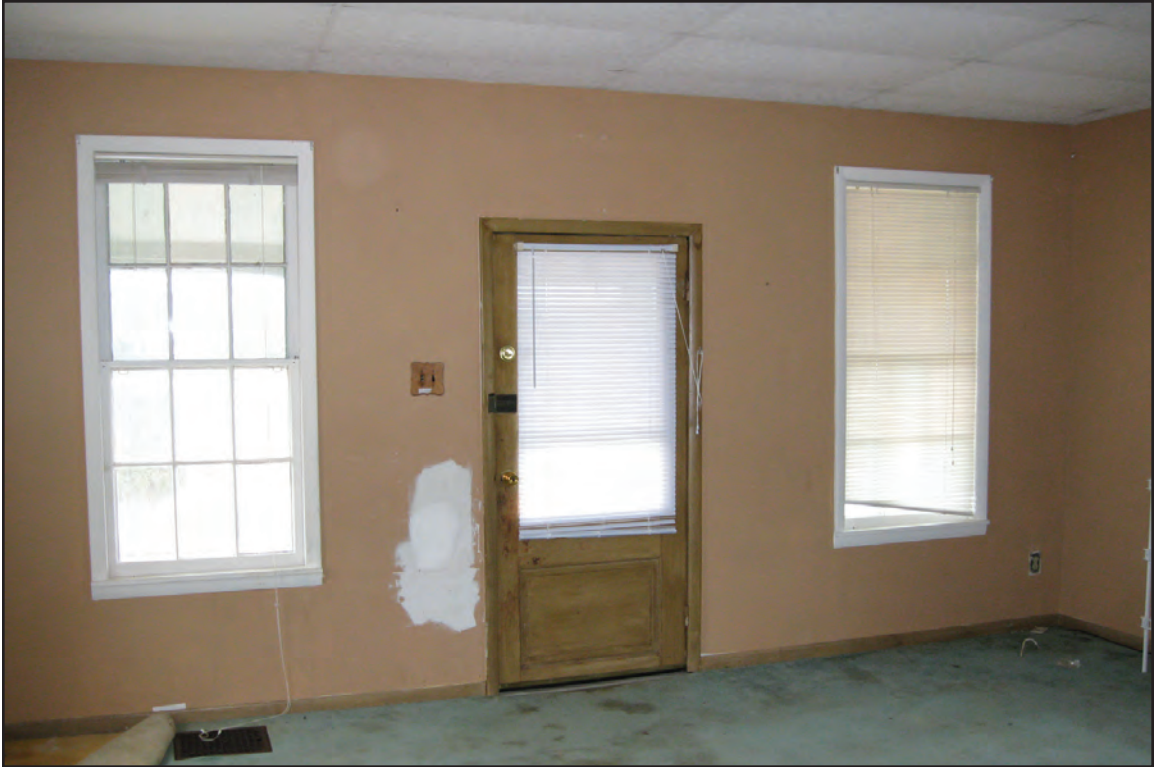
The Office is three rooms deep on the first floor: a front (south) room (Room 101), back (north) room (Room 105), and a middle room (Room 104). The front and back rooms are the full width of the building, connected by a hallway along the original east exterior wall. (Figures 57, 58 and 59) Doorways to the middle room and basement stairway are on the west side of this hallway; a doorway to the East Addition is on the east (see Sheet 1, First Floor Plan). (Figure 60) The physical integrity of the interior is good, although nearly all visible surfaces reflect 20th century modifications.

Figure 57 First floor, front room, view to southwest.

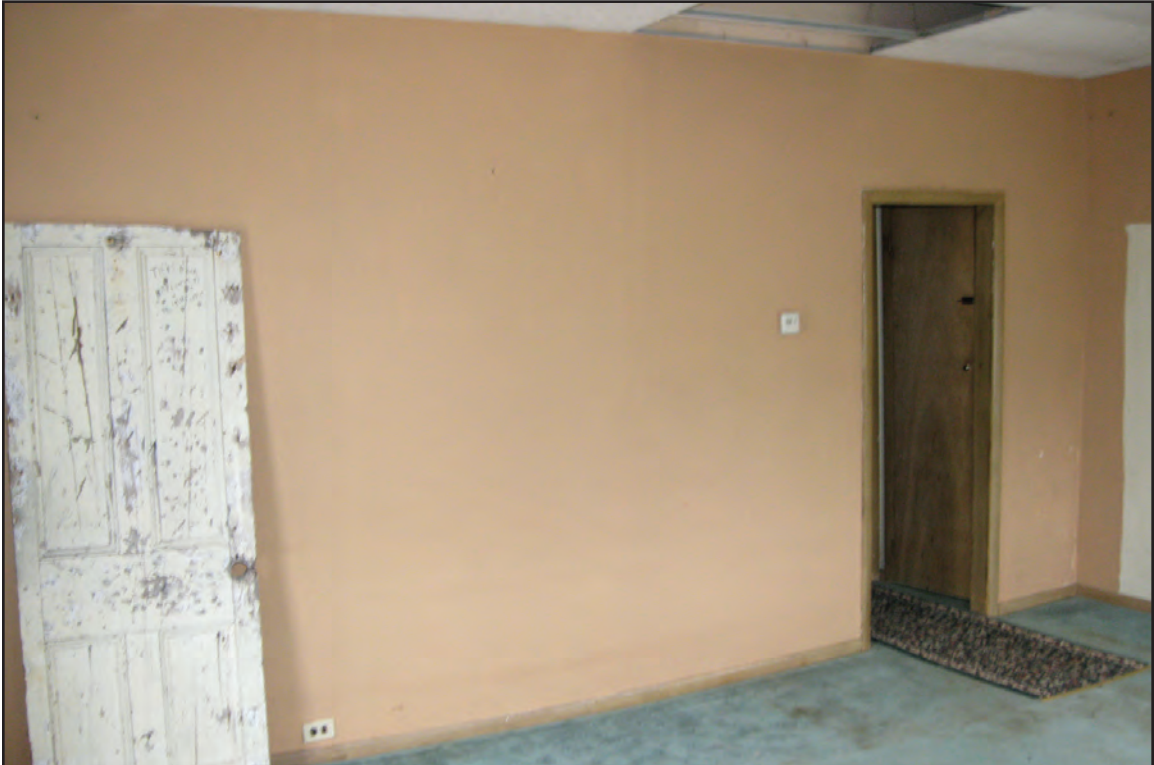
Figure 58 First floor, front room, view to northeast.

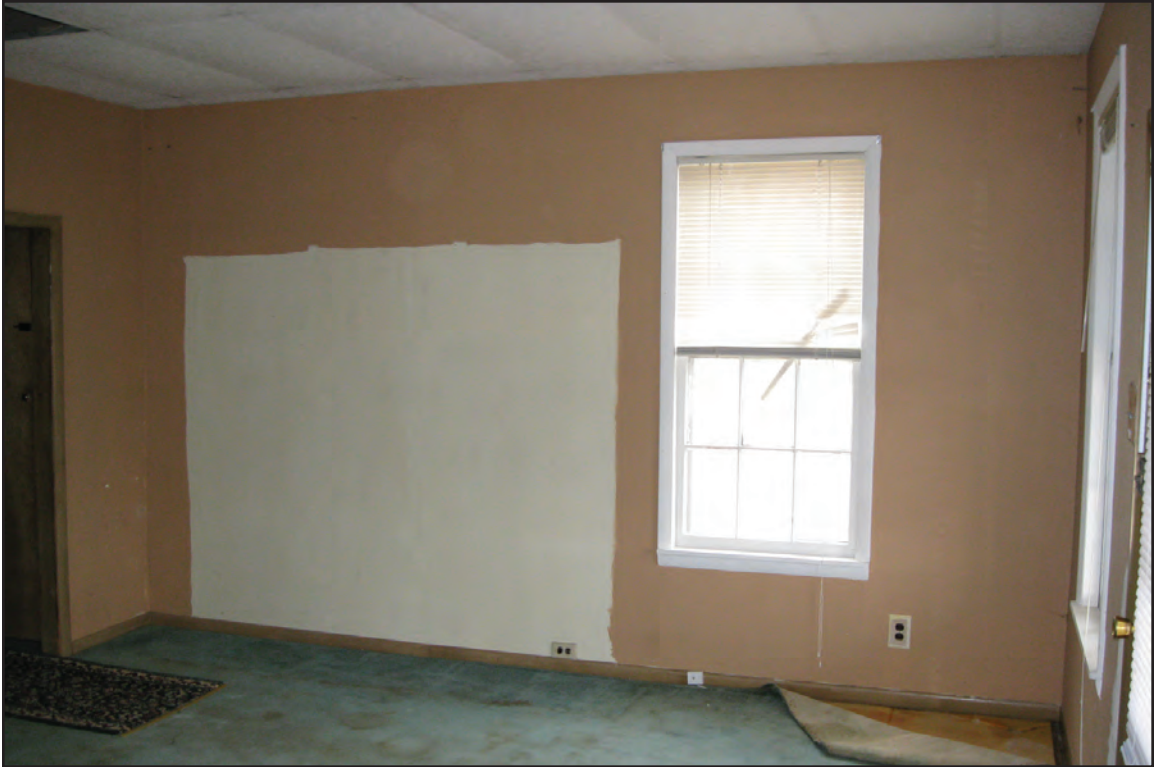
Figure 59 First floor, front room, view to northeast.

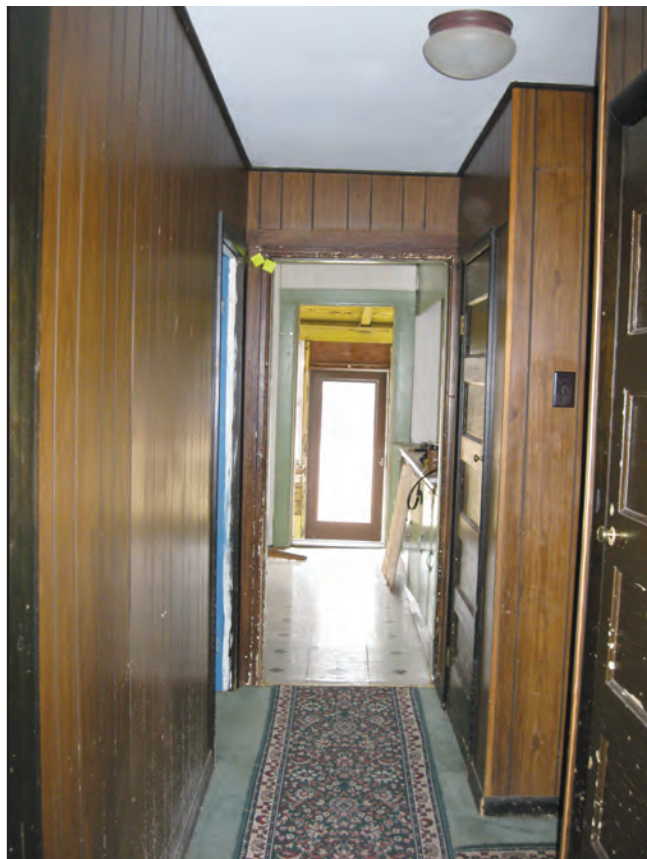
Figure 60 First floor, hallway, view to north toward back room and north exterior door. The basement doorway is just out of view at left photo. The middle room doorway is a white vertical line at left photo. The doorway to the East Addition is at right photo.

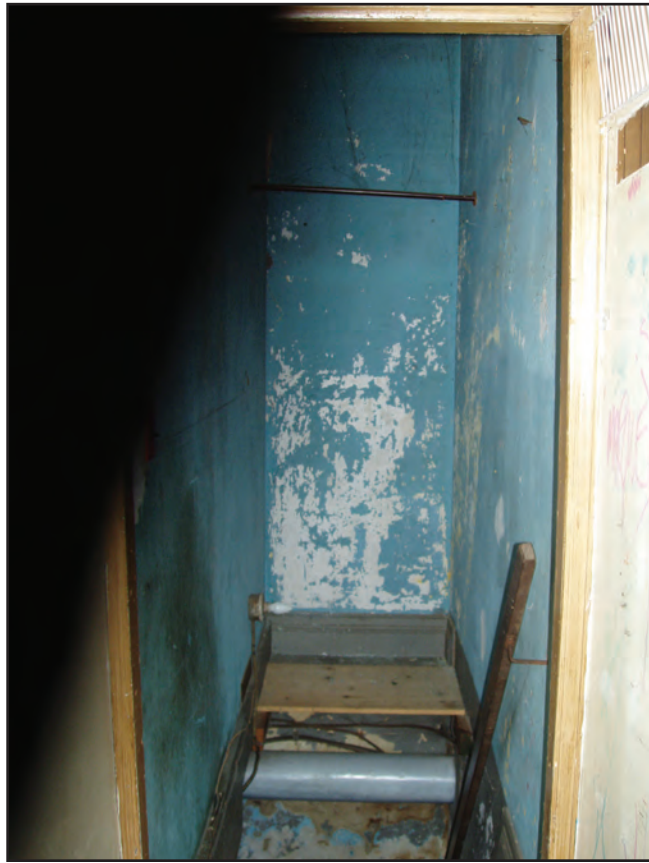
All four walls in Room 101 have been furred out with gypsum wall board or particle board. Trim at windows and doors is modern "clamshell" trim. Walls between rooms 104 and 103 (the middle room and basement stairway, respectively), and the middle room and back room (rooms 104 and 105) are plaster on lath; the east and west walls in the middle room are furred out and paneled. (Figures 61, 62 and 63) All four back room walls are plaster on lath. (Figures 64, 65 and 66)

Figure 61 Basement stairway viewed from the first floor landing; view to west.

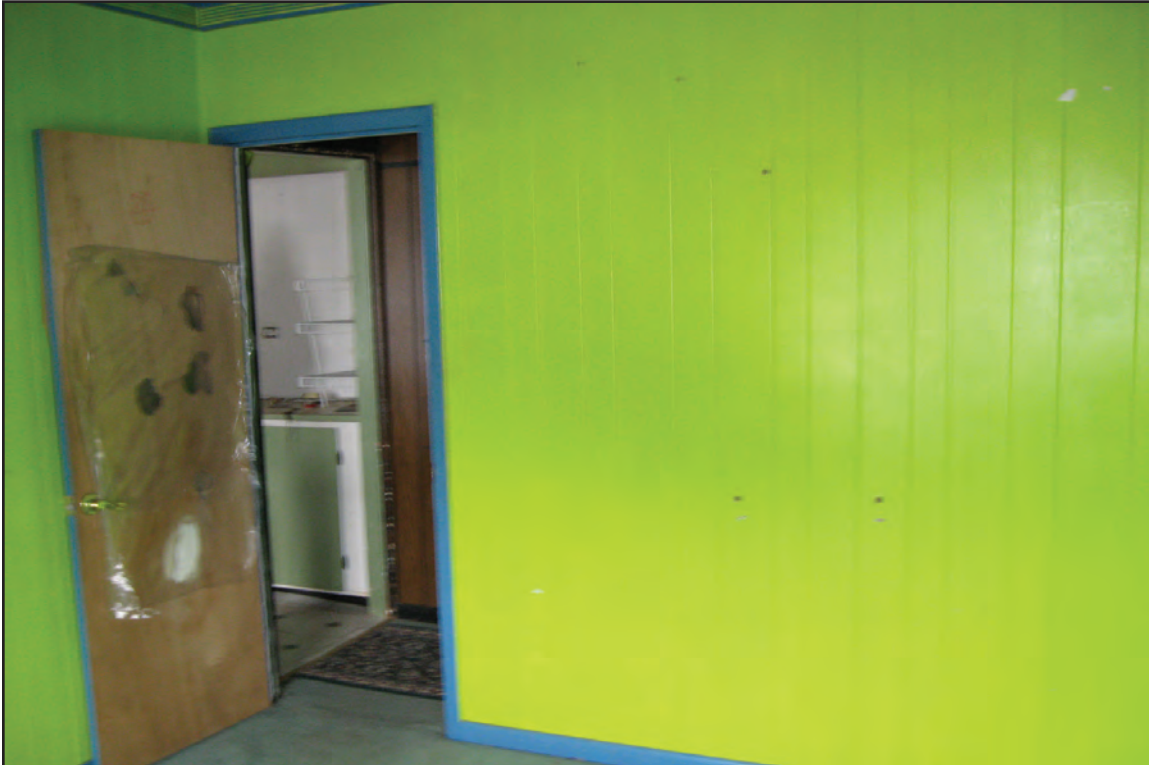
Figure 62 First floor, middle room, view to northeast.

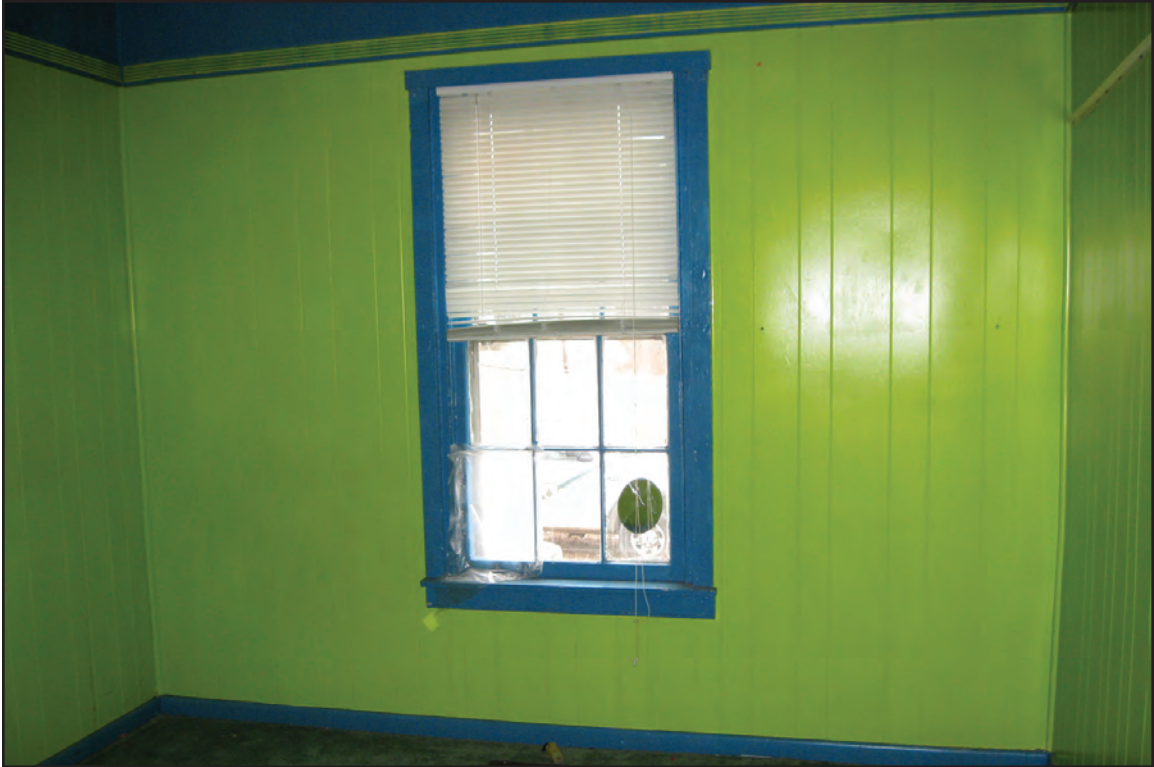
Figure 63 First floor, middle room, view to west.

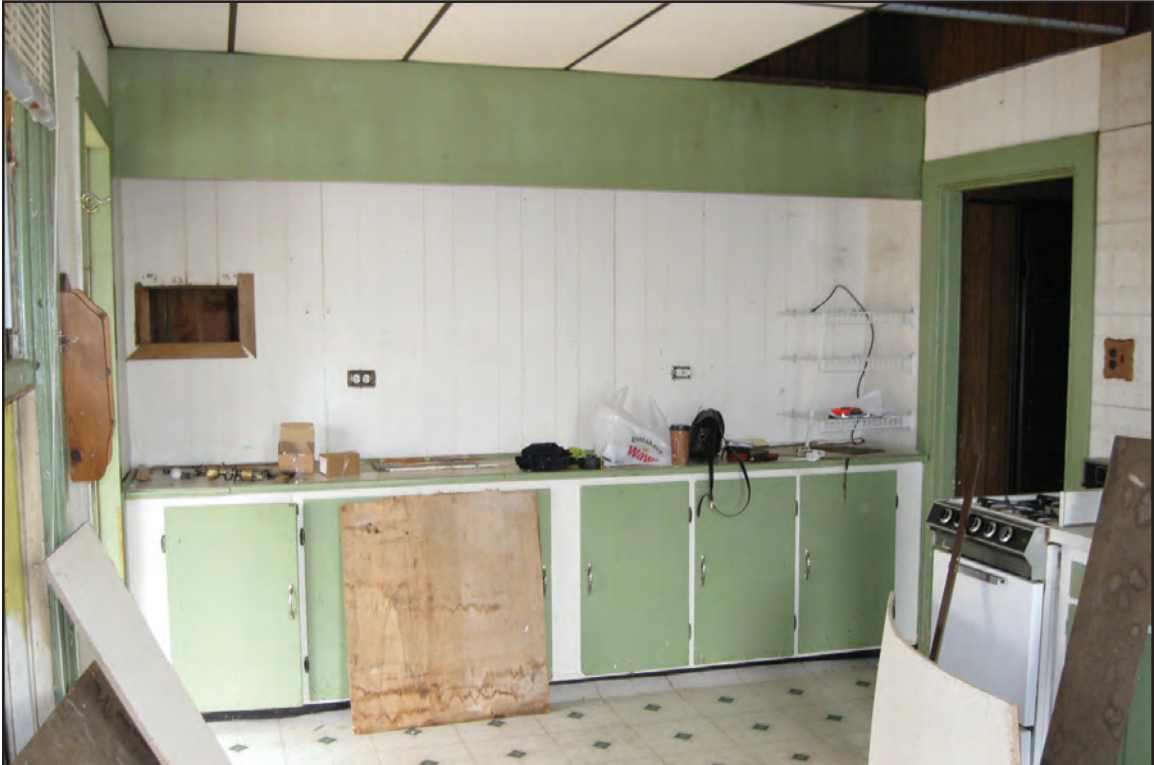
Figure 64 Back room, view to southeast.

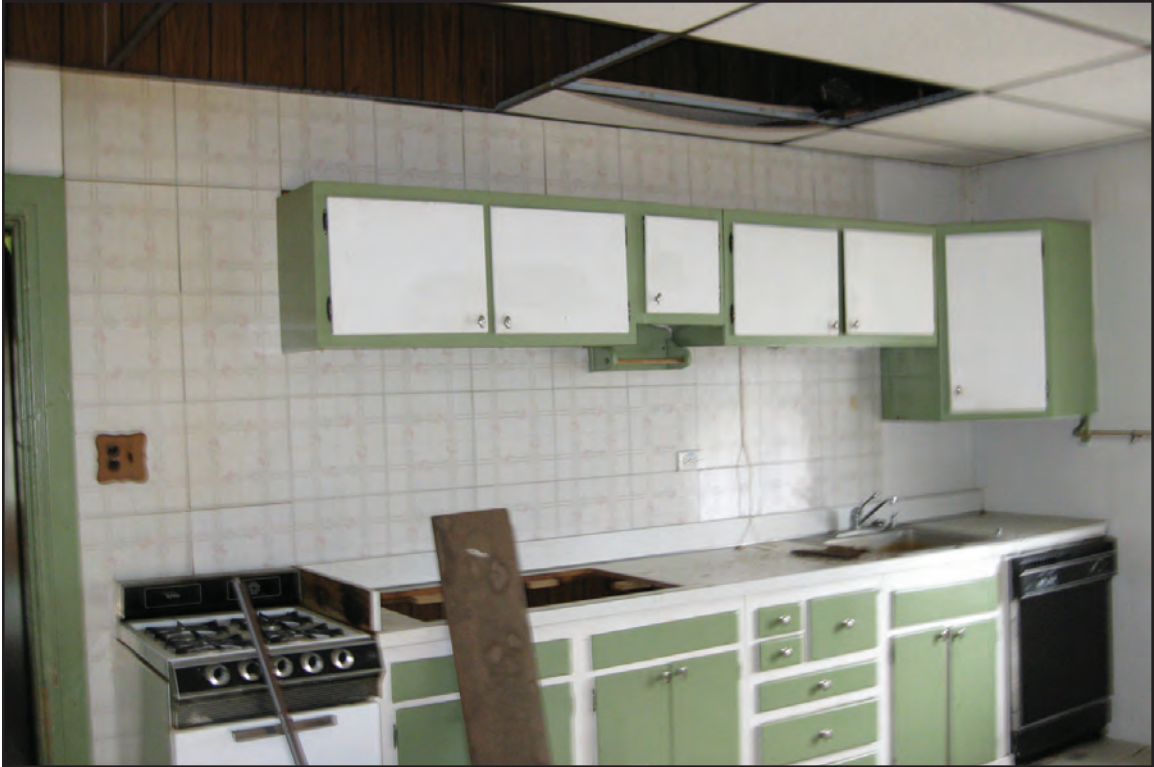
Figure 65 Back room, view to northwest. Note the suspended ceiling; the original plaster ceiling is above.

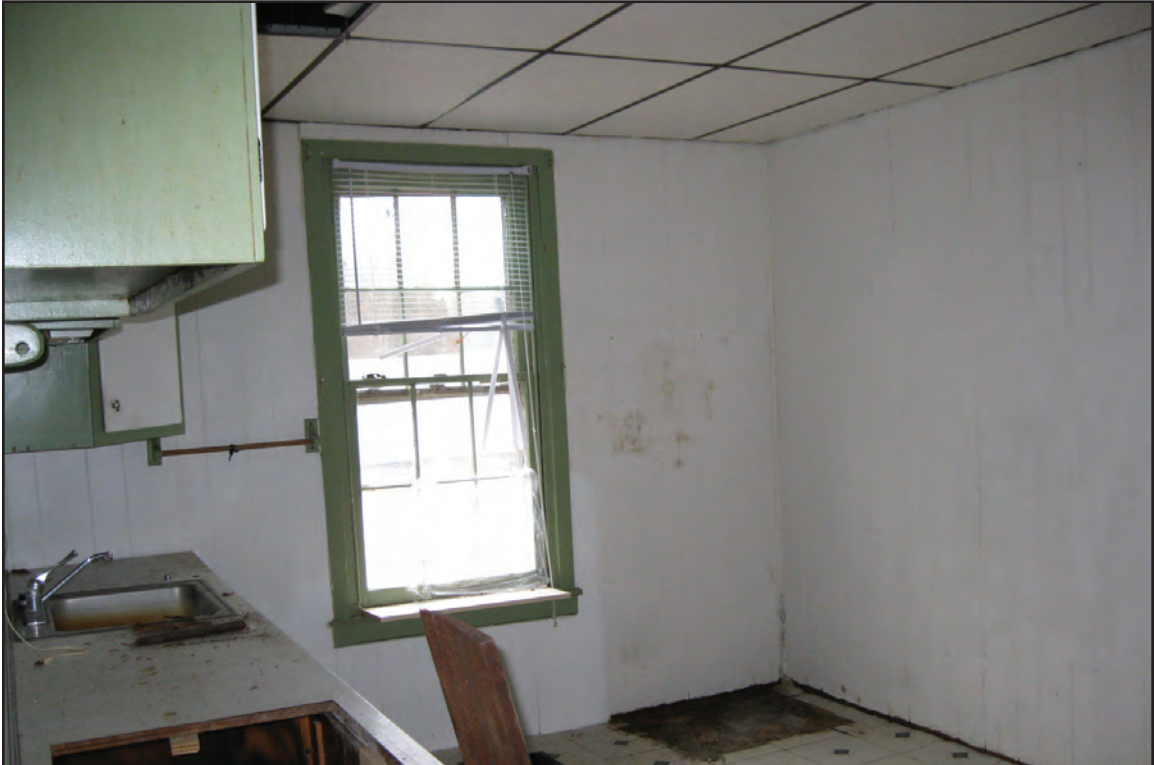
Figure 66 Back room, view to southwest.

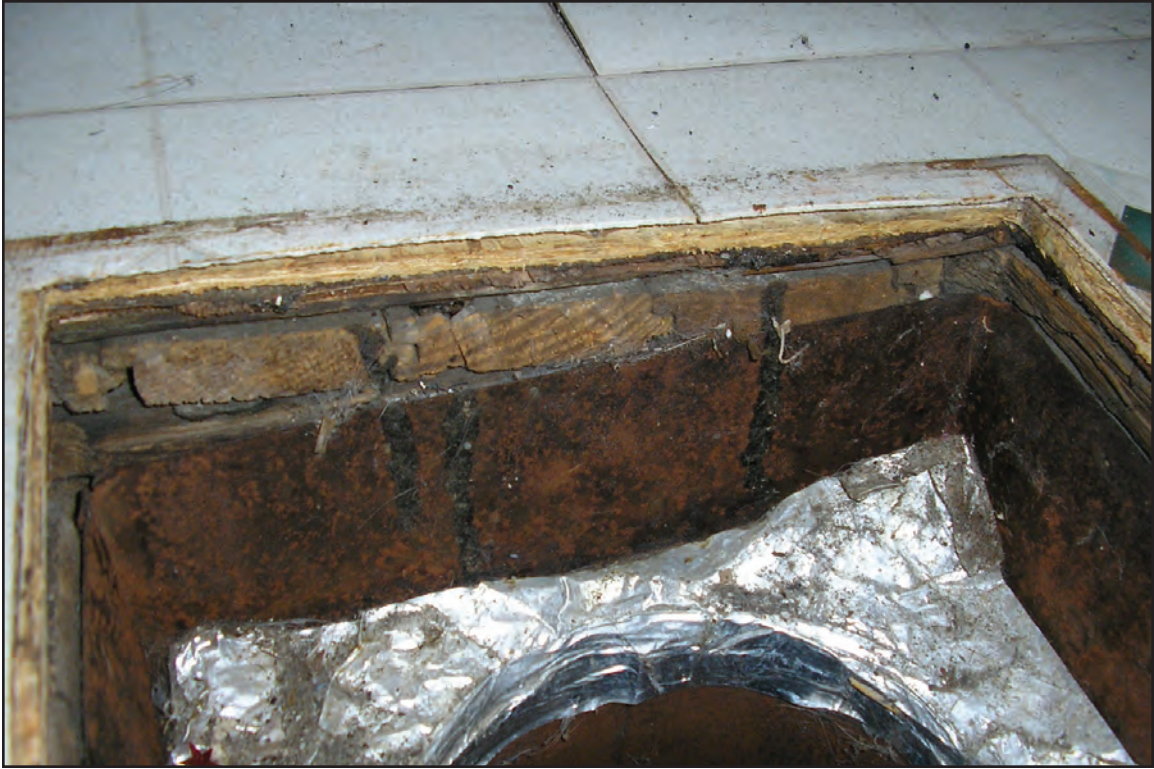
All of the floors on the first floor have been covered with carpet or linoleum tile over a plywood base layer. The original wood floors could be seen, still in place, below these later finishes when heating grates were removed. (Figure 67) All later first floor interior finishes—carpeting, plywood, gypsum wall board and particle board, paneling, ceiling tiles—should be carefully removed and documented. (Figure 68) This peeling away of layers may reveal that more original features survive (window trim, for example) and may yield new information on the original floor plan, such as whether or not the furred out wall between the front room and basement stairway is original. This investigation would hopefully also provide information on the location of the stove mentioned in the 1882 Still Office Inventory, and possibly even the location of furnishings or fixtures based on wear patterns in the floor boards.

Figure 67 Early/original wood floor boards are visible in openings for floor heating grates.

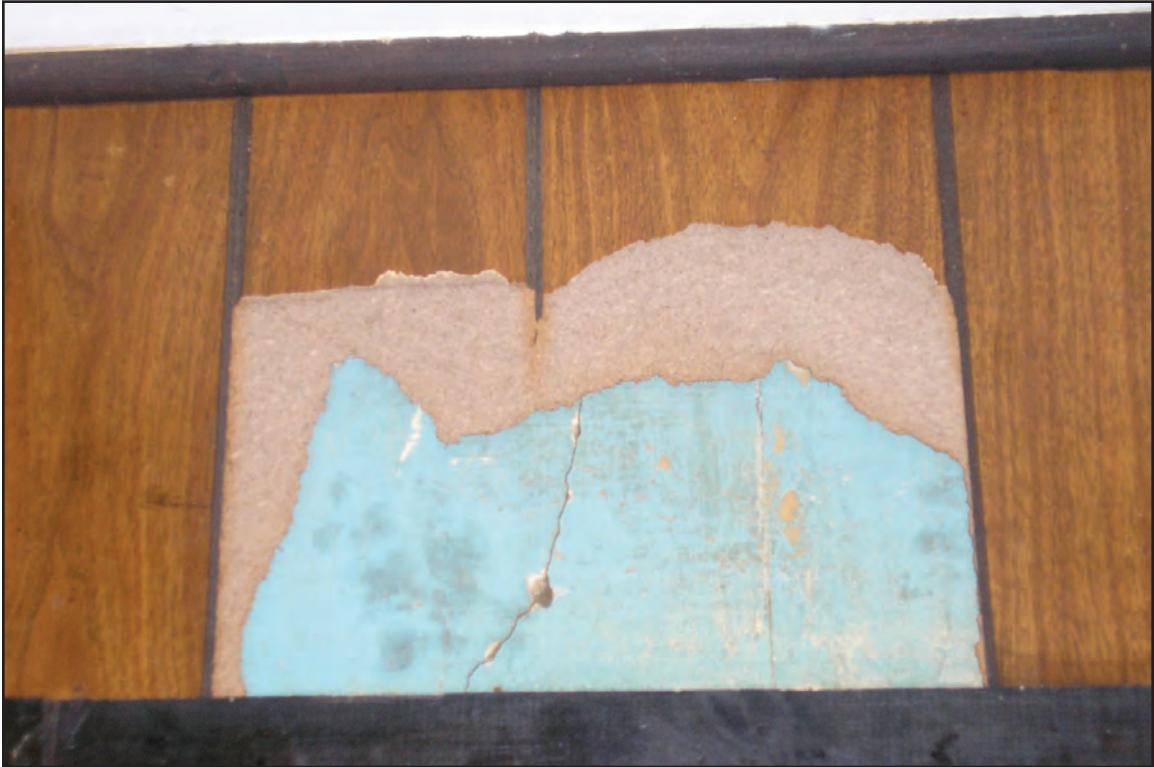
Figure 68 Plaster walls are behind later finishes, such as this modern paneling in the hallway.

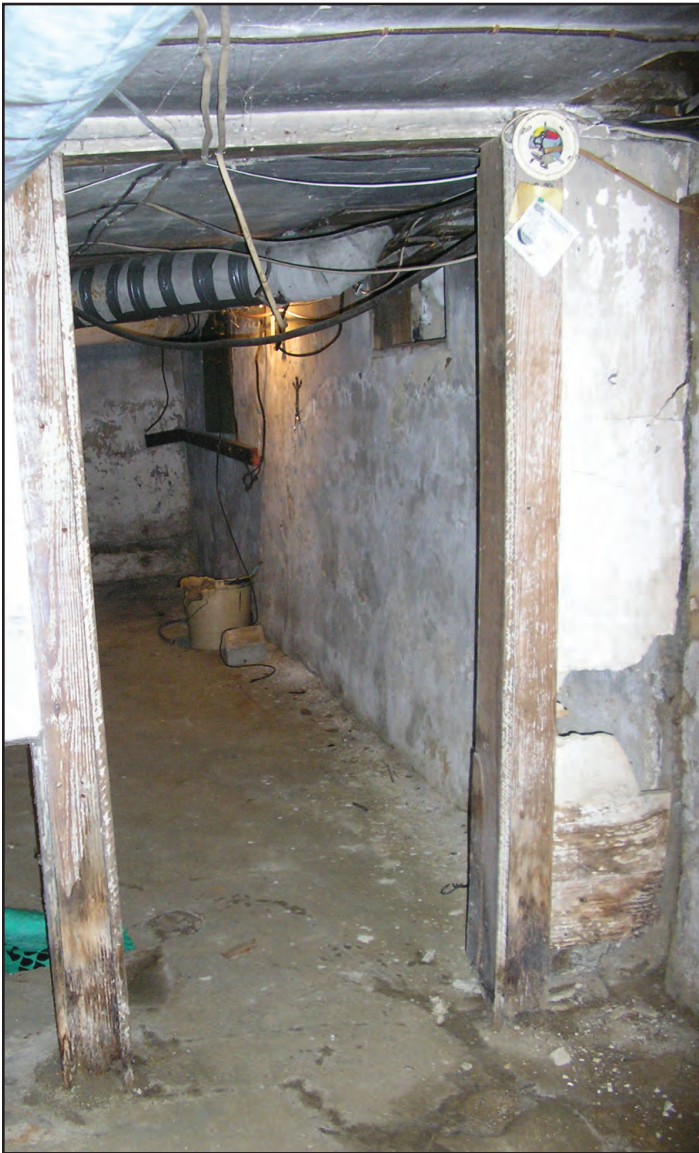
Figure 69 The doorway between the front and rear basement rooms is believed to be early/original; view to the north from the front (south) room.

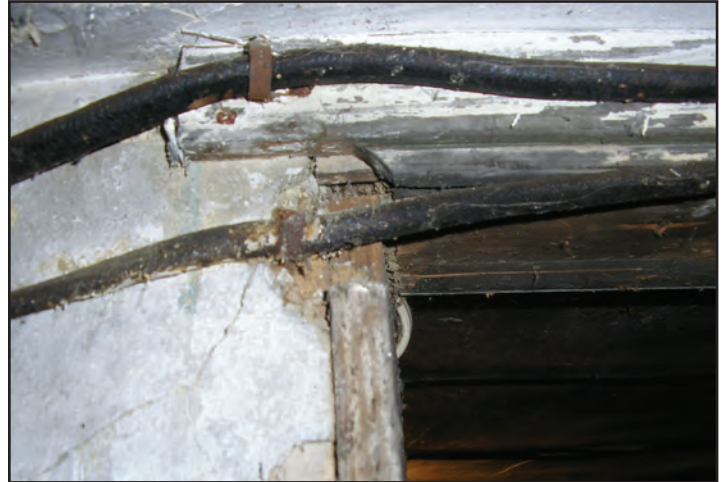
Figure 70 Early/original beaded trim at the doorway between the front and rear basement rooms.

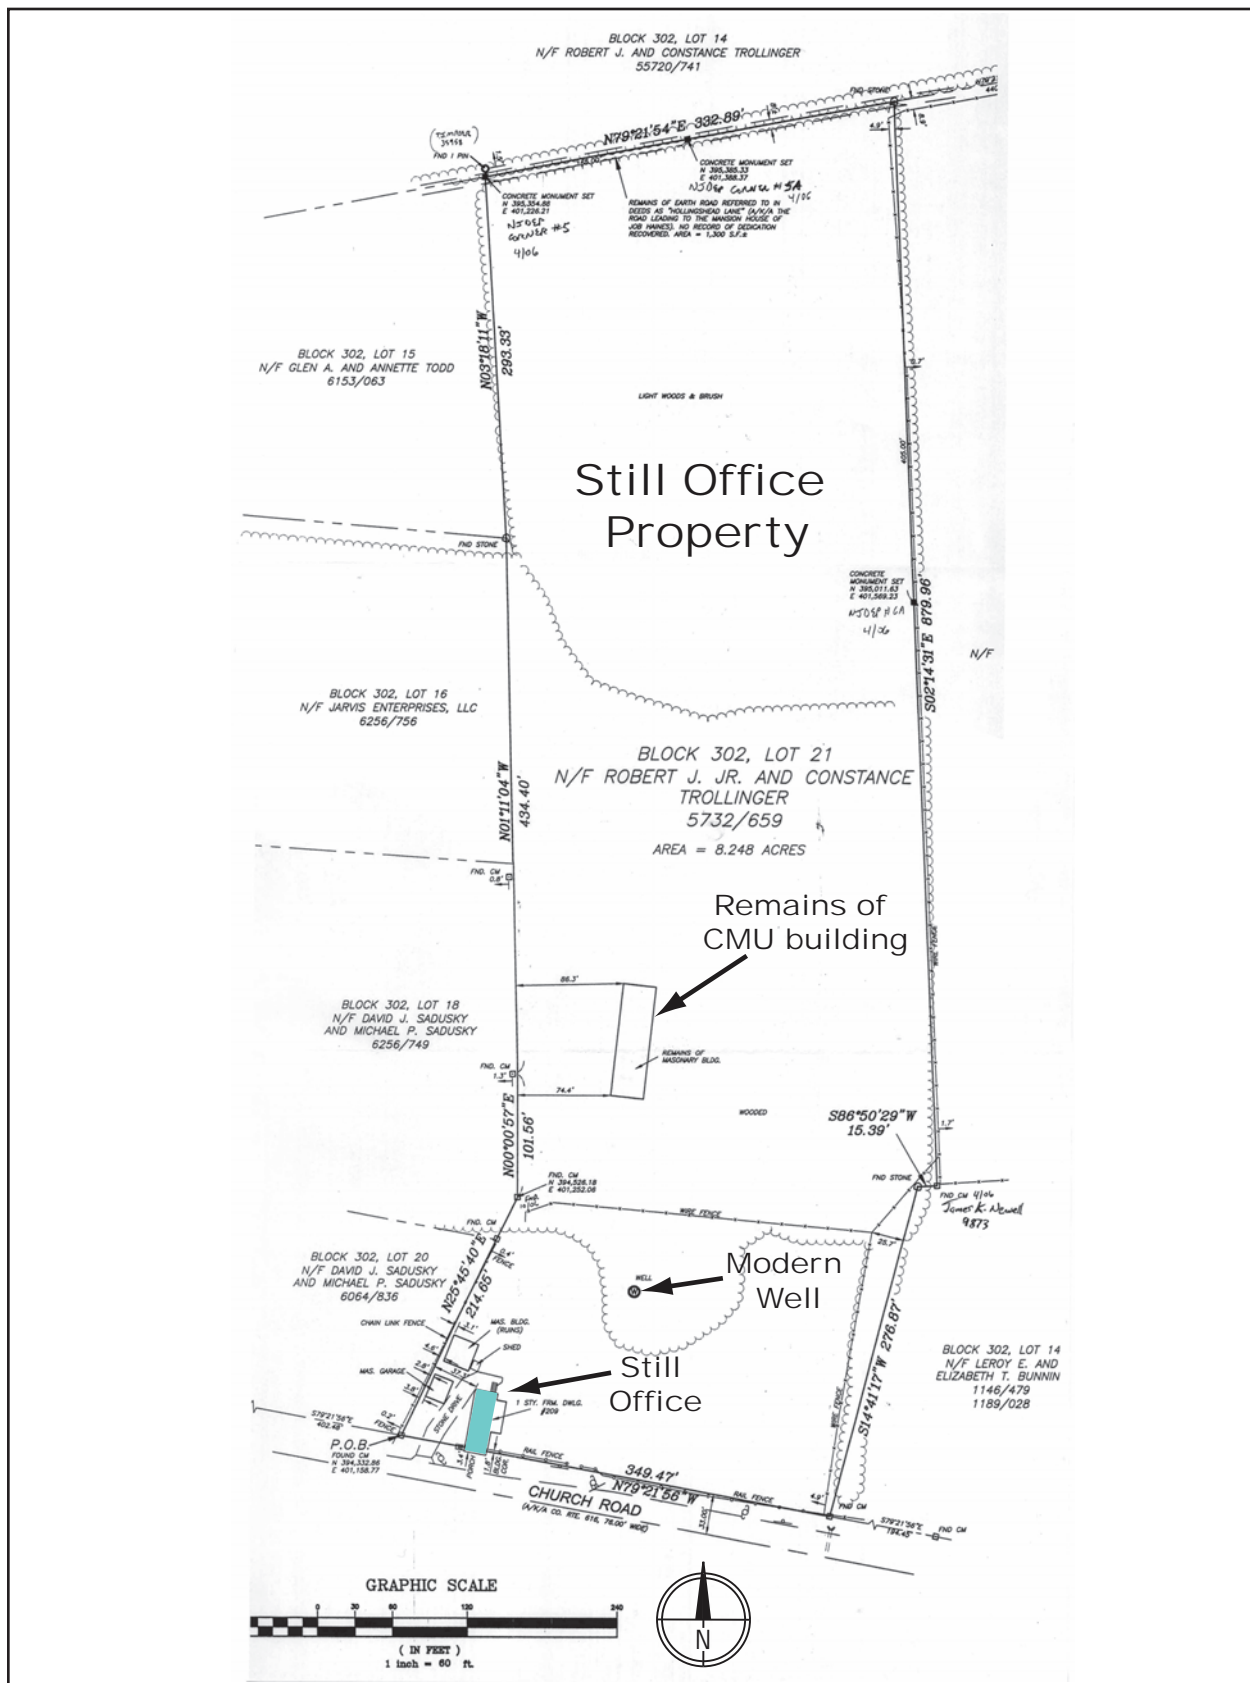
The rear portion of the tract (the dog-leg) is wooded in the southern half and covered in light woods and brush in the northern half. In the southwest corner of this area are the remains of the CMU building, 75 to 85 feet east of the western property boundary (see Figure 76). The area around these ruins is relatively open. A lane that extends along the northern and western edges of the former building is discernable in an area otherwise overgrown with thick vegetation. Pieces of farm machinery are present nearby.

Figure 76. Site Plan, Still Office property. Vargo Associates, Map of Survey, Block 302, Lot 21, Plate 3, Medford Township, Burlington County, New Jersey, 4-28-06.

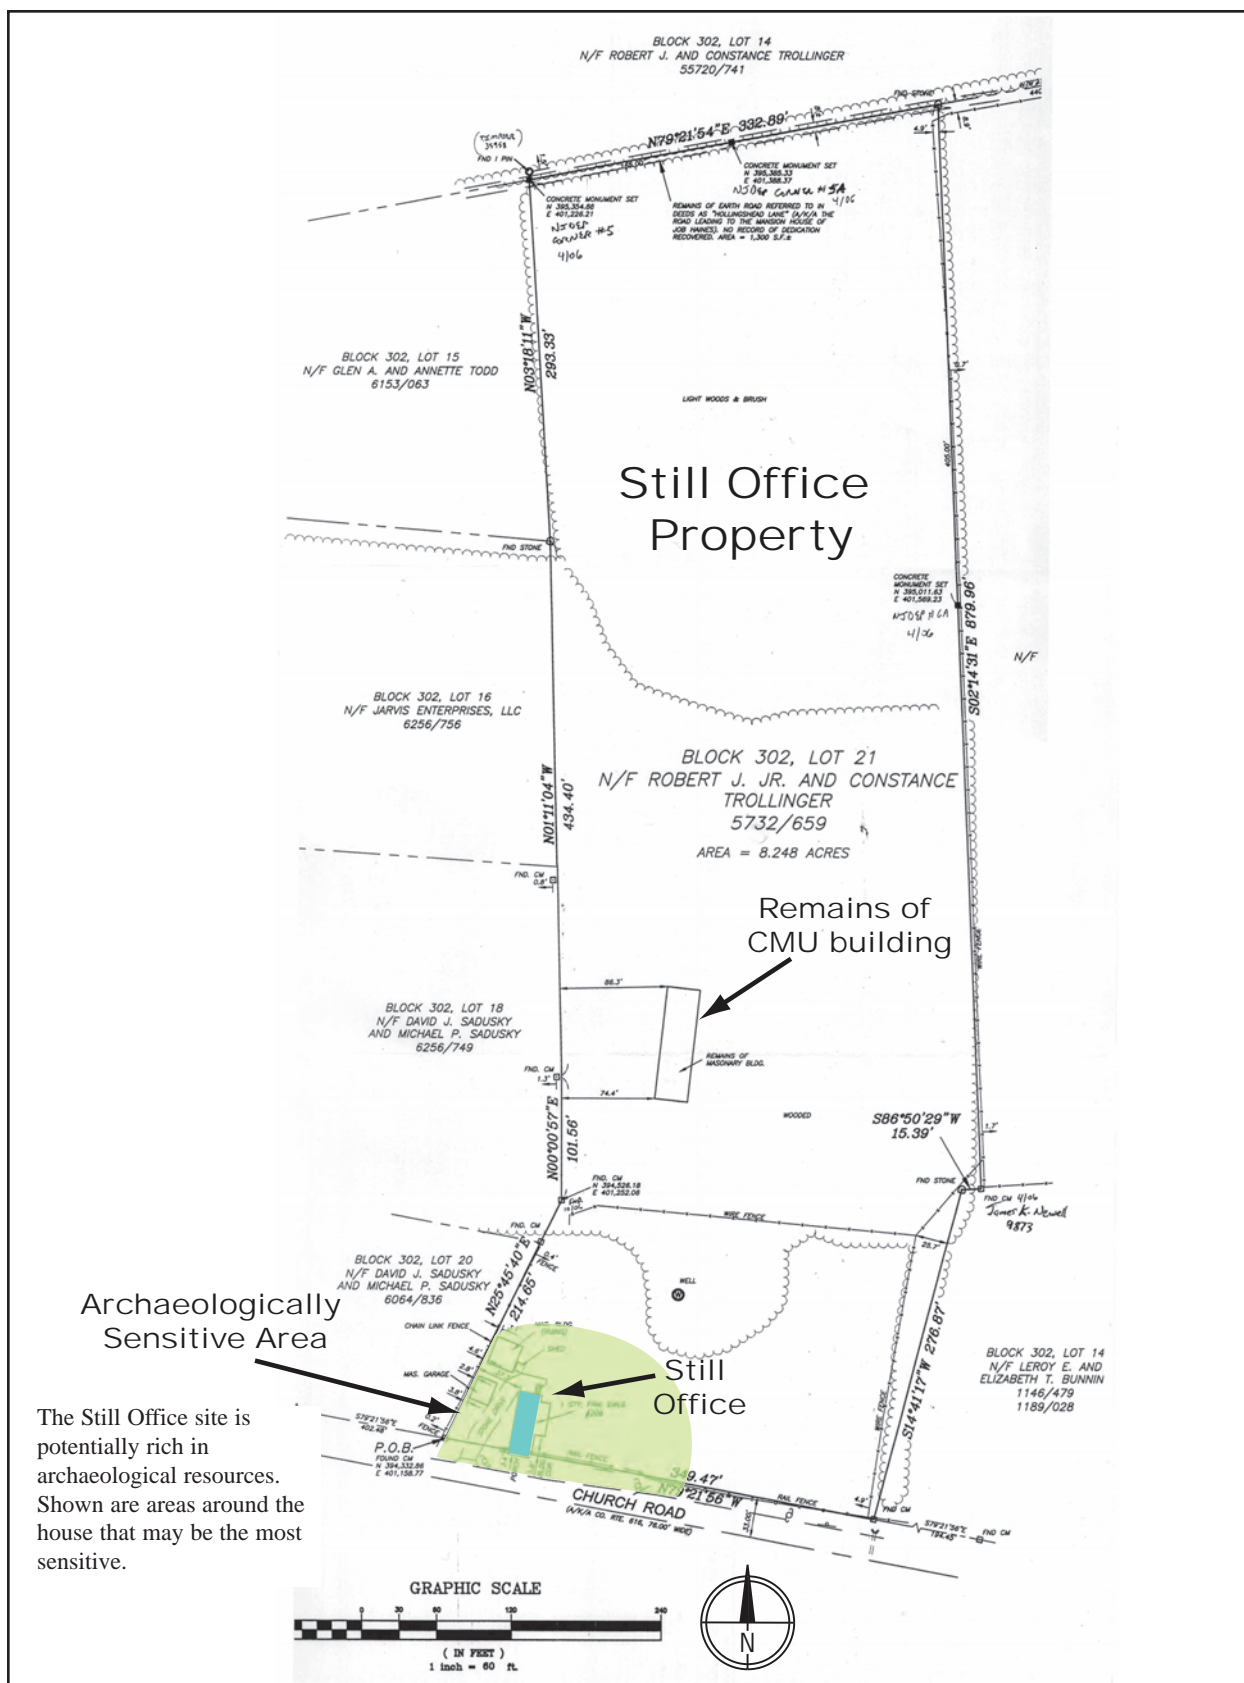
Figure 77. Archaeologically sensitive areas adjacent to the Still Office. Site plan is by Vargo Associates, *Map of Survey, Block 302, Lot 21, Plate 3, Medford Township, Burlington County, New Jersey*, 4-28-06.

It is recommended that the location of the house and area surrounding it be left undisturbed until the property is fully secured and activities are planned for its use (Figure 77). Initiating investigations while the property remains vacant may serve to attract attention from curiosity seekers who may intentionally or inadvertently cause harm to archaeological resources on the property. Machine access should be through areas either west of the Office or to the east of the large trees that stand east of the house location (see Appendix III, Plate 3) to avoid accidental damage to the underlying remains. Shaft features such as wells and privies may be located to the rear (north) of the former house site, and this area should be avoided also.

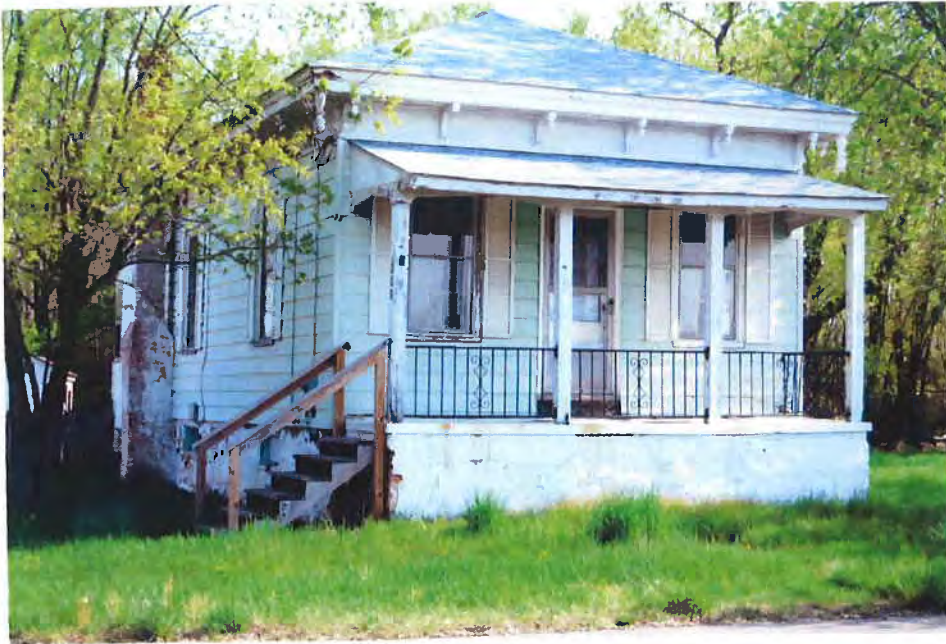
Photo 1

6. The wood posts on the front porch have decayed at the base [Photo 1]. These posts should be replaced with more period appropriate posts as a part of any restoration.

Front of the building
with the front porch

Photo 1: Overall view of the front (south elevation) of the James Still Office.

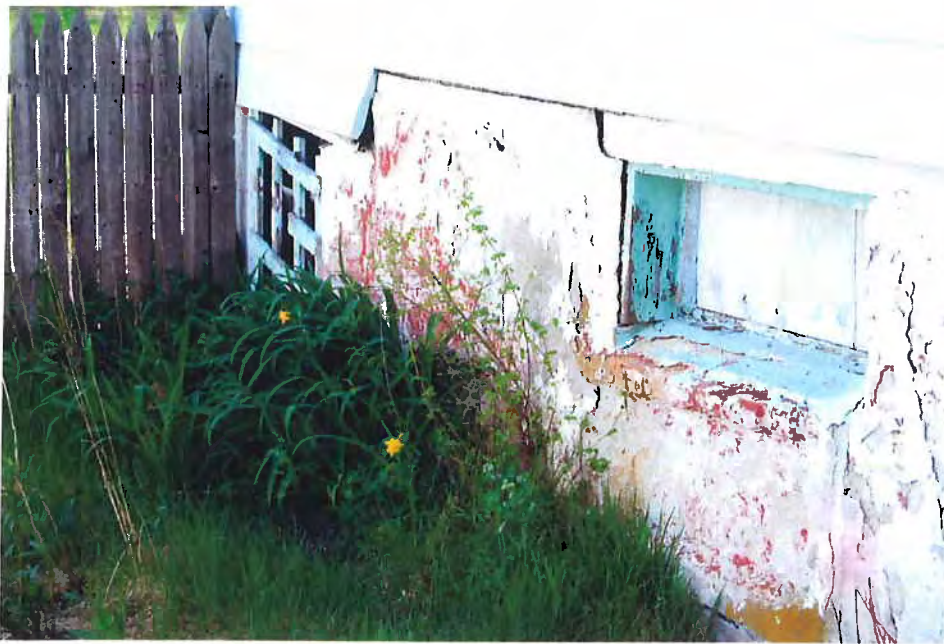
Photo 3

4. Significant settlement of the foundation wall has occurred at the northwest corner of the basement [Photos 3 and 4]. The damage is around a well located inside the basement at that corner [Photo 27]. The basement wall could be stabilized by placing a new footing under the wall corner across the distressed soil extending to sound soil on the side and on the rear of the building. The loose stone could then be rebuilt or stabilized in its current subsided location.

Settlement of the
northwest corner seen
at the basement
window.

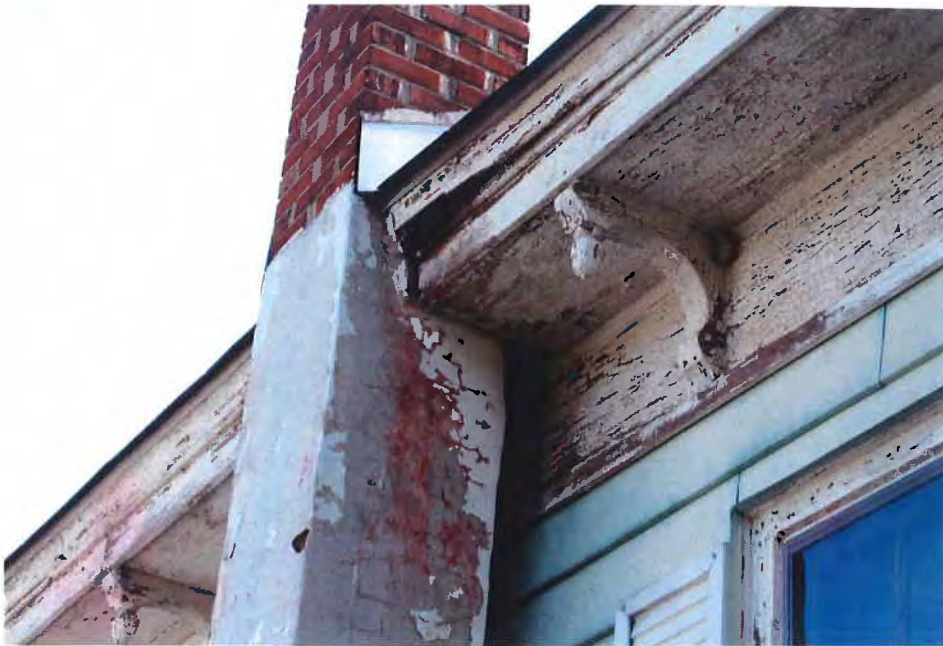
Photo 8

Space between chimney and the building with siding passing through.

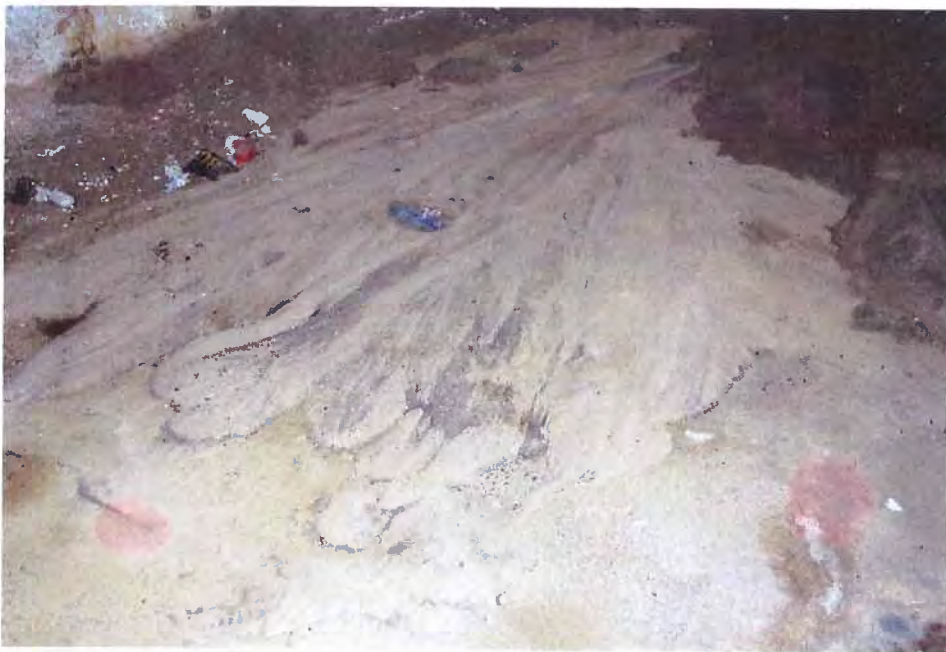
Photo 22

5. The basement walls have loose cement parge which should be repaired. Water infiltration through the basement walls has deposited alluvial mud fans on the basement floor [Photo 22 to 24]. The masonry curb mass along the base of one wall may have been placed to prevent water infiltration along that wall [Photo 25]. After the loose parge has been removed, any voids in the basement wall should be packed with a lime rich mortar before applying new parge. Improved re-grading along the four sides would reduce the surface water along the basement walls.

Sand and mud deposit in the basement.
