James Still Office Preservation Plan

Submitted to:
New Jersey Historic Trust

Prepared by:
KSK Architects Planners Historians, Inc.

Final Copy: 30 October 2009

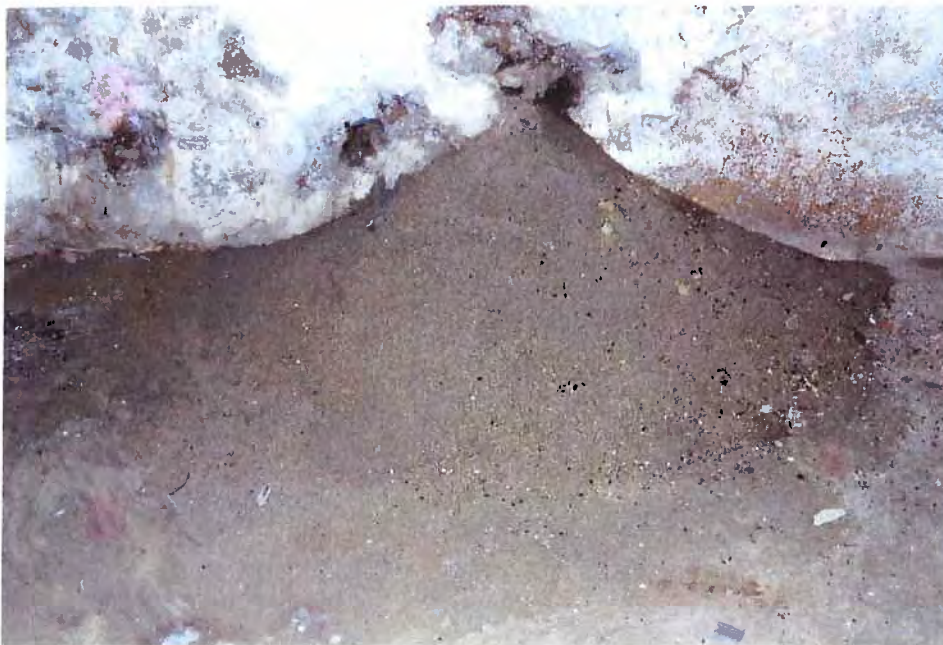
Photo 23

5. The basement walls have loose cement parge which should be repaired. Water infiltration through the basement walls has deposited alluvial mud fans on the basement floor [Photo 22 to 24]. The masonry curb mass along the base of one wall may have been placed to prevent water infiltration along that wall [Photo 25]. After the loose parge has been removed, any voids in the basement wall should be packed with a lime rich mortar before applying new parge. Improved re-grading along the four sides would reduce the surface water along the basement walls.

Sand and mud
deposit in the
basement.

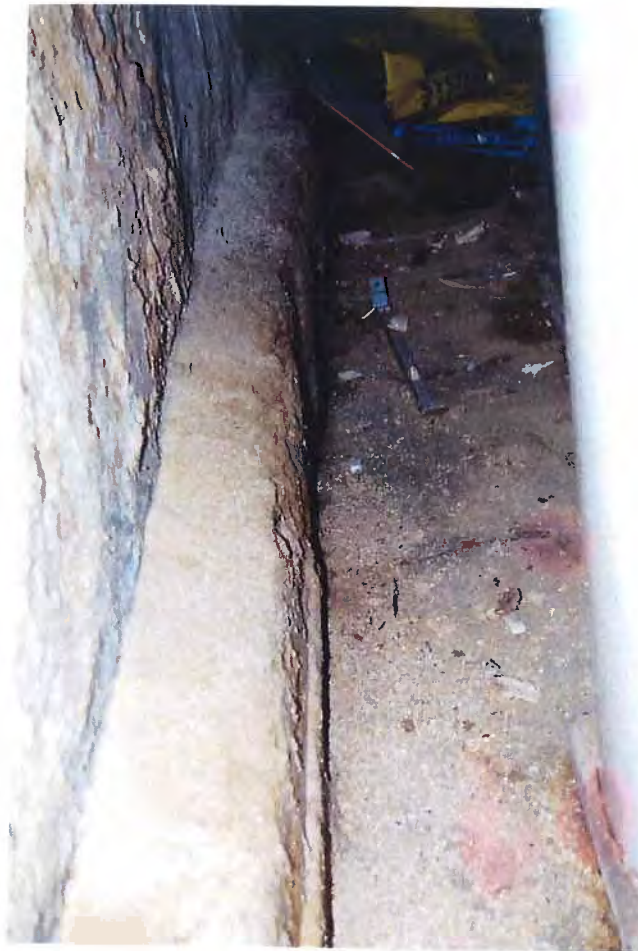
Photo 24

Sand deposit in
basement.

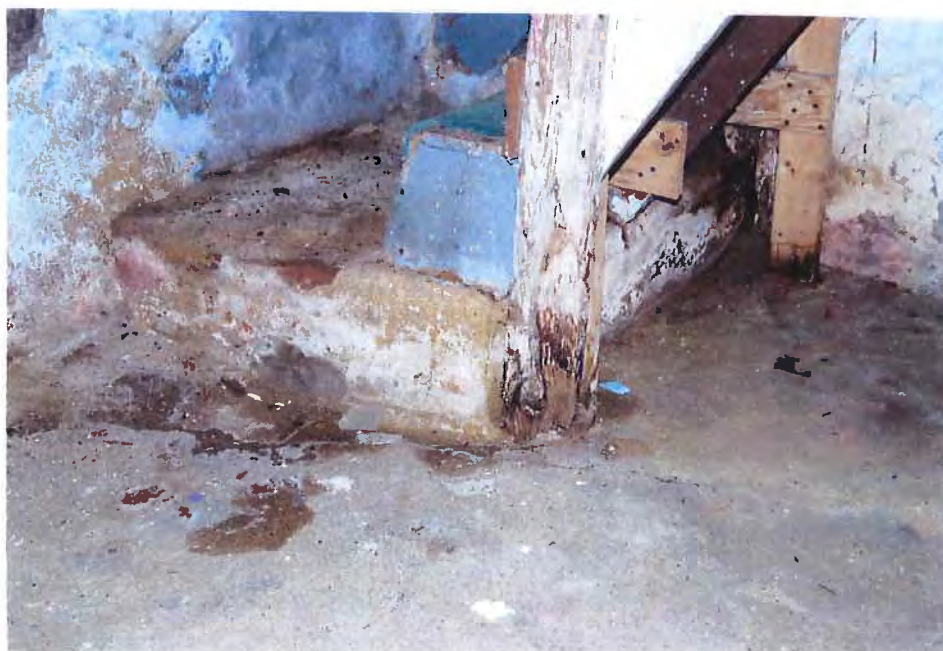
Photo 25

Curb placed against
half of the west
basement wall.

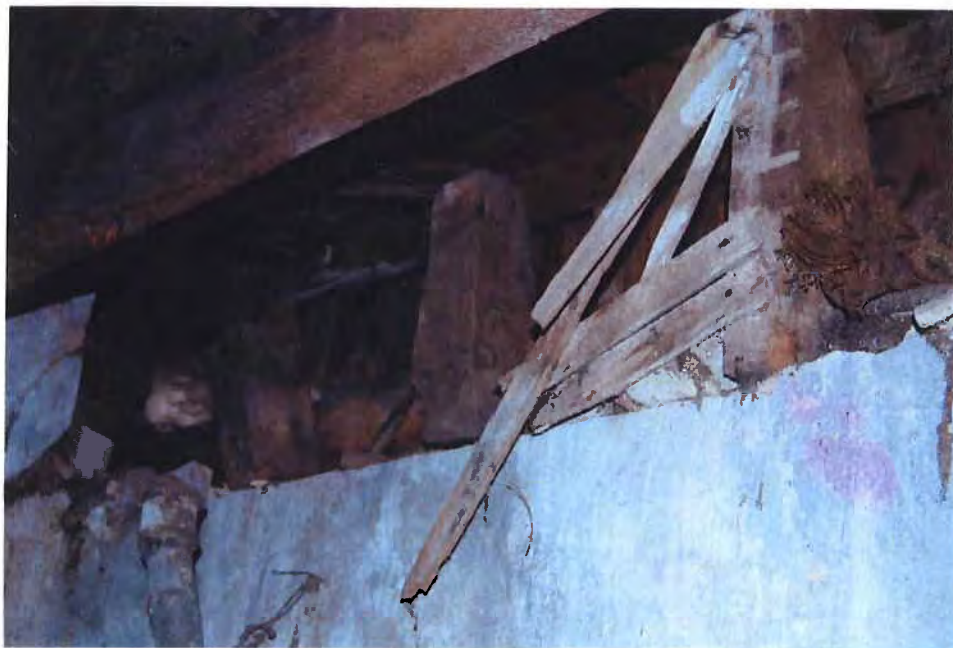
Photo 27

4. Significant settlement of the foundation wall has occurred at the northwest corner of the basement [Photos 3 and 4]. The damage is around a well located inside the basement at that corner [Photo 27]. The basement wall could be stabilized by placing a new footing under the wall corner across the distressed soil extending to sound soil on the side and on the rear of the building. The loose stone could then be rebuilt or stabilized in its current subsided location.

Well in the corner of the basement.

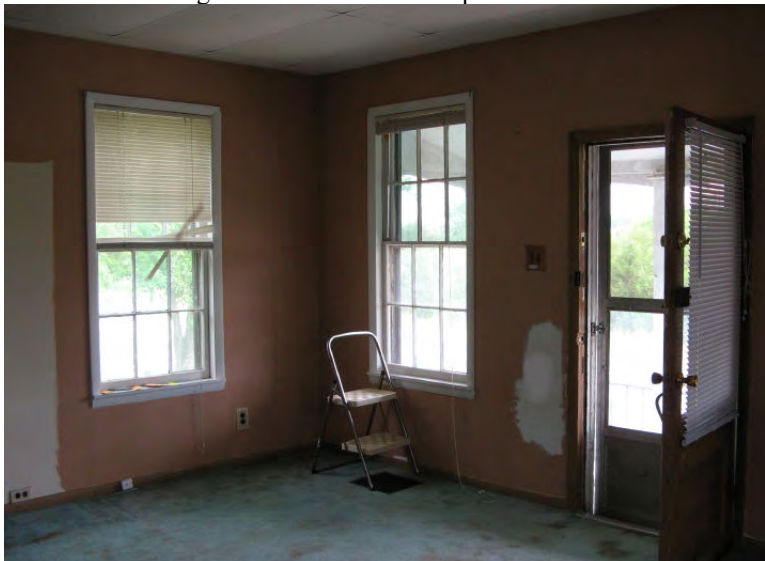
Location of samples JS13, JS14

Front room looking southeast Window sampled is to the left.

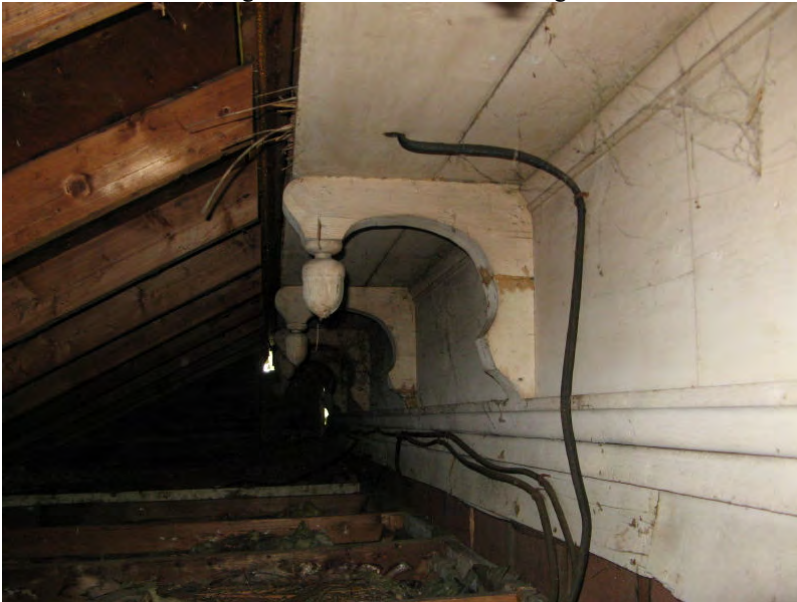
Locations of samples JS15, JS16

View to the south along the cornice above the ceiling line in the addition.

Paint Seriation Chart		
Layer No.	Color Name	SW Color Number
Substrate:	Wood	
1.	Translucent White/cream	FN106-SW6105
2.	Translucent white/cream	FN106-SW6105
3.	Translucent white/cream	FN120-SW6119
4.	White	FN232-SW6231
5.	White	E15- SW7006
6.	Yellow	Y-O/Y/68-SW6668
7.	Pale yellow (thin)	Y-O/Y/80-SWSW6372
8.	Translucent yellow	FN139-SW6138
9.	Translucent grayish white	E26-SW7015
10.	Dark cream	FN129-SW6128
11.	Dark cream	FN129-SW6128
Technician: L. Schnabel		Date: 8/8/08
Comments: Samples JS16 and JS17 have essentially the same layer sequence suggesting all the wall was exposed contemporaneously until the lean-to was built.

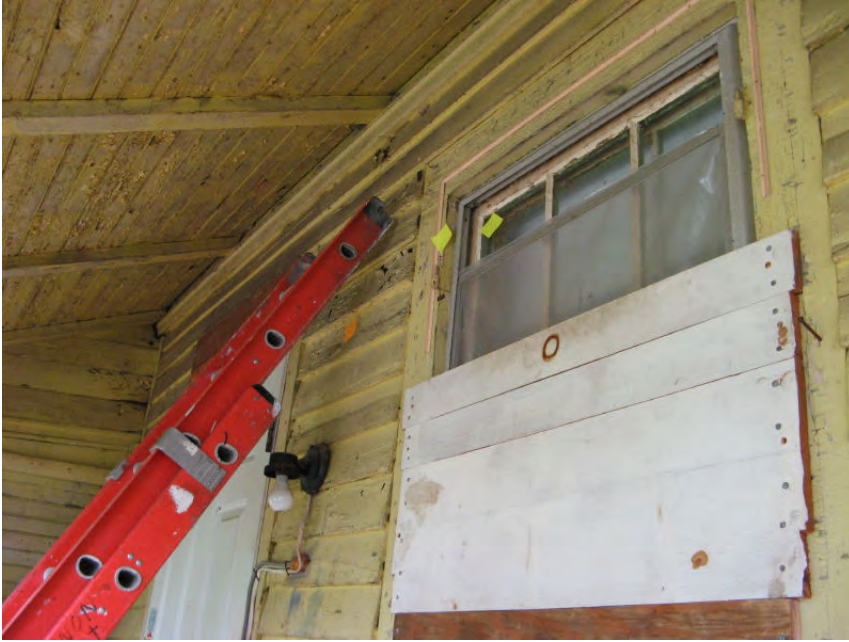
24.	Dirt	
25.	Blue-gray	E29-SW7018
26.	Green	Y-G/G/103-SW6440
27.	Dark Cream	EPP54-SW2858
28.	Dirt	
29.	Dark Cream	EPP53-SW2853
30.	Dark Cream	FN129-SW6128
31.	Bright Yellow	Y-O/Y/88-SW6910
Technician: L. Schnabel		Date: 8/8/08
Comments: Sequences are difficult to distinguish/distorted somewhat due to sample location at area of paint accumulation/build-up due to dripping. Some samples have only a few of the layers shown above. No correspondence with colors on the siding samples from the east elevation except for second to last color—Layer 30 on this sample corresponds with Layer 11 on Sample JS16.

Exterior rear (north) wall at porch showing sample locations at window and siding (orange)

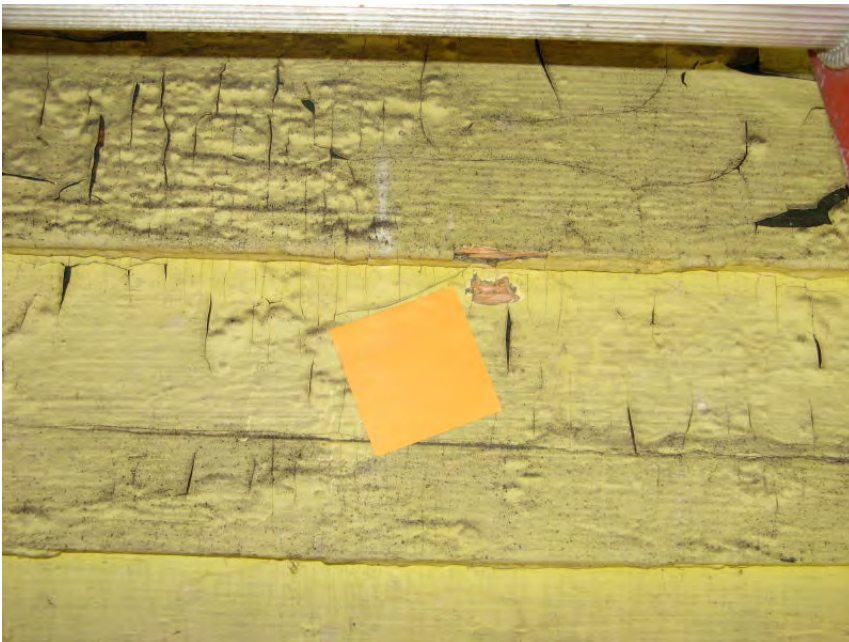
Detail of siding sample location.

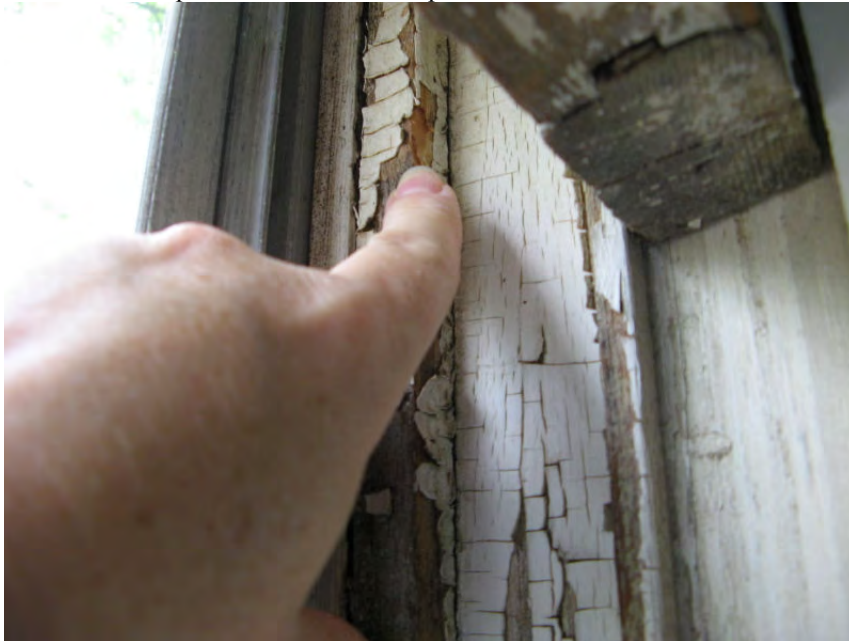
Location of frame and sash samples from the north elevation.

Paint Seriation Chart		
Layer No.	Color Name	SW Color Number
Substrate:	Wood	
1.	Cream	FN128-SW6127
2.	Gold	Y-O/Y/83-SW6375
3.	Cream	FN128-SW6127
4.	Dark Cream	FN129 SW6128
5.	Bright Yellow	Y-O/Y/88-SW6910
Technician: L. Schnabel		Date: 8/19/08
Comments: The sequence from the frame (JS33) of the window at the north elevation matches that from the south window frame except for the outer-most layers. The south window has multiple white layers after the cream; the north elevation has a single layer of yellow. Sample JS34 has only layers 3 and 4 of sample JS33; it also matches the sequence of the south elevation sash, but has a single outer white layer instead of the multiple white layers of sample JS31.

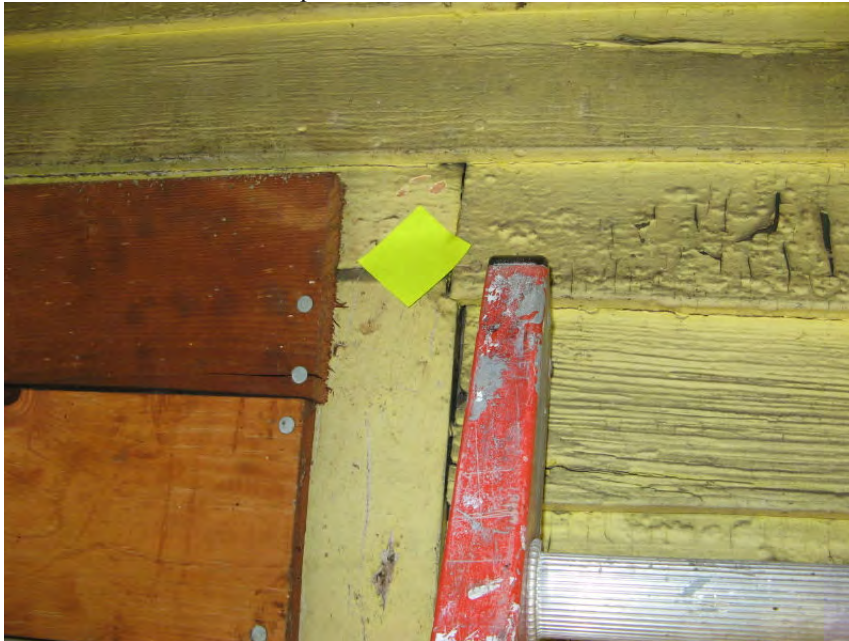
Location of door frame sample

Paint Seriation Chart		
Layer No.	Color Name	SW Color Number
Substrate:	Wood	
1.	Cream	
2.	Dark Cream	
3.	White	
4.	Dark Yellow Cream	
5.	Cream	FN128-SW6127
6.	Dark Cream	FN129 SW6128
7.	Bright Yellow	Y-O/Y/88-SW6910
Technician: L. Schnabel		Date: 8/19/08
Comments: Layers 1 and 2 are the two outer clapboard colors. The sequence matches the window frame sequence minus the gold layer.

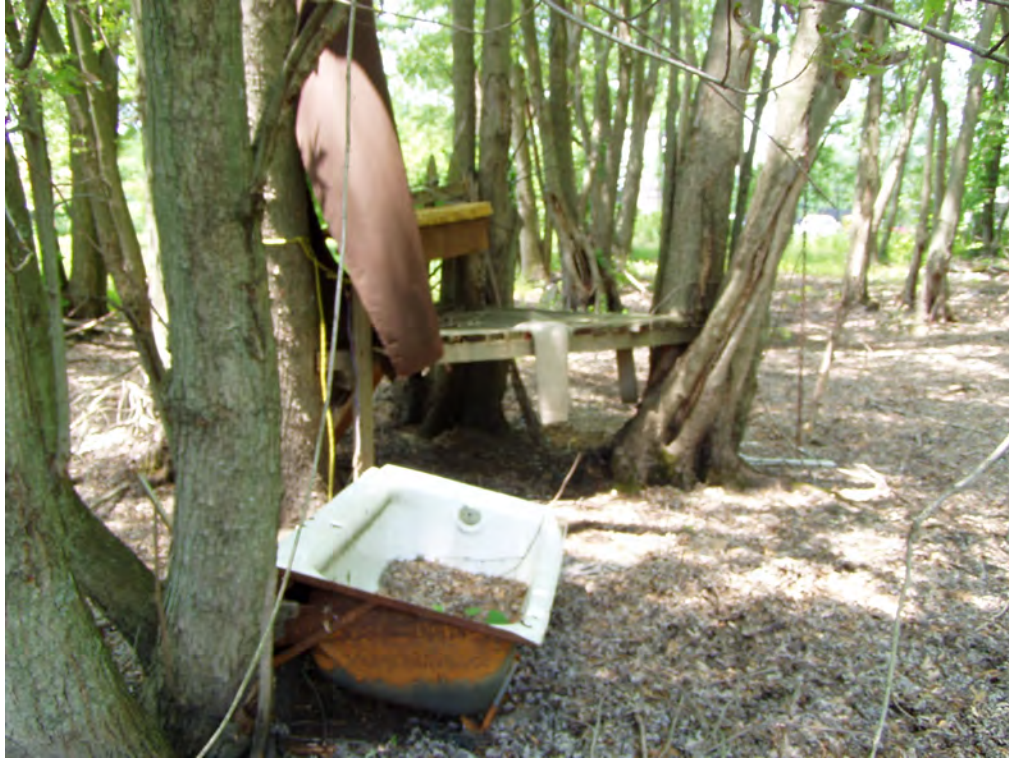
Plate 1: General view of area to the north of Dr. Stills' office containing discarded bath tub and platform/treehouse. Facing west.

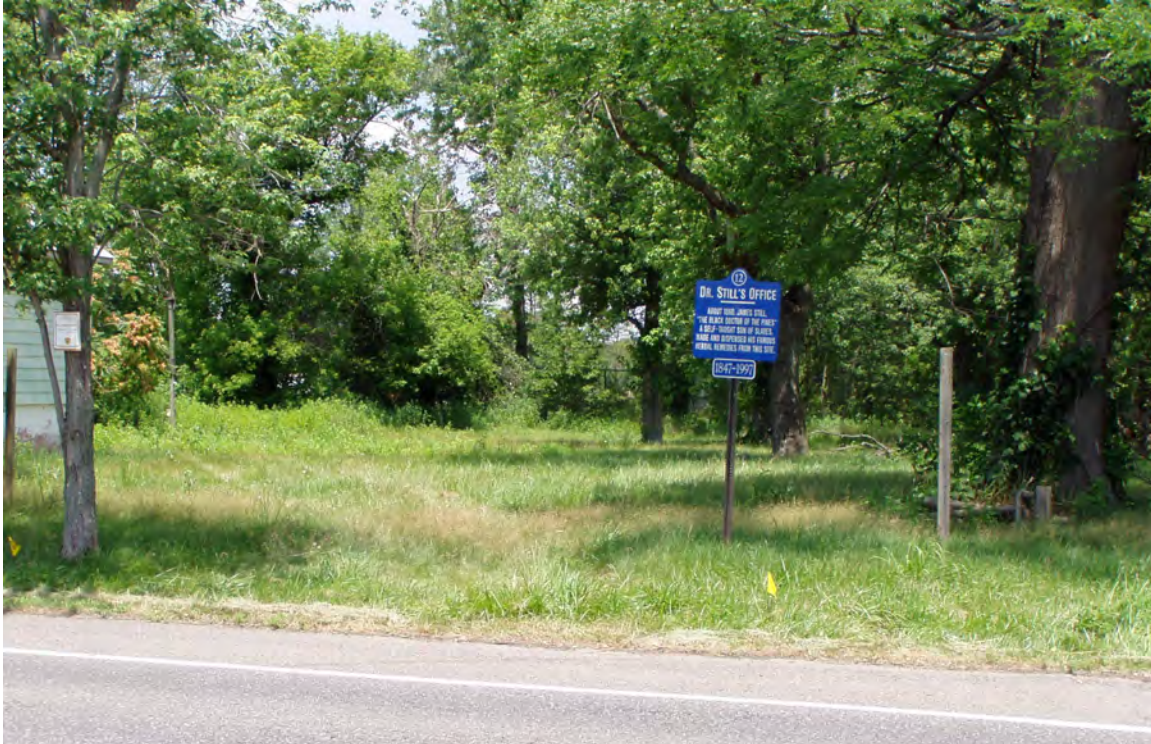
Plate 3: Former location of the Stills residence to the east of the extant office and west of large trees. Facing north.

It is recommended that the location of the house and area surrounding it be left undisturbed until the property is fully secured and activities are planned for its use. Initiating investigations while the property remains vacant may serve to attract attention from curiosity seekers who may intentionally or inadvertently cause harm to the archaeological resources on the property. Machine access should be through areas either west of the office or to the east of the large trees that stand east of the house location (see Plate 3) to avoid accidental damage to the underlying remains. Shaft features such as wells and privies may be located to the rear (north) of the former house site and this area should be avoided also.

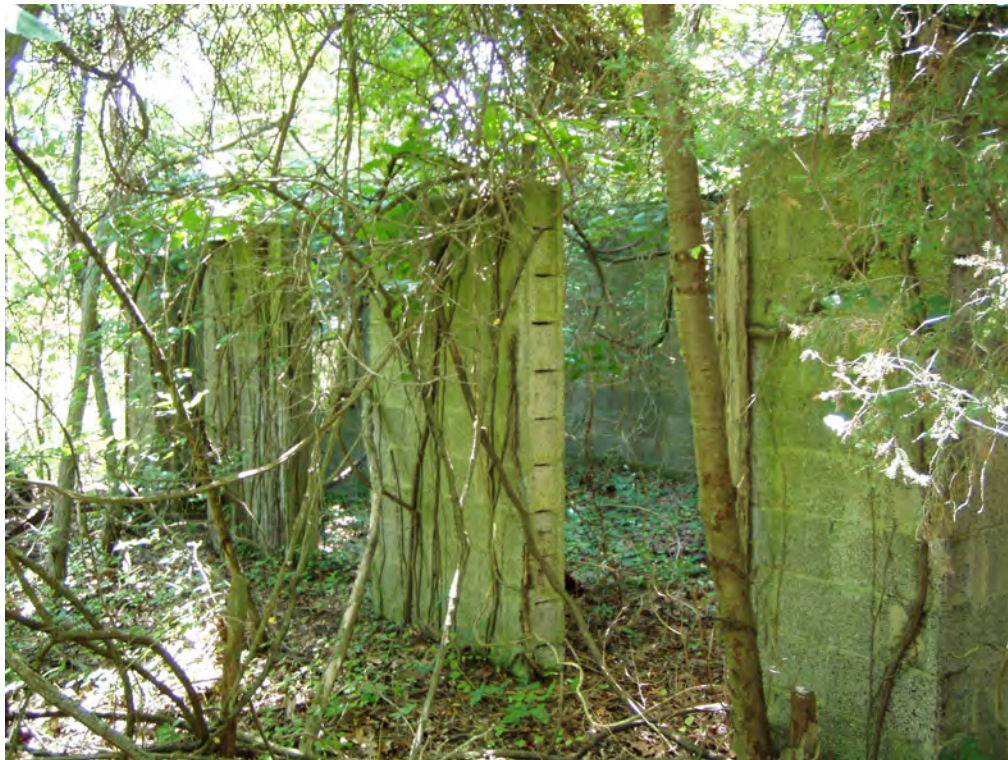
Plate 4: Northern end of cinder block outbuilding depicted on tax map (see **Figure 2**). Facing southeast.

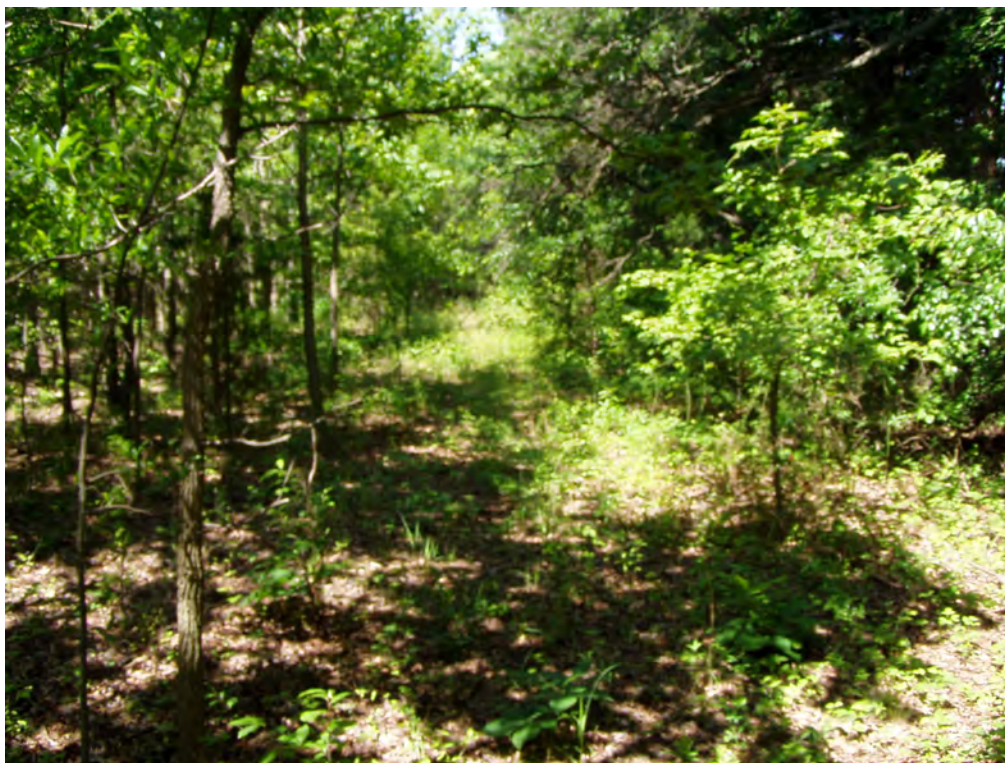
The northernmost portion of the property, up to 460 feet south of the northern property line, is lightly wooded. A path, overgrown but still easily discernable, encircles this area of new growth forest (**Plate 5**). Subsurface probing encountered a profile consistent with cultivation, suggesting that this area had previously been planted in crops. The immature nature of the trees growing in this area indicates that such activities probably occurred after, or were continued from, the time during which Dr. Still occupied the property. The final feature of note on the parcel is an earthen road straddling the northern property line (**Plate 6**). This road, which extends beyond the east and west boundaries of the property, is referred to as Hollingshead Lane or "the road leading to the mansion house of Job Haines" in deeds related to the property (noted on tax map – see **Figure 2**).

Plate 5: Informal path which encircles the area of new growth forest in the northern third of the property. Facing south.

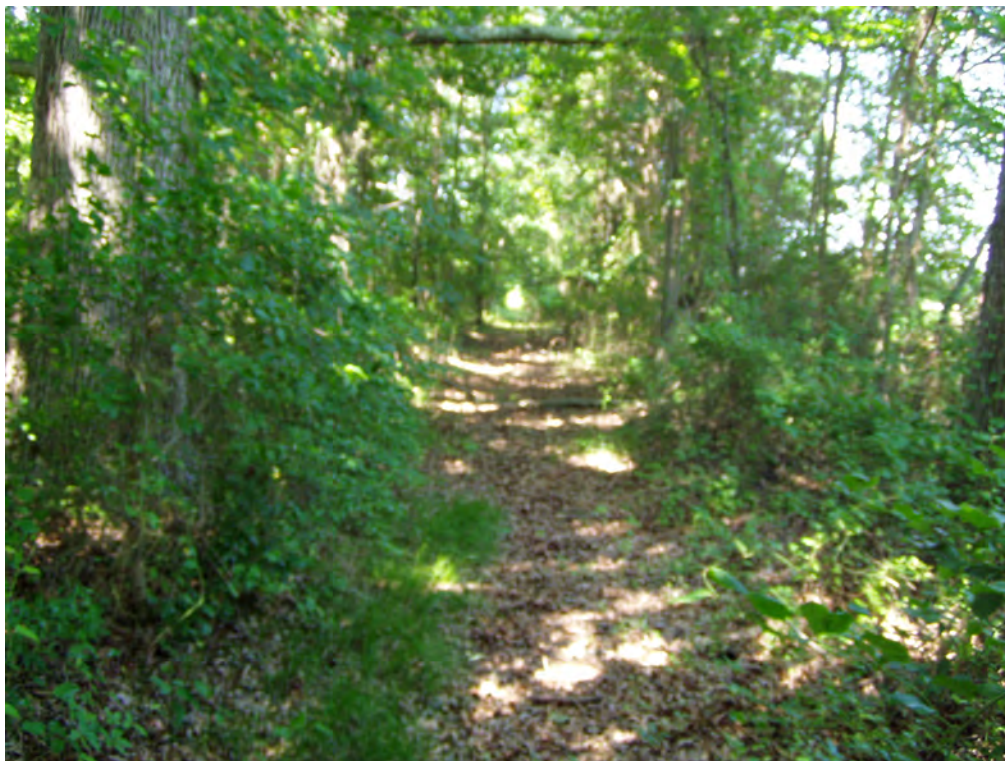
Plate 6: Earthen road running along the northern property line, noted as “Hollingshead Lane” on tax map (see **Figure 2**). Facing west.
